Marconi's Carnarvon Station 1912-1939

Archaeological Reconstruction
and History of a Trans-Oceanic
Wireless Site

John Rowlands

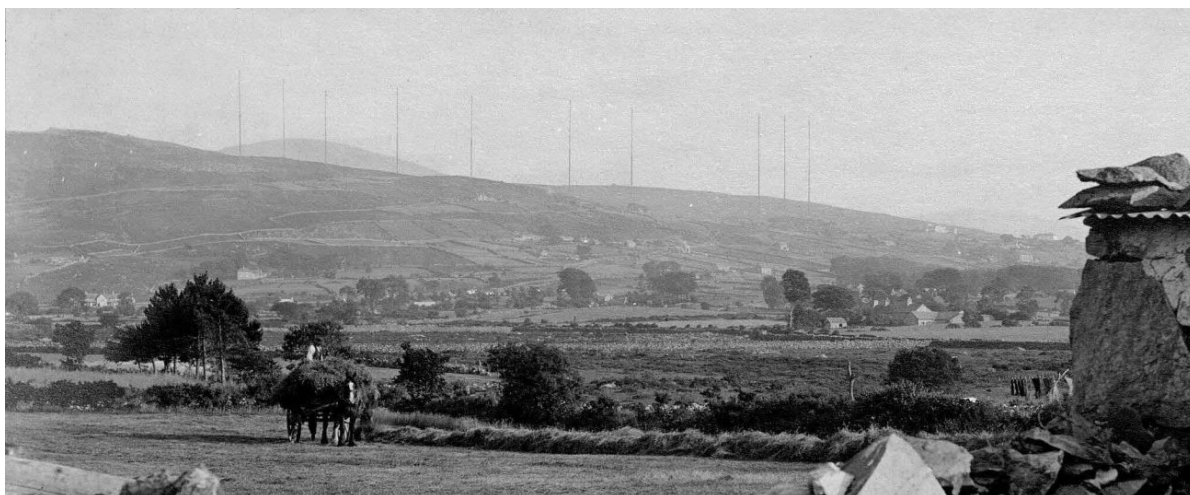
2. *Modern communications technology contrasts sharply with rural ways in this side view, taken in summer 1918 from near Llanrug – almost certainly, from Rhôs-lan (SH 52993 63140), of the 1914 antenna to the south-east, running up Cefn Du. Detail of a larger image from Bodleian Special Collection MS.Photogr.c.243, photograph P.2070 (see also related P.2067, P.2068, P.2069).*

The overall form, but not the detail, for the first, 1914 antenna at Carnarvon is readily reconstructed, with little dispute, from images of the time and from remaining base structures. Ten tubular steel masts of 400' height ran uphill from the transmitter buildings, such that the horizontal part of the antenna wire they supported sloped at a noticeable, 12% mean gradient (328' total gain in height between lower and upper mast bases) in the case of the 1914, unmodified antenna. The masts were arranged in a 3, 2, 2, 3 pattern widthwise, with the three mast arrangement being at either end of the antenna, the extra mast taking up the additional end loads (see 2). The radiating wires hung from insulators attached to steel triatic suspension wires, themselves isolated from the masts by ceramic rod and 'reel' insulators (see Draft Specifications, Appendix III, p.162).

Spacing between the masts in the long direction was a constant 900'. The width of the antenna (between the 2-mast pairs, or outer two masts at the 3-mast ends) increased by a constant 50' per set, uphill. The outer masts of the lower extremity of the antenna were 450' apart. The next masts up were 500' apart. The third pair 550', and the final outer masts of the upper, 3-mast end, 600' apart. A Marconi Company pamphlet of ca. 1922 (*The Marconi High-Power Wireless Station at Carnarvon*. MS.Marconi.198) describes the masts as spreading 'fanwise', an exaggerated depiction of a front-to-rear increase in span of only 150' over 2685'.

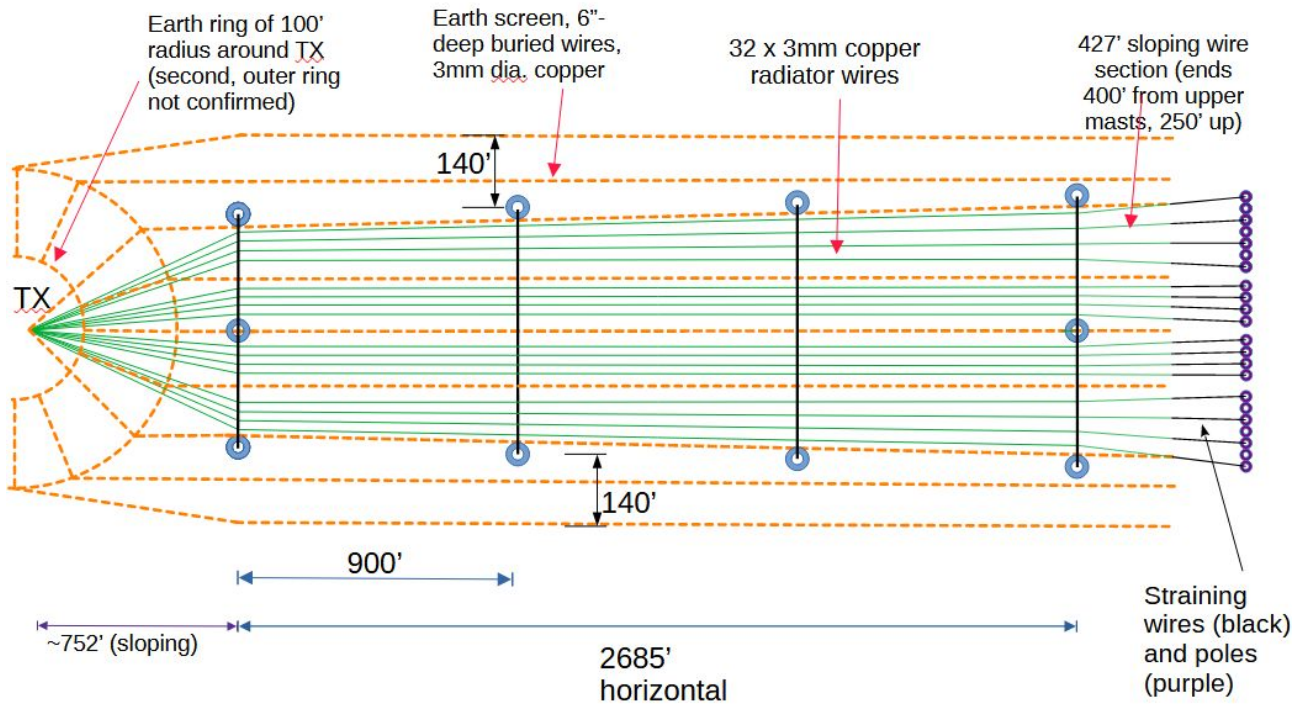
3. Simplified schematic of the 1914 antenna, prior to first modification (i.e. pre-ca.1921). There were initially 32 radiating wires, arranged in a 2 x (2 x 8) group, manifesting as an 8-16-8 pattern at the rear strainers, with a gap between groups. Only an indicative number of radiating wires is shown, in green, in order also to show the earth screen wires, in dashed orange. The screen extended in width (N-S) to just inside the outermost anchor blocks and, it seems, lengthwise, to the east, at least as far as the termination of the radiating wires. The row of purple circles to the rear indicate the wire straining poles, now numbering 29 in all; the three missing strainer bases, which would bring the total up to 32, can reliably be accounted for as having been destroyed to make way for the 1923 double ATI building. Locating the 'lost' strainers by measuring 4.5m from each of the centre strainers correctly places them in a coherent plan. Accounts of the antenna can be confusing to the unwary because often, they do not make clear which period of the site they were referring to, may themselves conflate different periods, changes were rapid and often experimental and temporary, and texts were often at least partly based on much earlier writing.

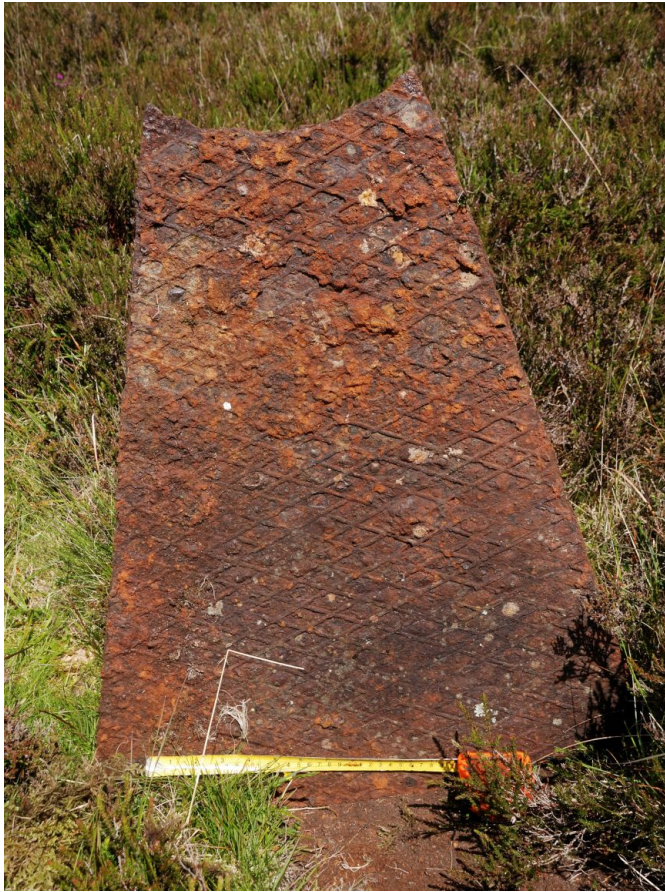
5. Tread steel plate, with inner and outer curved edges, possibly part of the standing area of a mast-top gallery, potentially Mast 8, which is seen in a 1939 British Pathé film reel ('Felling Wireless Masts at Carnarvon', Film ID: 1013.05, issued 1/06/1939) to fold on toppling, which might explain this plate being found 265', and not 400' from the mast base. Yellow part of tape open to 1 foot. 25¾" long, outer edge 21¾" long, inner edge 9½" long, ½" thick.

A gallery was fitted between the last and next-to-last tube unit at the top of the masts. This seems, from photographs, again of inadequate quality to be absolutely sure, to have had only a couple of steel plates either side of the mast top, rather than a continuous walkway all the way around. A section of tread steel plate was discovered in a position reflecting roughly where the top of Mast 9 might have come to rest (269' from its base) when the site was cleared in 1939. This may well be the tower seen falling, folding in the process (hence the 269' from the base, rather than ~400') to the north, recorded in a 1939 British Pathé newsreel about the demolition, work which was undertaken by Thomas William Ward Ltd., Sheffield – famous in earlier times for hiring an elephant and its keeper to haul trailers during WW1, when horses were in very short supply. The base stud nuts were first cut (see **21**), and then the guys on one side blown with gelignite (**6**), causing the mast to "sway ominously". The steel plates of the masts were sent to the Rhondda Valley for use as water carriers (*Liverpool Daily Post*, 24/5/1939, p.13).

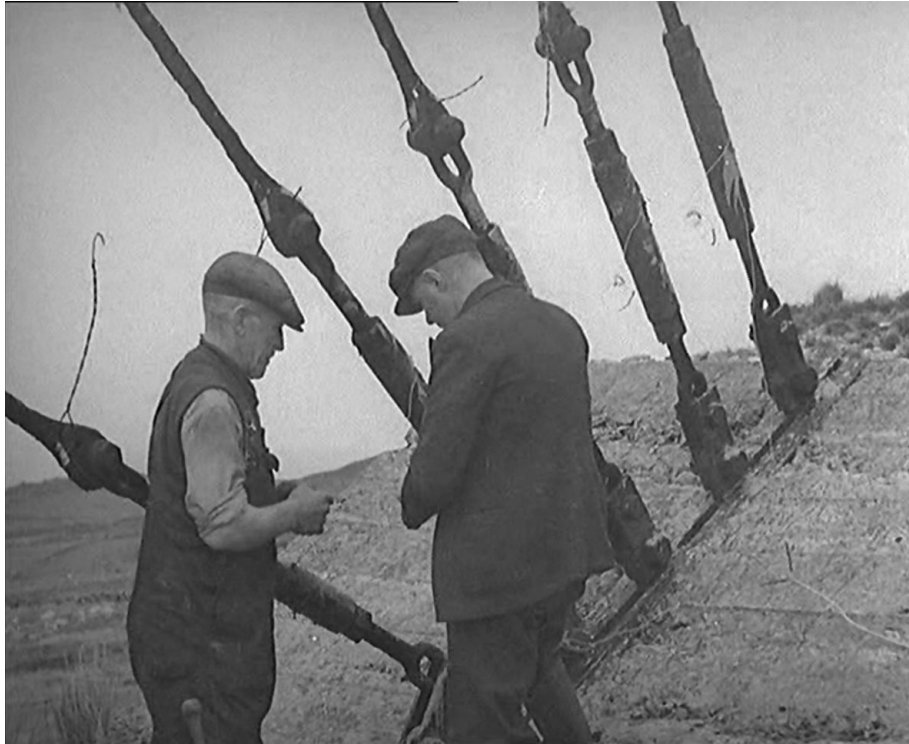
6. Preparations for stay cutting with explosives (method confirmed in *Aberdeen Evening Express*, 24th May, 1939, p.5 and *Liverpool Daily Post* of the same date, p.13), during May 1939. Five stay attachments are seen. Other photographs show seven stay wires. This is explained by two wires being attached, via a trapezoid plate, to each of the lower two anchor attachment rings (plate just visible lower centre). In this image, and in another of the tower immediately before felling, some of the lower stays have already been detached. The projecting thin wires appear to be copper grounding wires (cut) between stays. Image © Reuters via British Pathé, still N°. 7, Film ID: 1013.05, issue date: 1/06/1939, under licence.

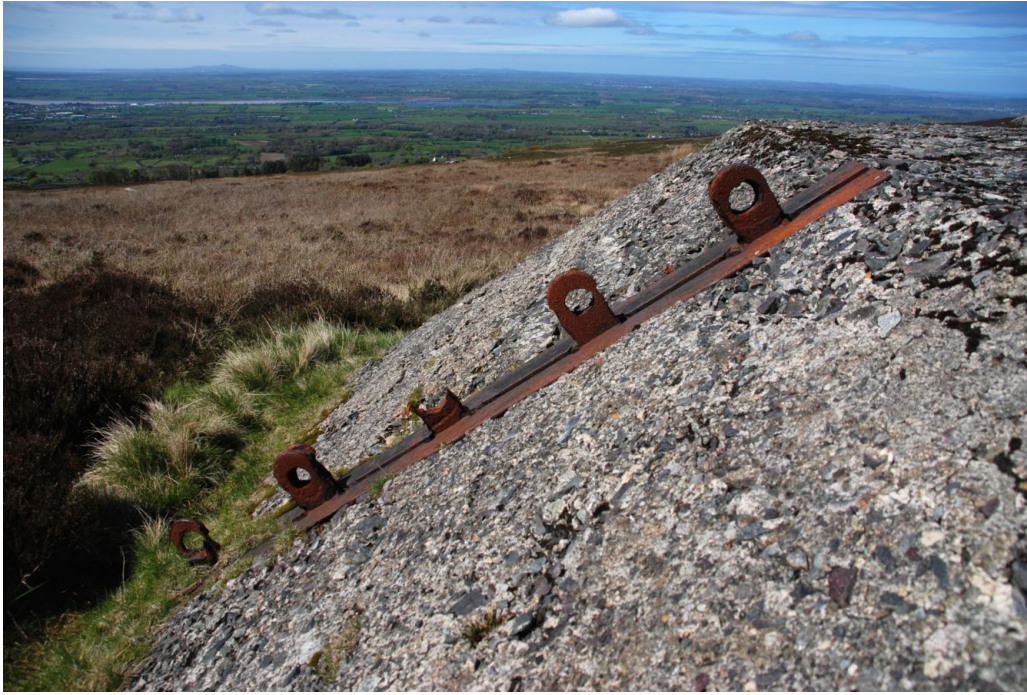
8. Anchor block (6C) and stay turnbuckle attachment points, April 2017.

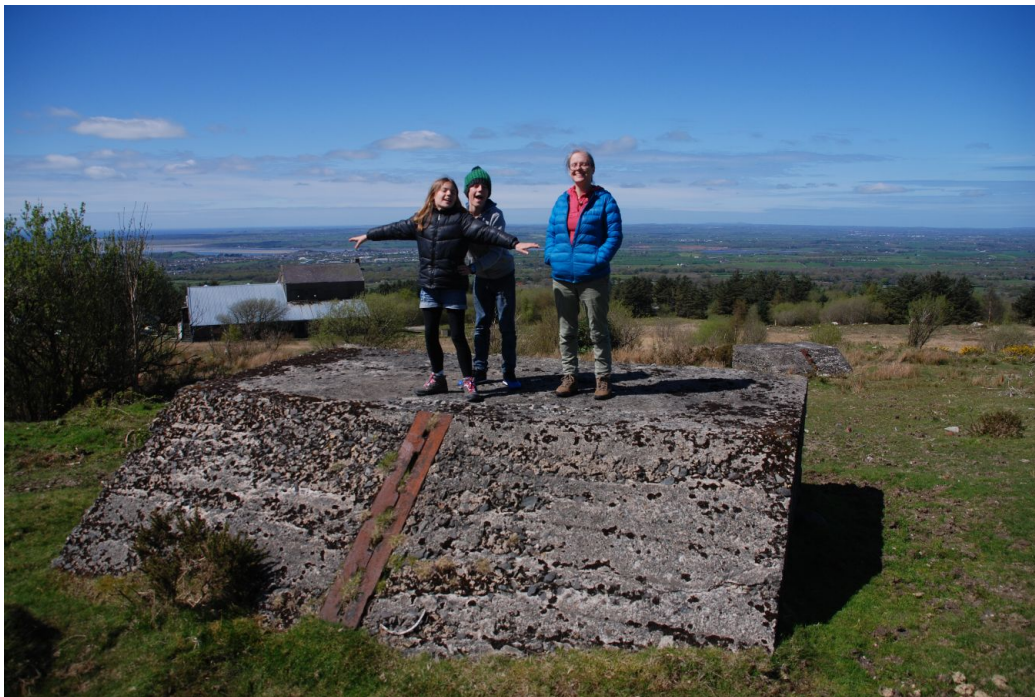
9. A wider, April 2017 view of concrete anchor 3B, with family members for scale! Transmitter buildings seen in background, centre left. The blocks present a 35.5-37 degree (varies slightly between blocks) sloping face, within which stay attachment points are inserted between and bolted to a concreted-in, $\frac{1}{4}$ "-thick, pair of 4"x4" 'L'-section steel retainers, 7' long (slot between is 1.5" wide). Anchors 143" x 124", height variable according to surrounding ground, typically about 45". Anchor fixings 4.25" long. Their mass, some 98 tons ('Trans-Ocean Wireless Telegraphy, New Transatlantic Service, The English [sic] Station Described'; The Wireless World, July 1914, p. 218) has led to at least two of the anchor bases tipping in the peaty ground; 10D by 3 degrees and 4C by 5 degrees. Anchor 4B is in poor condition, but because of this, allows the internal anchor steelwork to be understood (see 123, 124).

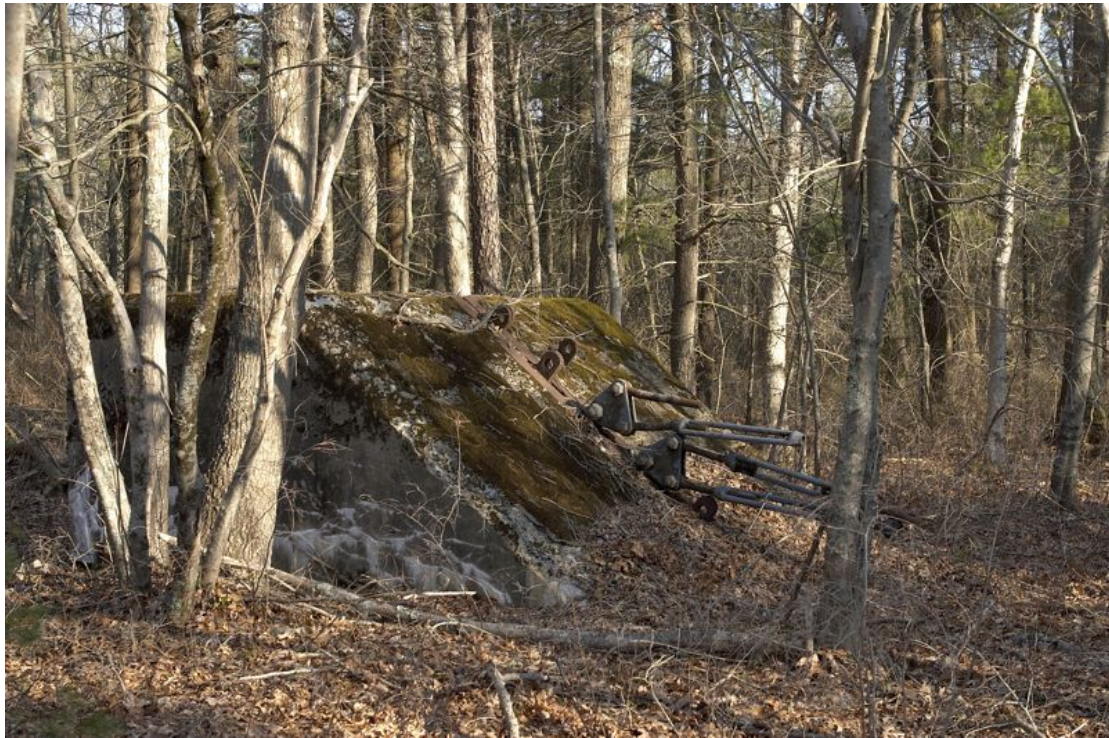
10. The familiar form, together with trapezoid, two-anchor attachment plates, now blending into the forest taking over the site of Marconi's Marion site, Massachusetts, USA. Image by kind permission of Marian Howell via Sippican Lands Trust.

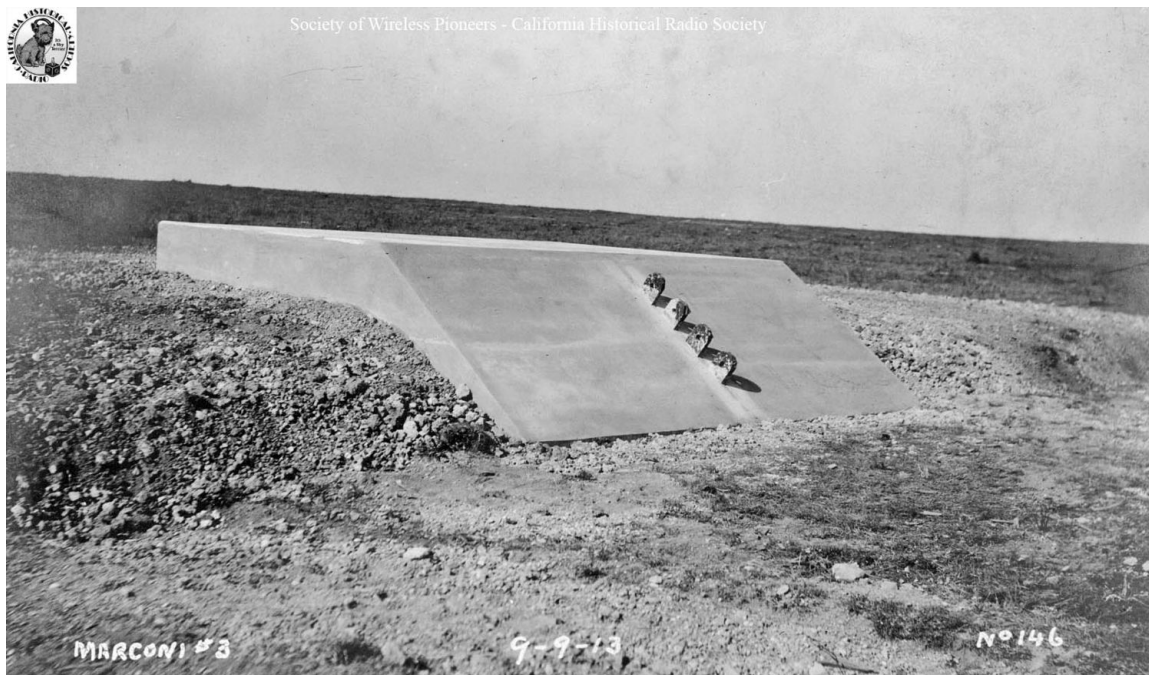
11. The global span of Marconi's wireless system becomes clear as we find an anchor block of the same form in Bolinas (initially callsigned 'KET'), California, USA, at 5,168 miles from Carnarvon. All US Marconi stations were soon taken over by RCA due to government concerns over control of communications. Date as per photo annotation. Image courtesy California Historical Radio Society, which, in 2017, revived the later callsign 'KPH' as a WSPR beacon receiving station on the amateur radio HF bands.

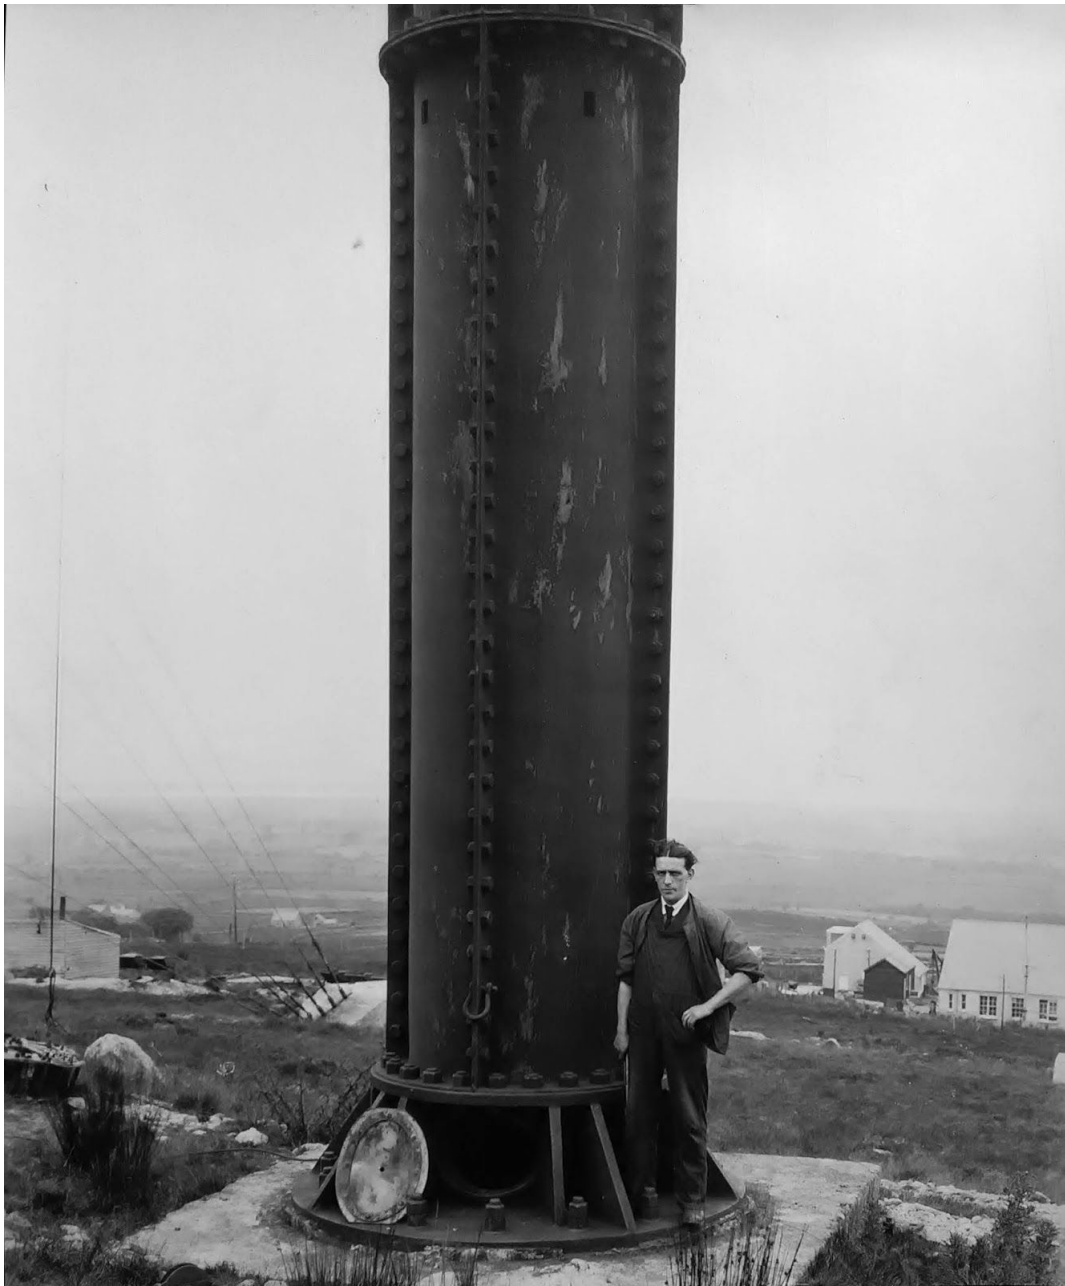
12. Central mast (Mast 2) of the first three masts at the transmitter (western) end of the antenna. A hatch is laid open, giving access to the ladder running to the top gallery, within (The Wireless World, July 1914, p.218). The baseplate at the concrete (6' diameter stud outer to stud outer) is of 16 threaded studs of 2" OD, with two nuts of 2½" OD securing each. The ¼ section mast elements, each 15 feet long, are of fairly thin steel (see **129**), perhaps ¼" or less thick, with 29 bolts joining each vertically and 20 radially. Rectangular holes, of unknown purpose but potentially related to the raising mast platform used during erection, are seen in the upper centre of each section – also seen in images of Marion (USA) and Ullandhaug (Norway) masts. The lower part of the mast was 3'6" in diameter (presumably internal, but not known – both referenced accounts fail to indicate), the upper part 2'6" (The Wireless World, July 1914, p.217 and Marconi station pamphlet in MS.Marconi.198). Note the 7-stay anchor at rear left of mast and what is probably a triatic halyard, at far left. The item on the floor at left is difficult to identify. The lanyard is behind, rather than connected to it. There are no smaller steel masts either side of the transmitter house at this time. Bodleian Special Collections MS. Photogr. c.243, document P.2092. Date unknown, but pre-elevated counterpoise, and therefore pre-1921, probably around 1918.

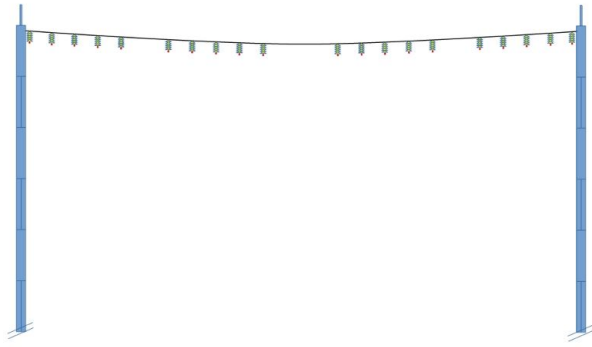
14. *General arrangement of 1914 mast heads, triatic support wire widthwise between them and insulator supports hung from it. The lower insulators were 'reel' (pulley-wheel) type, through which the antenna wire moved freely to allow for dynamic tensioning from the rear, where triatics had a design breaking strain of 7½ tons (draft specifications appearing in The Marconigraph, September 1912, pp. 214-216). The view is looking either up or down hill, along the antenna. This depiction, for clarity, shows just 20 radiating wires, whereas there were 32 initially. Two wider gaps between sets of insulators are inferred from the pattern of the rear wire strainers and the centre gap inferred due to the presence of central towers at either end of the array.*

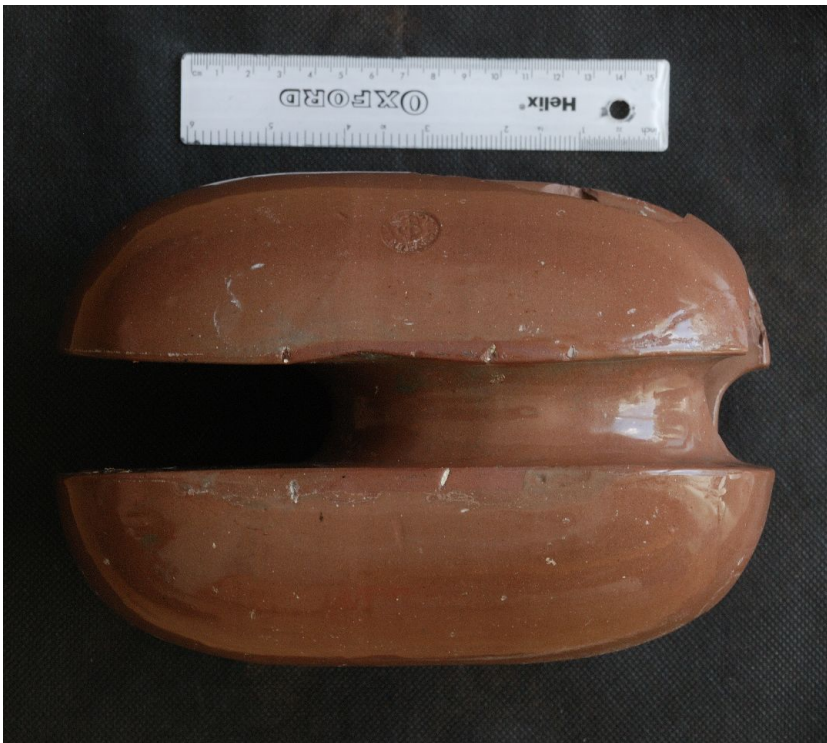
17. Recovered, nearly-intact egg insulator, showing Taylor & Tunnicliff maker's mark, centre top. Cable groove width = 30mm, to accommodate 1" diameter (termed a 3" (circumference) cable). Rule = 15cm/6". A small amount of black 'tarline', which gave some 'padding' between insulator and cable, remains on the side faces (not visible).

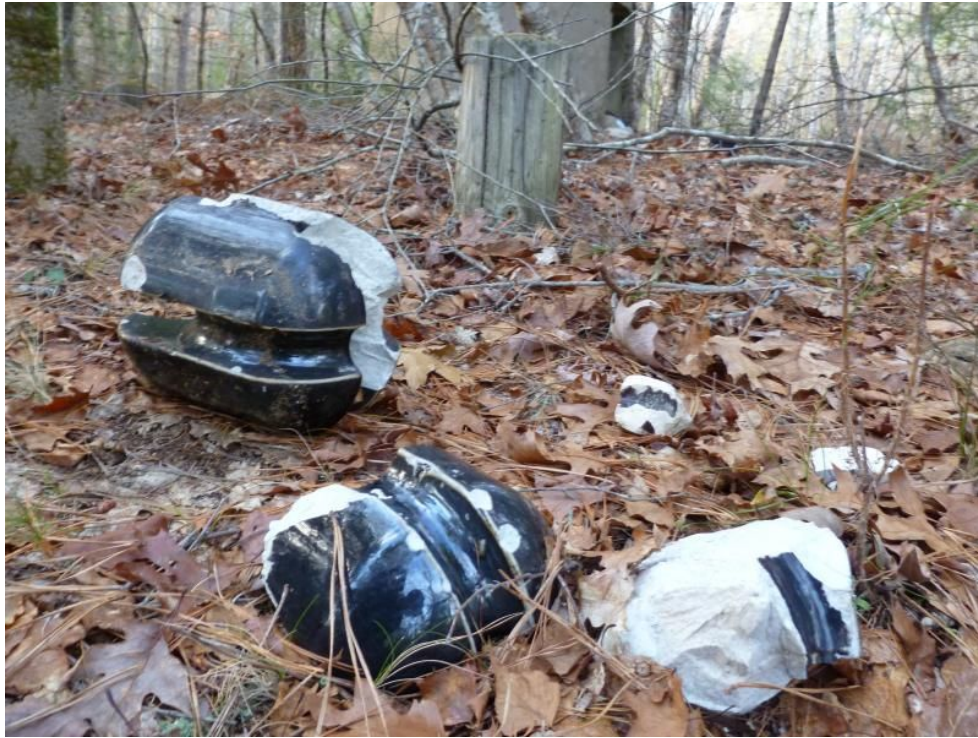
18. Egg insulator remains, identical to Carnarvon, except for the glaze colour, at Marion, MA, USA. Image by kind permission and © of Marian Howell via Sippican Lands Trust.

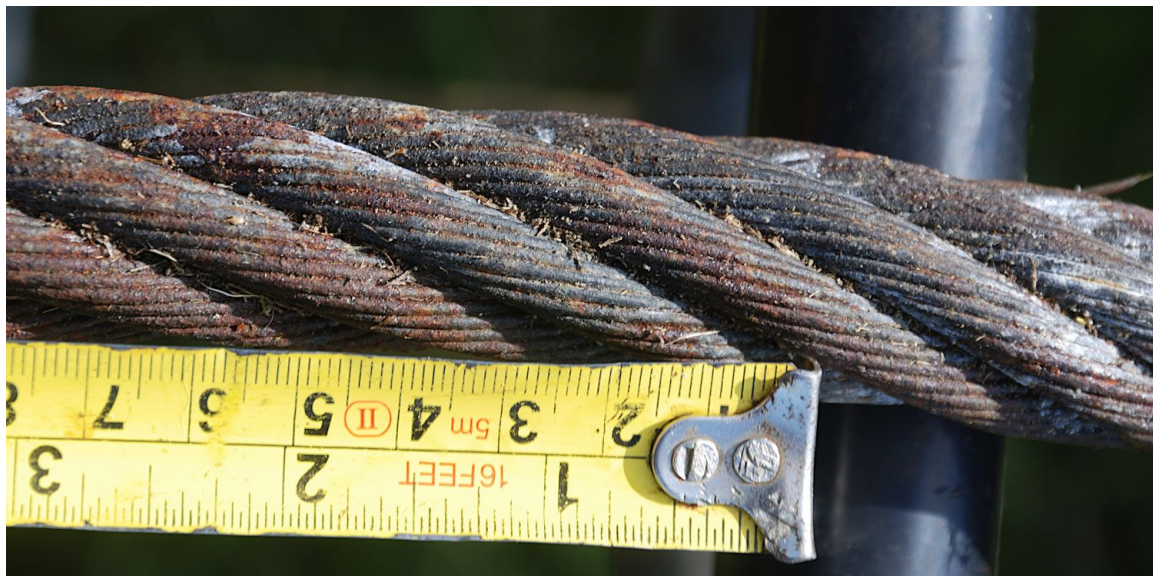
19. 1" diameter stranded stay cable – usually then termed 3" [circumference] cable – was discovered, buried at the western foot of the octagonal concrete base (see **108**) during fieldwork. for this study.

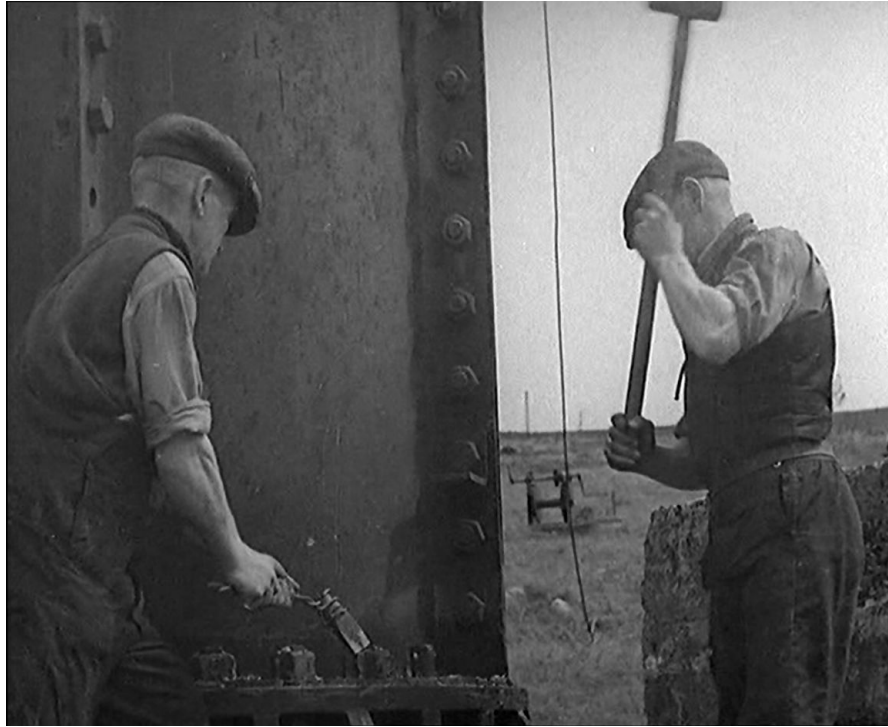
21. Hand-operated, empty, possibly triatic winch uphill of a mast, almost certainly Mast 1, given the concrete anchor to the immediate right of the hammer-wielding gentleman, during demolition in 1939. The scene shows the men splitting mast base flange to tube-securing nuts with a sharp chisel mounted on a thick twisted-wire handle to eliminate impact shock to the user's hand. This usefully explains the numerous split nuts still to be found across the site. Source: © Reuters via British Pathé, Film ID: 1013.05, issue date: 1/06/1939, under licence.

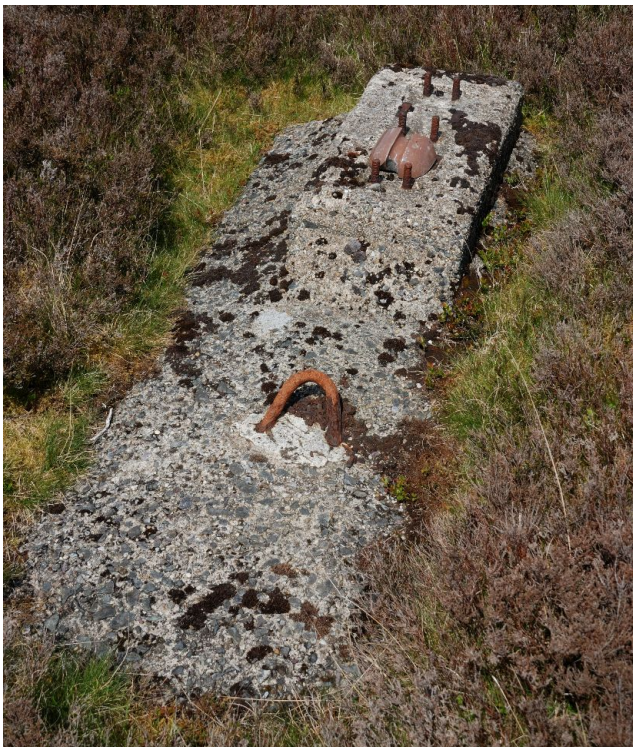
22. Winch base and wire-guiding loop (erosion of the underside of the loop apex is evident by touch). The lighter fine concrete at the base of the loop, evident at all winder sites, suggests it was added at a later point to the base. Protruding block 25½" x 7½" (with variations); bolt centres 10" and 11"; bolts ¾" dia, protruding 2½". Lower base typically 85¼" x 37". Lower and upper base apparently cast as one unit. A broken brown stay insulator rests to the rear.

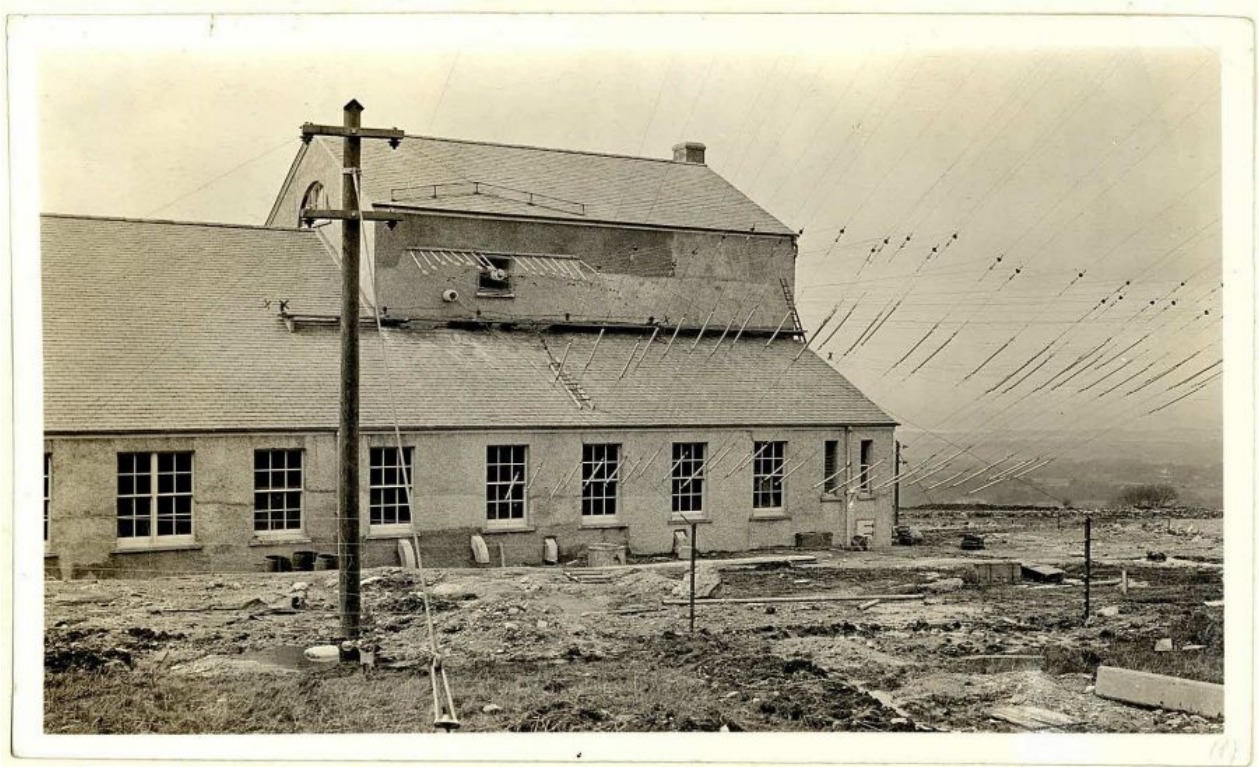
26. Carnarvon transmitter house, antenna and ground feedlines, date unknown, but from the debris and ground disturbance, early-on and certainly not later than 1917, as the same image appears in Bucher (*op.cit.* p.294). The 'telegraph' pole at left feed the two of several fence posts in the right foreground, which have multiple wires, the start of the buried earth screen, running into the ground (cf.45). The sloping radiators are fixed, via rod insulators, to a steel beam fixed on or just behind the retaining dam/wall (see 40).

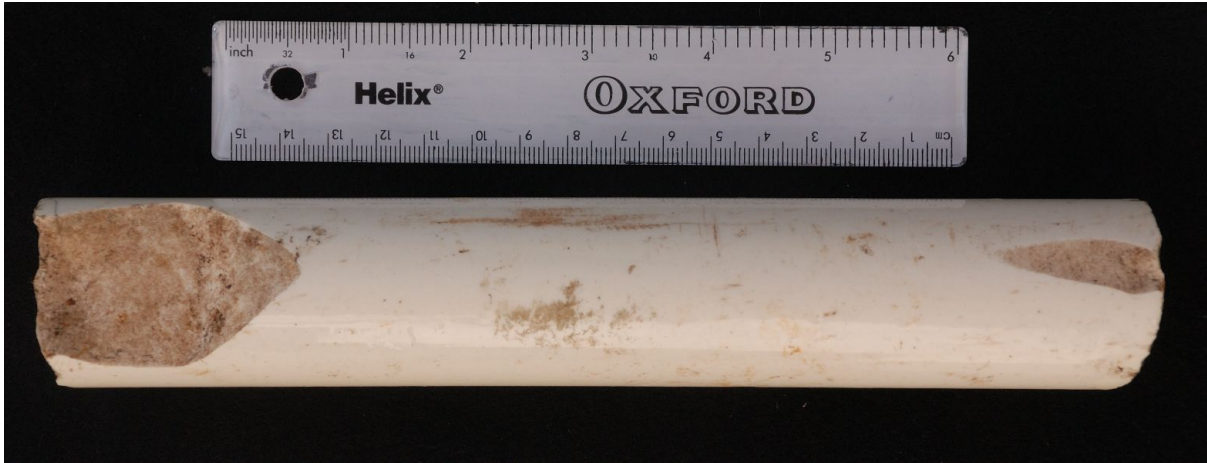
28. *Ceramic rod insulator fragment recovered at Carnarvon. These were used extensively for various purposes around the site. Scale = 150mm/6”*

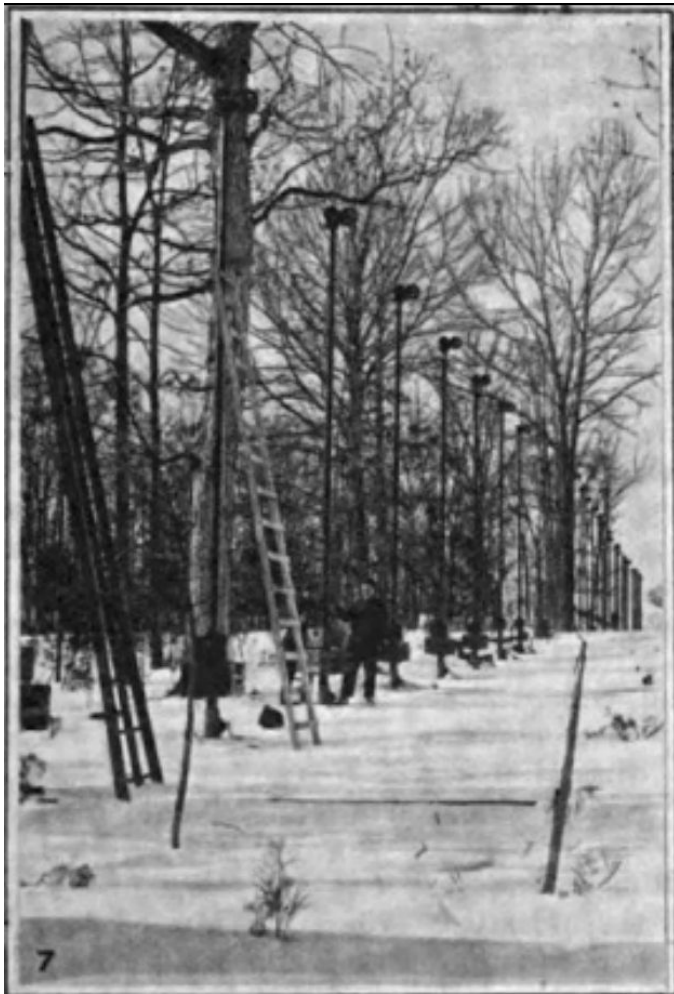
30. A poor copy image from *The Wireless World*, May 1914 (p.95, image 7 of a montage of 8), showing a row of wire tensioners at the Marconi, New Brunswick station, USA. Note pulleys at top, facing the antenna (off scene, to right), and coaxial weights near their bases. Height of the bases, taking the man to be an approximate guide, is about 22 feet. Chains attached to the bottom of the poles (just visible to the left of the ladder base, and still to be found at Marion and one base at Carnarvon) are of unknown function at the time of writing, but possibly for limiting the upwards extent of the weights' movement. See also 31-34.

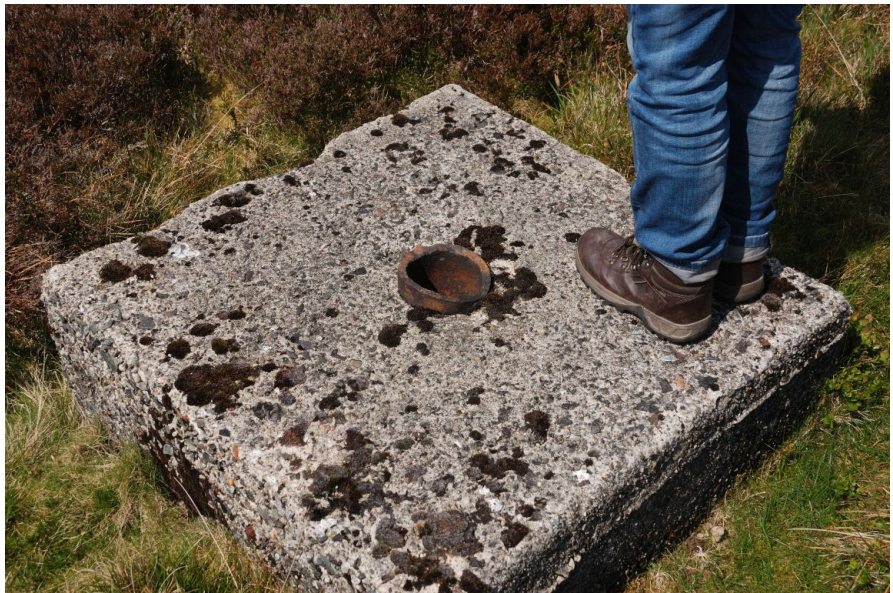
31. Concrete base, showing the remains of a 6" OD lower steel tube, part of a straining system for each of the antenna wires. Base is 3' x 3'.

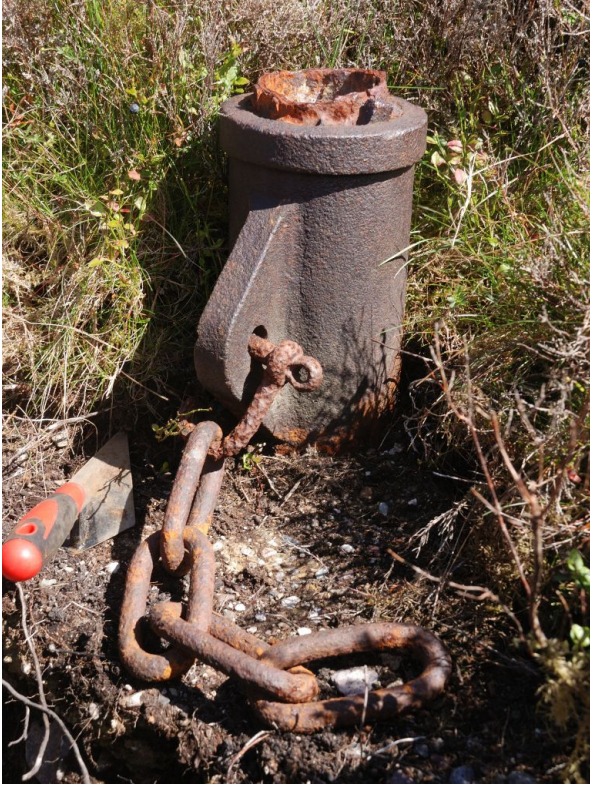
32. Iron tube base at Carnarvon, showing attachment point, shackle and chain, which is also seen at Marion (see 33). Chain appears more substantial at Carnarvon, and no trace of an attachment on the base block was found on any such base. 53.122130°, -4.176786°. Trowel blade = 6"/150mm.

The same base-and-tube structures are seen at the remains of Marion, MA, USA, which also have tubes with an attachment point, in this case, with a light chain, possibly to arrest excessive upward movement of the straining weight, running to a loop in the base side via a 'D'-ring, which may or may not have been attached to the tube base. At Carnarvon, the attachment point on all remaining 29 tubes was immersed almost by half, to the level of the hole, in concrete, whilst it was well-clear in the Marion example. Late in this project a single example of a collared and chained tube was discovered (32, above) to the west of the row of 29 tubes; a further non-collared and unchained example lay some 9 yards to the east of this.

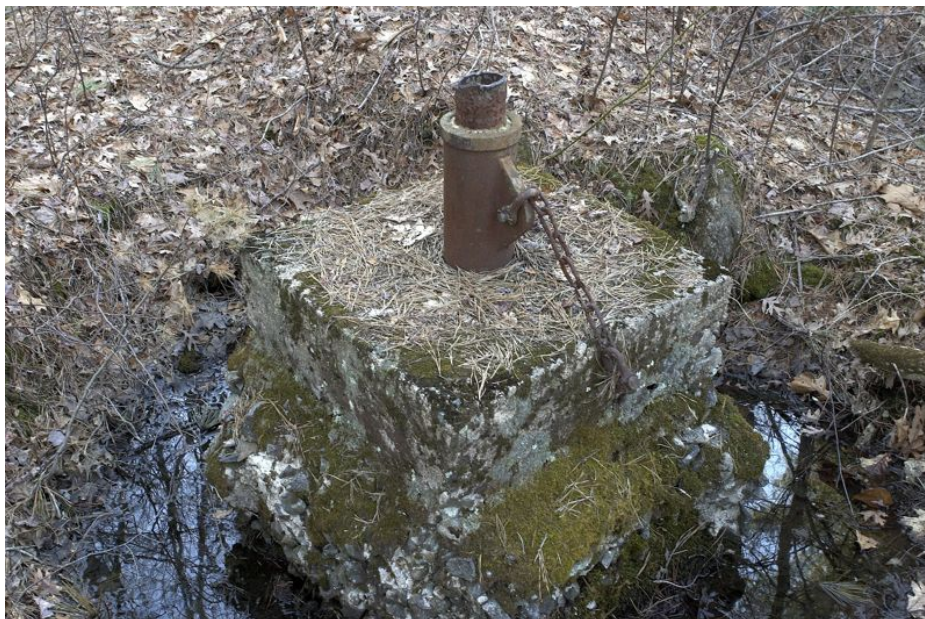
33. Wire strainer base at Marion, MA. Image by kind permission and © of Marian Howell via Sippican Lands Trust.

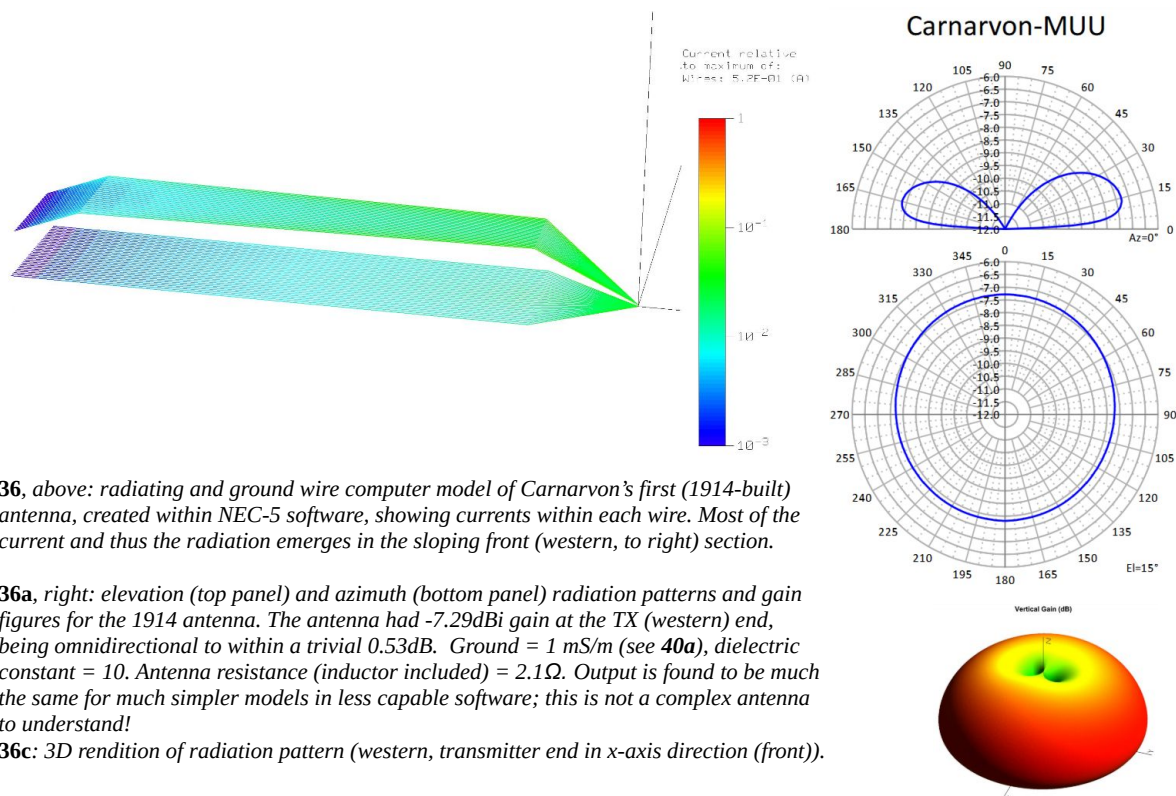
36, above: radiating and ground wire computer model of Carnarvon's first (1914-built) antenna, created within NEC-5 software, showing currents within each wire. Most of the current and thus the radiation emerges in the sloping front (western, to right) section.

36a, right: elevation (top panel) and azimuth (bottom panel) radiation patterns and gain figures for the 1914 antenna. The antenna had -7.29dBi gain at the TX (western) end, being omnidirectional to within a trivial 0.53dB. Ground = 1 mS/m (see **40a**), dielectric constant = 10. Antenna resistance (inductor included) = 2.1Ω. Output is found to be much the same for much simpler models in less capable software; this is not a complex antenna to understand!

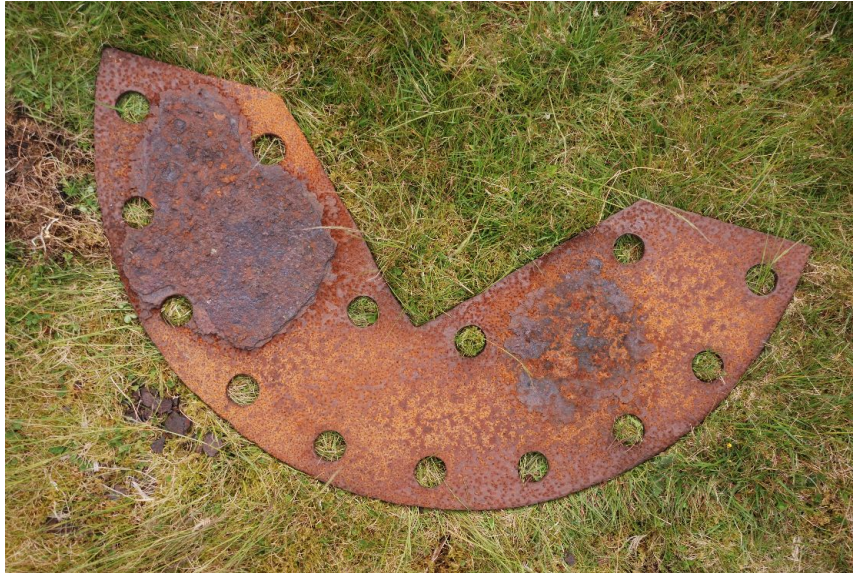
39. *One half of a heavy steel plate with outer and inner bolt holes and a square central section. It's role is uncertain, but the inner bolt holes may indicate a square-section element was attached within and almost certainly relates to one of the 1914 masts; the description of diaphragm plates between mast tube sections, for the purpose of guiding the rising erecting platform, matches this plate; if it was indeed such a plate, the square opening was probably sufficient for a man to pass through for access up the mast. Diameter = 39.25"; central square of sides 14.5"; hole diameters 1.75". Further understanding is sought. 53.122331°, -4.174260°.*

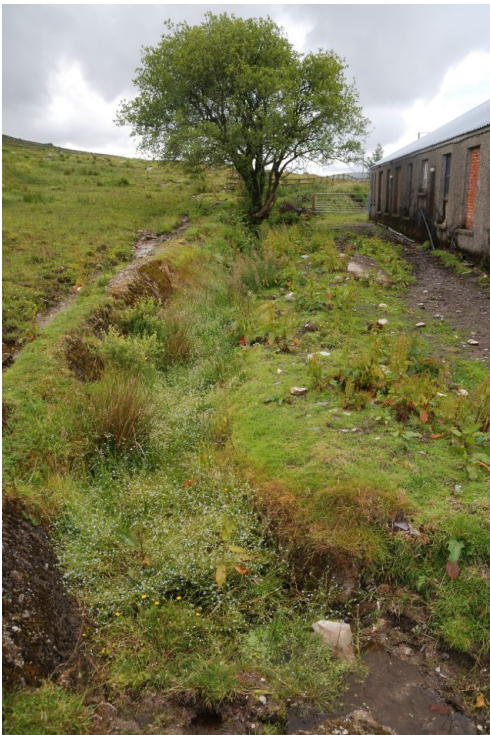
40. A low but substantial concrete retaining wall/dam (centre left) and deep drainage ditch (centre) in front of the station transmitter buildings. The site is extremely boggy and wet in all seasons, and is susceptible to soil movement. The boggy layer impedes the penetration of VLF waves into the acid igneous bedrock below, but the overall characteristics of the ground would nevertheless remain quite poor; the ITU global ground conductivity atlas maps (Recommendation ITU-R P.832-2, 1999, p.10) gives a low-resolution assessment of Wales’ ground conductivity (**40a**) as a poor, 1 mS/m; seasonal changes at VLF are insignificant (ibid. 3.1, p.2).

Bucher (op.cit., p.305), drawing on a January 1914 *Wireless World* article (‘Grounding Systems for High Power Stations’, p.610) provides a very clear, generalised diagram of how a typical Marconi station was earthed at radio frequency (see **44**). Bucher adds that slightly different arrangements might be used where stations were located on rocky or otherwise difficult ground; then, the ground system wires would simply be laid out on or very near the surface. Carnarvon’s transmitter buildings and immediate surroundings are on rocky ground, with a varying depth of boggy peat, overrun with water after heavy rain in any season. At the time, it was held to have good ground characteristics. Ground movement and water flow at the site was such that, at the eastern end of the transmitter building, facing the antenna, a fairly substantial concrete retaining wall, more akin to a deflecting 'dam', was built along the entire frontage, with a deep drainage ditch between it and the building.

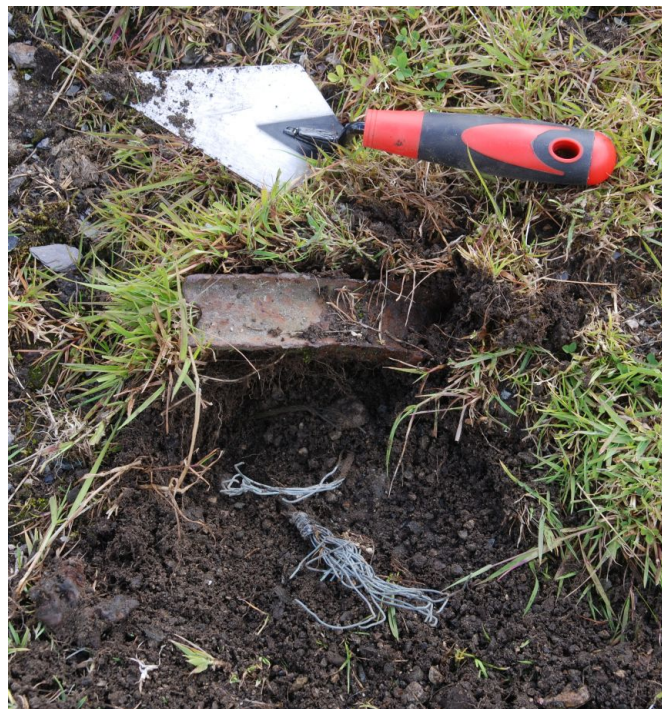
41. An iron peg, hook or handle, with stranded copper wire apparently firmly attached to it and seemingly leading away from the buildings, to the north, was found along a line that may have been that of the inner earth screen perimeter (diameter of ~100 feet). An iron/zinc earthing plate may well be buried beneath. Trowel blade = 6”/150mm long. Approx. 53.124134°, -4.193616°.

During fieldwork at the station transmitter buildings, by kind consent of the present owners, earth wires of 6-stranded copper, 3mm total diameter, were readily found at the margins of roughly circular, sloping ground that, with the edge of the slope being at the 100 foot radius, centred on the middle of the buildings (as given in the 7/12/1922 Bodleian document) almost certainly defined the first earth screen perimeter, towards the NNW of the transmitter buildings. Due to very boggy, mobile ground and vegetation, it is very difficult to look for evidence of any outer earth ring such as depicted generically by Bucher (see **44, 45**). The existence at Carnarvon of the second ring of greater radius is mentioned, however, both in *The Wireless World*, December 1913 (p.536) and in the later, July 1914 edition (p.217), though repetition of earlier works was common at this time, and cannot necessarily be taken to indicate accuracy. An outer ring is considered possible but presently unconfirmed. On the other hand, the lack of such an outer ring at Bolinas, a contemporary of Carnarvon, might suggest the latter also never had one.

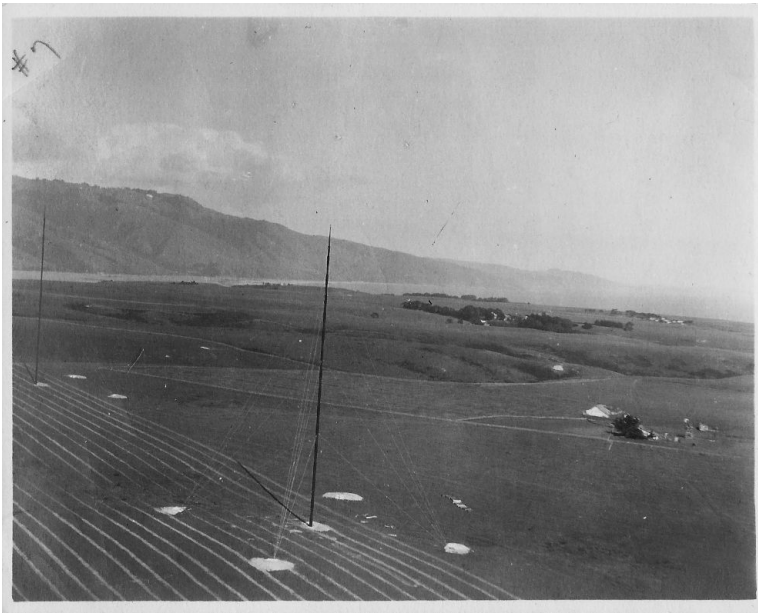
42 (left), 42a (above)

42. The pattern of the earth screen at Bolinas is seen very clearly, running lower centre to centre left, in an aerial photograph of 1913/14 (based on date of construction and opening given by Bolinas Museum, CA), taken shortly after installation where the bright cut ground for the wires contrasts strongly with the surrounding grassy cover. Survey at Carnarvon shows the extent of its buried screen was the same – to just inside the outer anchor blocks of each mast. **42a.** Station grounding at Bolinas, where there were 32 ground wires under the antenna (upper left) but only one ring and the same may have been true at Carnarvon. Images courtesy California Historical Radio society
