Marconi's Carnarvon Station 1912-1939

Archaeological Reconstruction
and History of a Trans-Oceanic
Wireless Site

John Rowlands

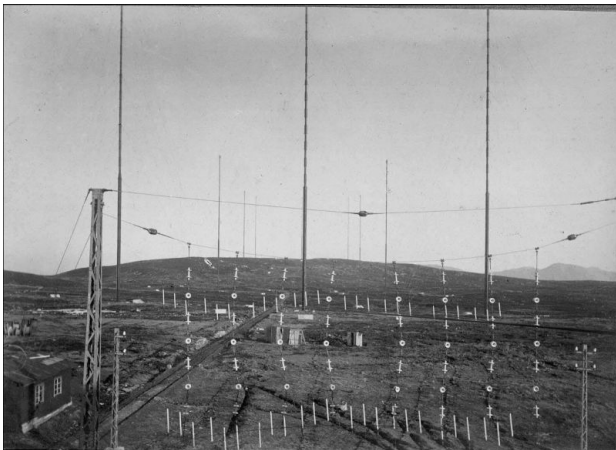
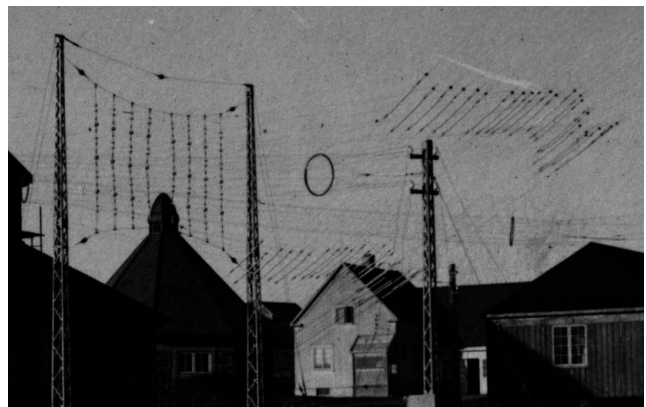
43 (left). Looking away from the transmitter building at Stavanger Norway – a close contemporary analogue of Carnarvon. As for Bolinas, CA, narrow trench scars for the buried earth screen are seen running towards the antenna masts. Here, incidentally, 24 feeds are clearly seen, thanks to the obvious white ceramic rod insulators (lower edge of photo). Carnarvon had 32 radiators initially, reduced to 20 later on. The multiply-insulated wires between the foreground lattice towers carried $(3 \times 8 = 24)$ radiator connections from the transmitter hall to the sloping radiators just in front of them which themselves are mechanically connected via insulators to the ground slightly behind the towers; all is confirmed in the highest quality, contrast-enhanced scan (**43a, right**) of Bodleian Special Collections MS. Photogr.c.249, photo NN290 (this is a duplicate number in the original album).

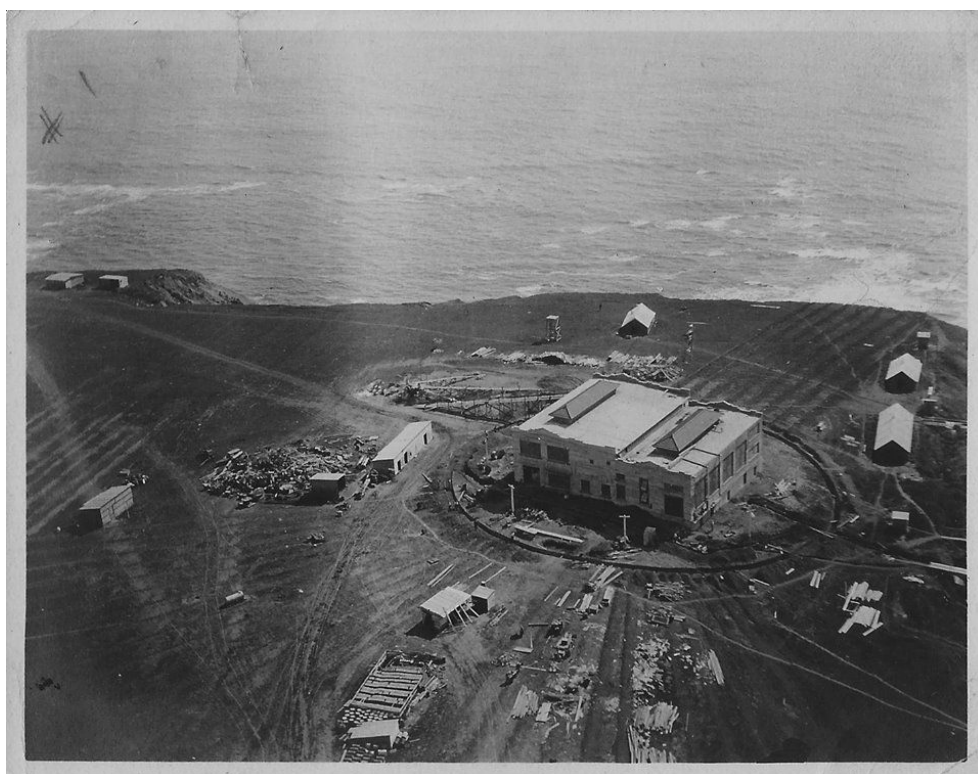
46. Whilst mobile, boggy ground has obliterated the fine detail of the lower reaches of the Carnarvon antenna site, a photograph of the earth screen – on very dry ground – at Bolinas, CA, shortly after installation shows how an earthing ring (which was irrigated by a 3/4" water pipe at the station) of 100 foot radius surrounded the transmitter building, with linear, buried wires leading away in all directions revealed by ground scars. The screen was led towards and over the cliff, and a connection, via a rectangular, 980 square foot plate, to the sea was made (Bill Ruck to Rowlands at Bolinas, pers comm 11/01/2023, with contemporary schematics examined but not released for publication). Image courtesy California Historical Radio Society.

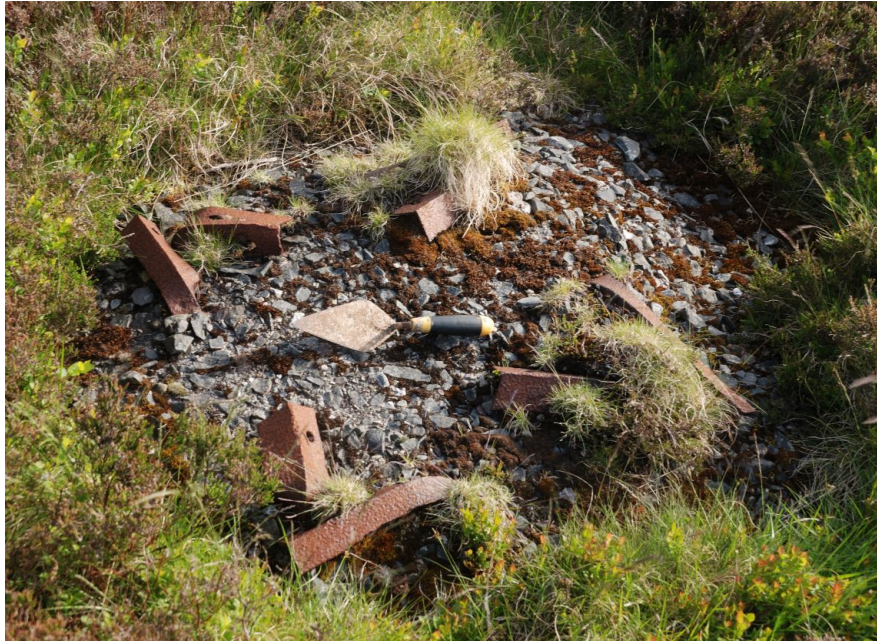
48. A typical concrete base for an elevated counterpoise lattice mast of the lower, N°1 antenna array after ca. 1921, with remains of the mast legs (1¾" x 1¾" L-section steel). Many of the bases can only now be found when the pattern of installation is worked out from those few that are more readily found, and the pattern of shallow trenches for ground wires that are still seen to run between them. The bases in many parts of the lower end of the lower antenna are now fully buried by deep bog growth, whilst the bases for the 1923 extension are typically overgrown by dense, tall heather and, at the lower end, by bog growth. Trowel blade = 6"/15cm, bases typically 35" x 35", lattice sides 20½" x 20½".

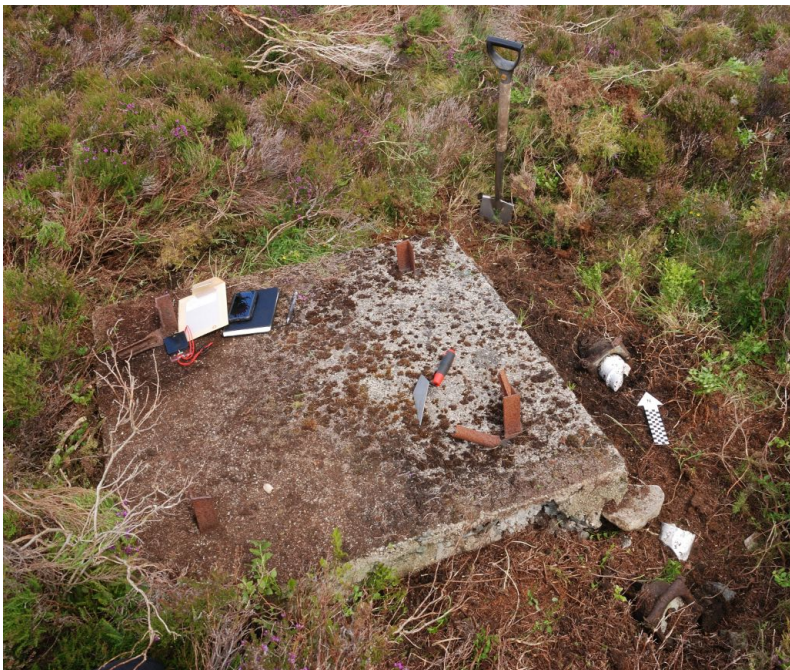
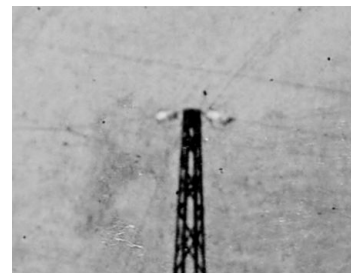
49. A counterpoise base (concrete of 4' x 4') for the 1923 extension/upper array, showing remnant lattice ironwork (32" x 32") and two large tubular insulator fixings, now known from detail visible in MS. Photogr.c.243 image 718 (inset, right) to be used to strain the wires at the tower; a 'jumper' wire interconnected both sides of the counterpoise wire over the tower. Concrete = 4' x 4'. 53.121962°, -4.169796°

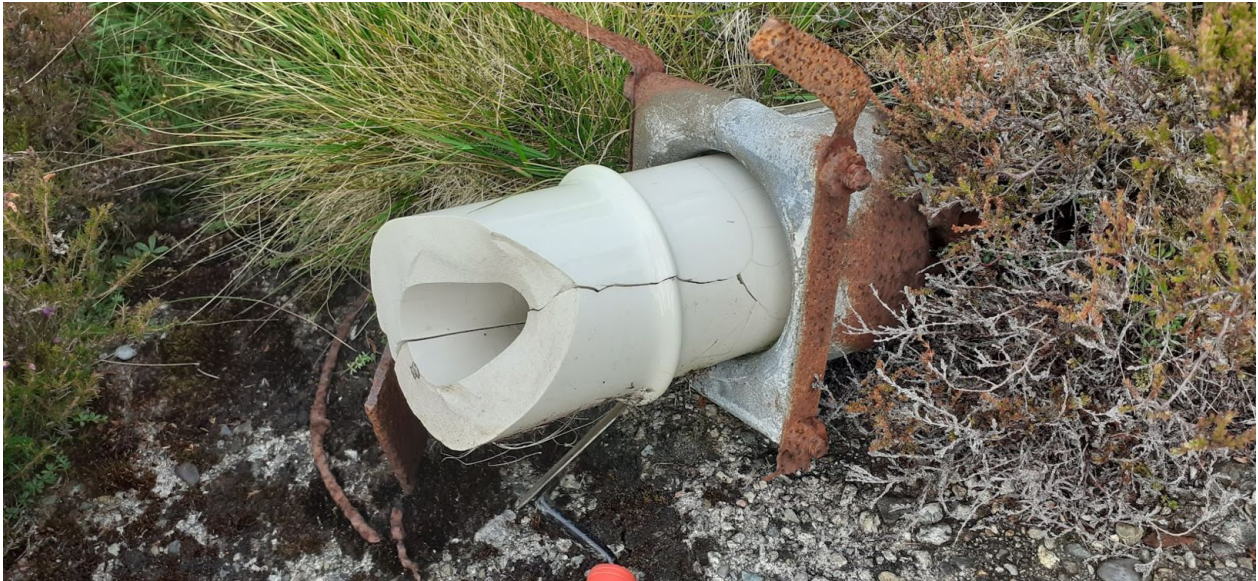
50. Detail of a 1923 counterpoise system insulator fixing (galvanised iron and ceramic).
53.122355°, -4.171794°

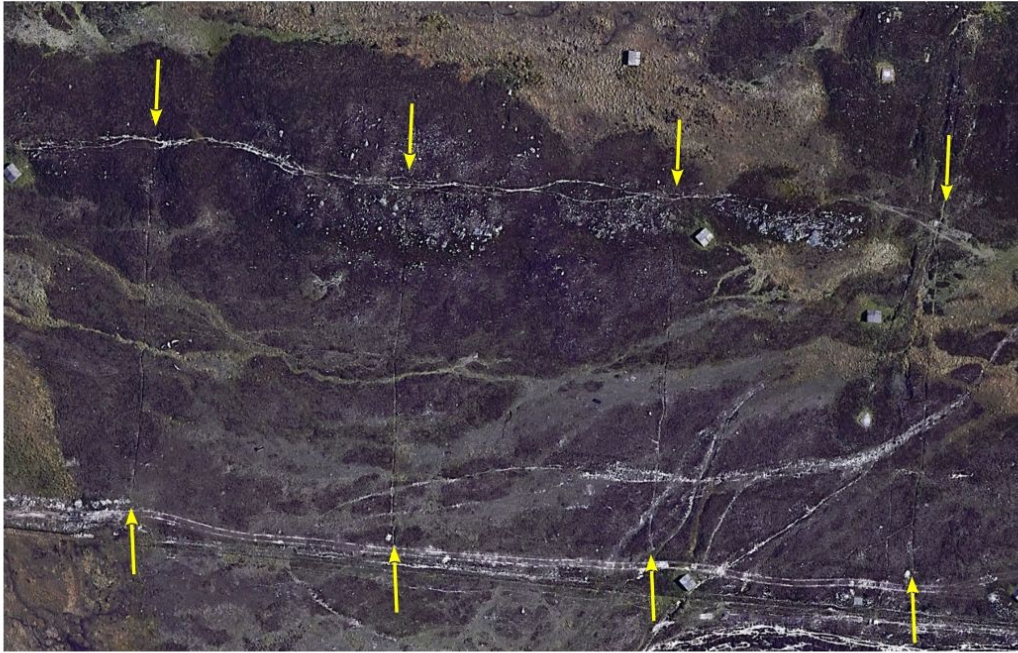
51. Arrows indicate obvious cuts in the ground running along a roughly N-S line between counterpoise masts (or existed beforehand). The cuts are also obvious from ground level.

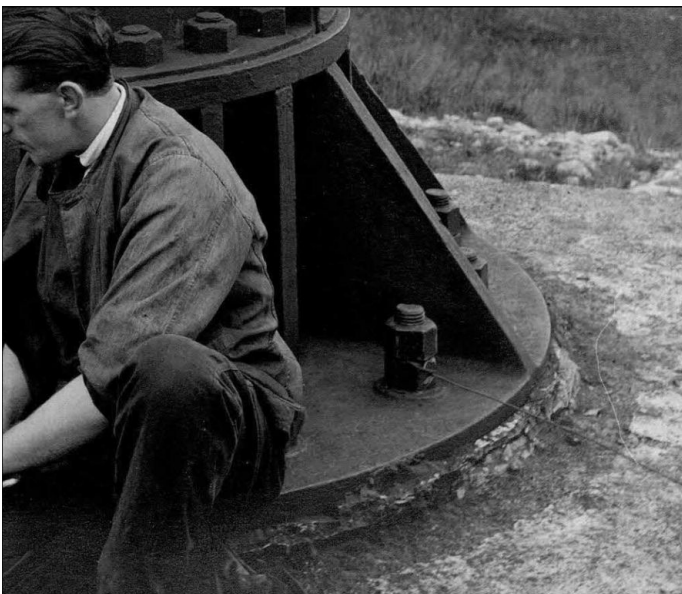
52. Detail from a larger photograph, showing the two nuts used at the base bolts. A wire is compressed between these particular nuts, which appears to be the 6-stranded copper $\sim 2/16''$ ($\sim 3.2\text{mm}$) wire still seen occasionally across the 1914 site (see 53, below). This appears to have been for tower earthing. Bodleian Special Collections, MS.Photogr.c.243, document P.2092)

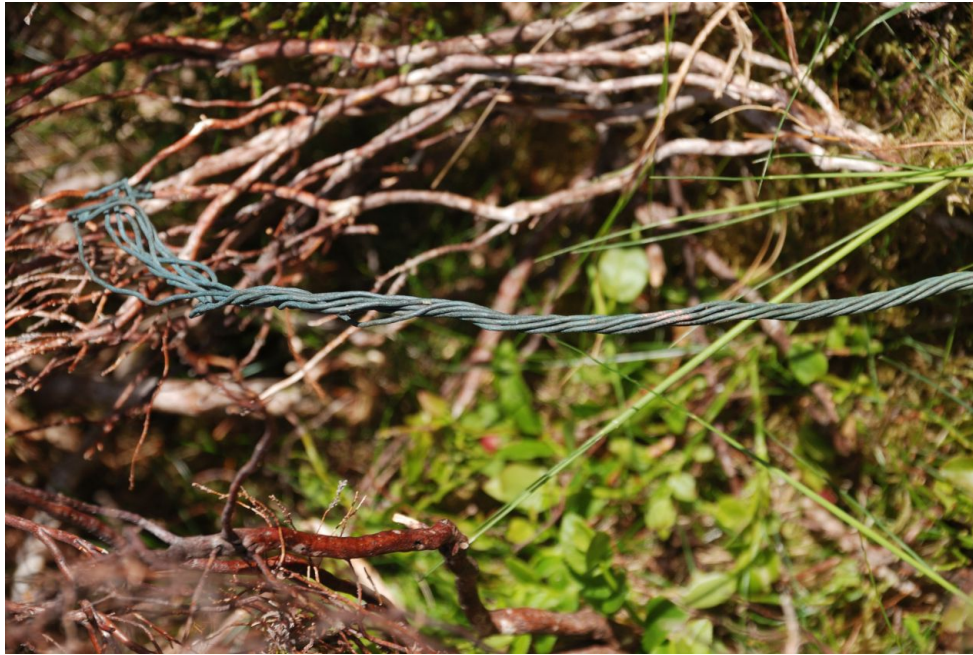
53. *Remnant wire found at the upper end of the 1923 extension. This is 7, rather than the 6-stranded wire generally seen around the 1914 site, though 7 strand was originally specified for the 1914 antenna.*

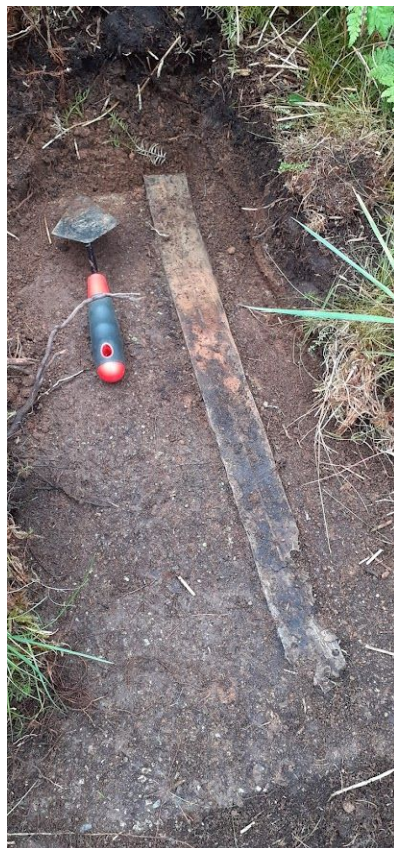
54. *A late discovery during fieldwork, this smaller concrete anchor block, which had an iron loop attachment to a sloping face and probably serving to backstay the counterpoise masts of the 1923 extension, shows a thin copper strap that bends over the rear of the concrete to earth. The wires running to the block were earthed via this strap. A piece of discarded, light steel wire (55, below) was discovered to the northern limit of the 1923 antenna's counterpoise, showing a neat winding of copper wire that likely made the connection to earthing straps like this. Identical windings were discovered in late 2023 on early AC transmission pole stay cable remains at Cwm Dyli. The Marconi site example was almost certainly a stay wire for one of the counterpoise masts. 53.123782°, -4.165569°.*

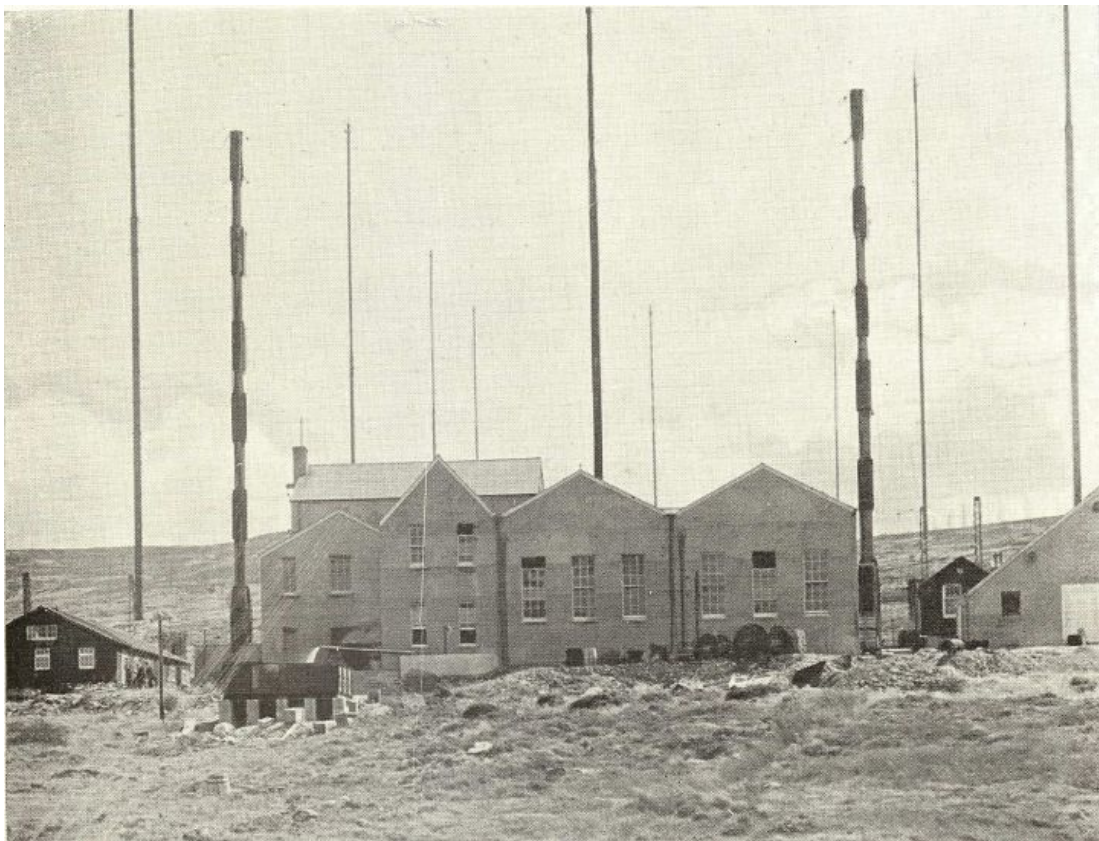
56. Looking uphill (east). The elevated ground screen is in place, as are the two shorter steel towers, which an account written for Engineering journal (Bodleian Special Collections, MS.Marconi.198) indicates is the forward radiator wire straining system that was a later addition and not part of the original, 1914 antenna. The wires are recounted as meeting at a common anchor, still present, to the west of the buildings – seen here converging towards the ground, at far lower left foreground. The ~500' extension masts to the rear are not seen. Date unstated. From the content of the pamphlet in relation to “recent removal” of timed spark transmitters (October 1921), the existence of Alexanderson alternators (from early 1921) and valves (1921), the absence of rear pylons (ca. 1921, uncertain) or the 1923 extension masts, the date of the photo is likely to be around mid-1921, the pamphlet itself somewhat later, perhaps very late 1921 or early 1922. The rear extension of ~500' must therefore have happened around mid-late 1921, as they were already removed by early-mid 1923.

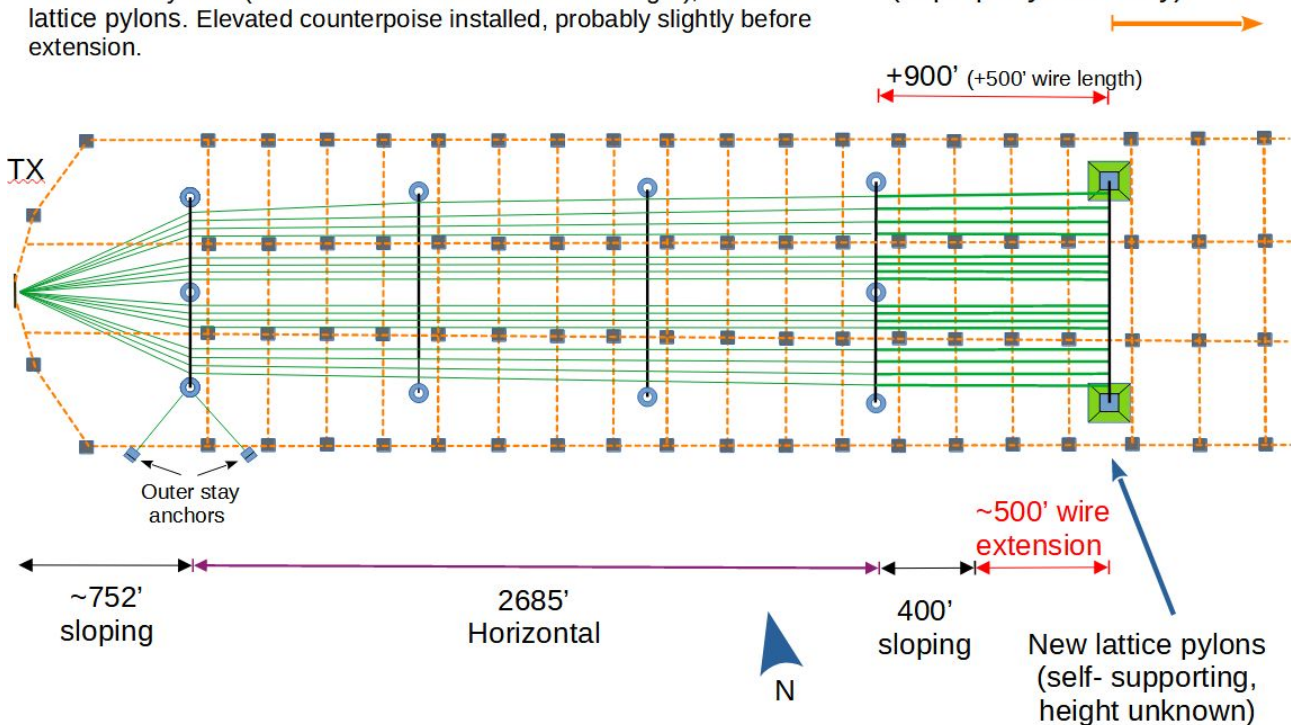
57. The ca. 1921 extension of ~500ft, to end 900ft from the original easternmost masts. The earlier buried ground screen was replaced with an elevated counterpoise system, probably slightly ahead and in anticipation of the extension. Not to scale. Two example outer stay anchors shown to indicate widthwise extent of counterpoise. The radiating wires (green) are indicative only and, for clarity, do not represent the installed number. Elevated counterpoise in orange dash. 'TX' = transmitter.

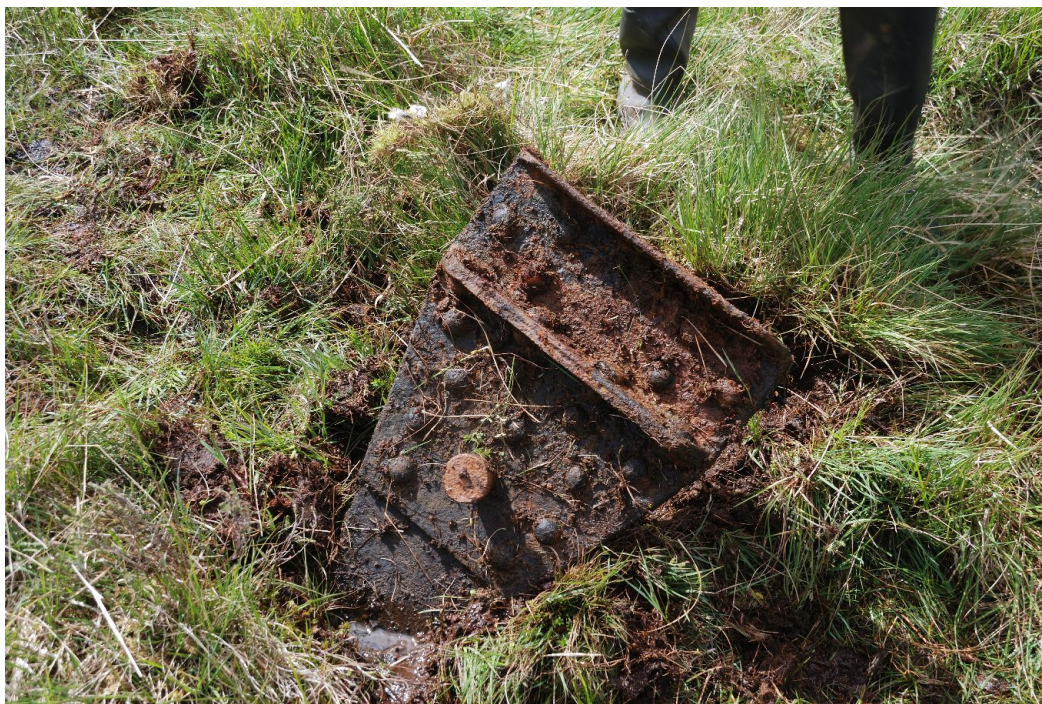
60. A chance discovery of a small, projecting piece of iron, made near to the field wall running down the hillside, revealed a large remnant that, on further examination, was seen to almost certainly be an upper part of the ill-fated Mast 13. Approximately 2' by 1½'. It appears to still be connected to a bracing rod, now buried in bog, under the apex at lower centre left. North to centre right. 53.125259°, -4.171007°.

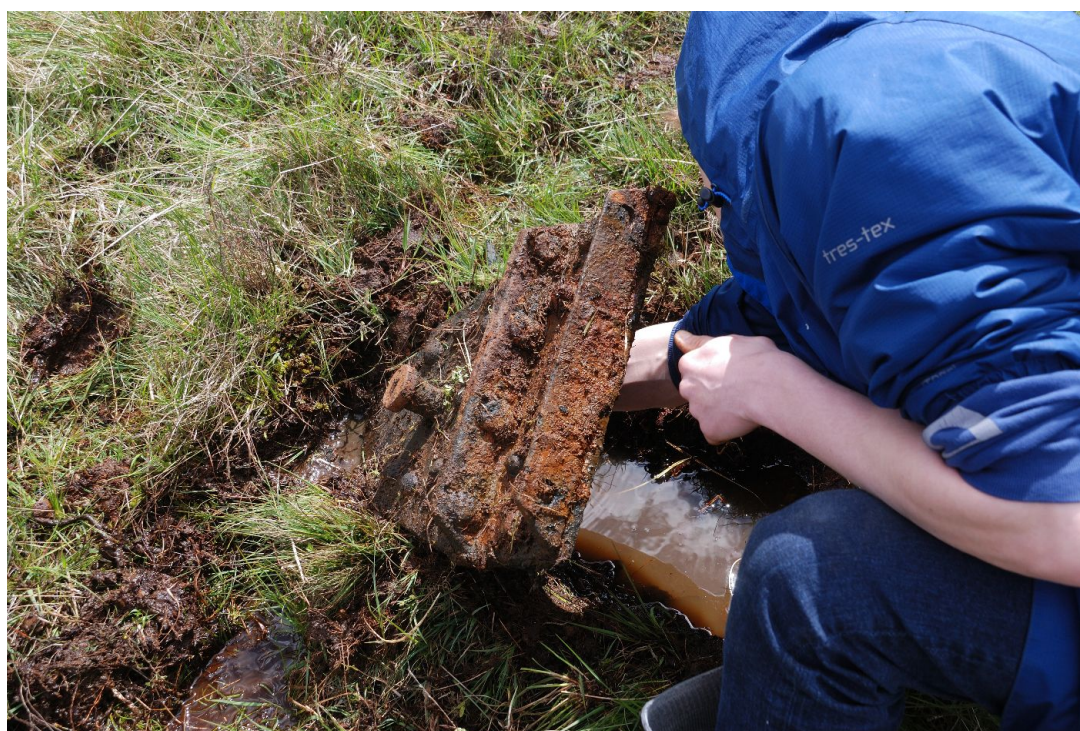
61. View of the end to which the fixing attached to Mast 13.

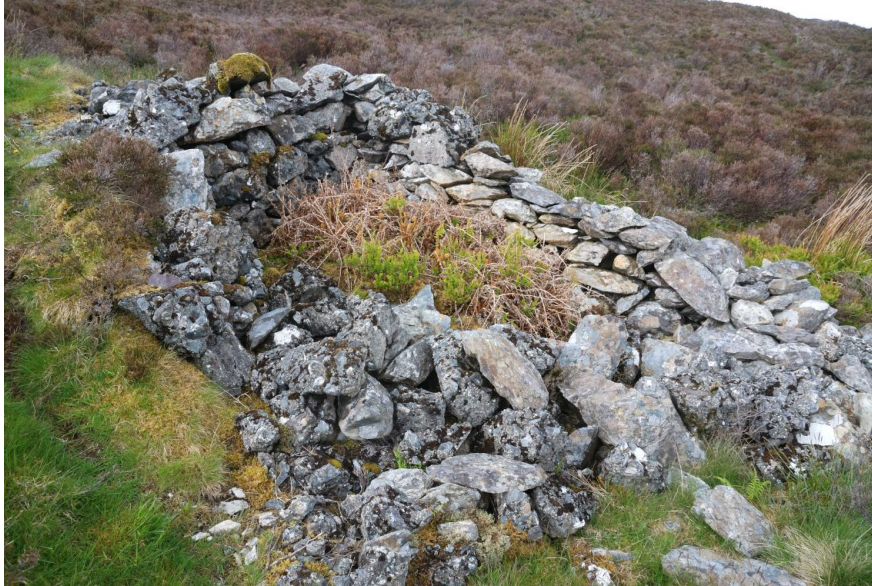
62. *Mixed stone and broken concrete from Mast 13/17 construction, fashioned into a rudimentary fold or hut built against a field boundary wall (to rear). 53.124712°, -4.171576°.*

An area of concrete, seen in photos to probably have been a built-up area to assist track access near the base of Mast 13/17 was deliberately broken up, seemingly immediately after the mast's construction. A number of blocks of this broken concrete were later incorporated into the walls of a small fold or hut built against the adjoining field wall. Many of the concrete pieces are by now covered in bright green moss pillows, highly reminiscent of such growth on ancient Icelandic lava flows.

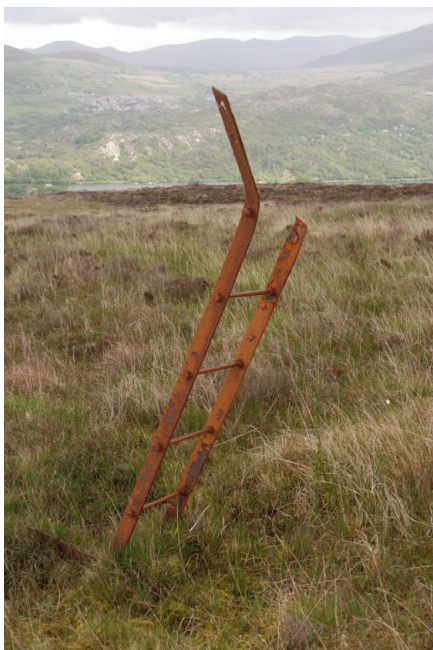
63. *Part of a ladder that probably ran inside Mast 13 before it collapsed. A mast-connecting section running at 90 degrees to the plane of the rungs can be seen running, partly-buried to the left at ground level (and unseen, extending to the right also). It is thus thought to have been the topmost ladder section, emerging onto a platform, as all the other connections to the mast were in the same plane as the rungs.*

To the NW of the where the collapsed mast came to rest, an iron ladder sticks up incongruously from a boggy flat area of the hill. Further down the hill, other sections of ladder are found amongst the heather. The length and position of the sections suggest they were part of the ladder that ran up tower 13. It is a significant amount of metal that was, for some reason, never salvaged from a site otherwise extremely thoroughly cleared.

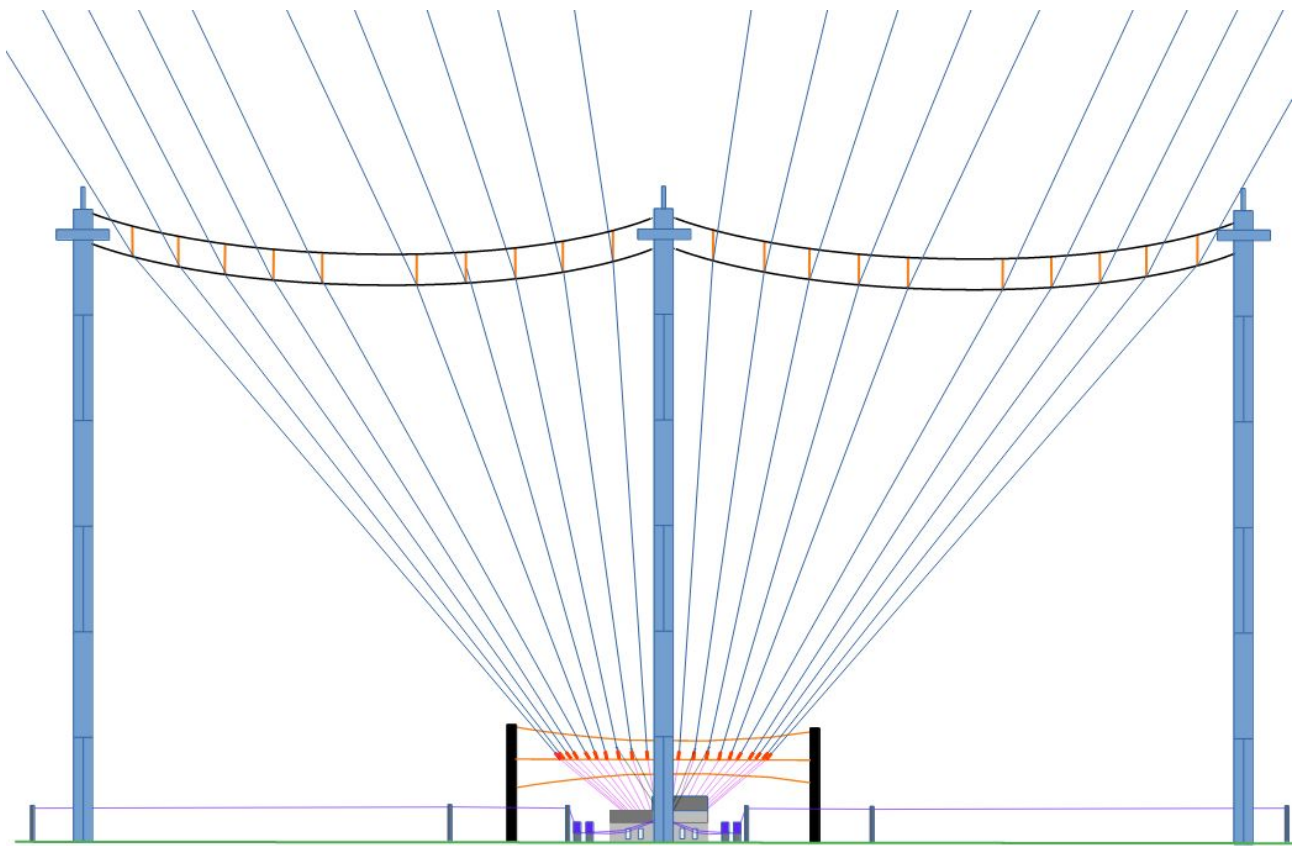
64b. Front wire feed and straining arrangements at the front (western) end of post-1921, No.1 array as seen looking WNW, towards the transmitter house from behind the first mast row. This was a considerably more engineered system than the 1914-ca 1921 arrangements, but with 20 rather than 32 radiators. The triatic insulators seem to have been simple ceramic rod types.

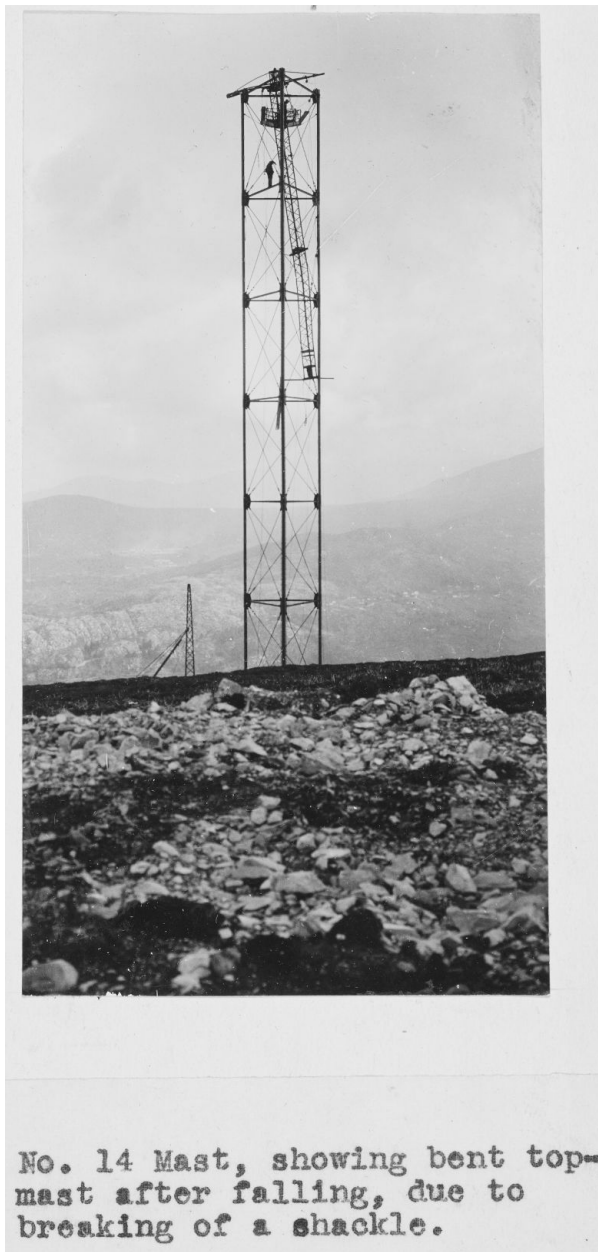
No. 14 Mast, showing bent top-
mast after falling, due to
breaking of a shackle.

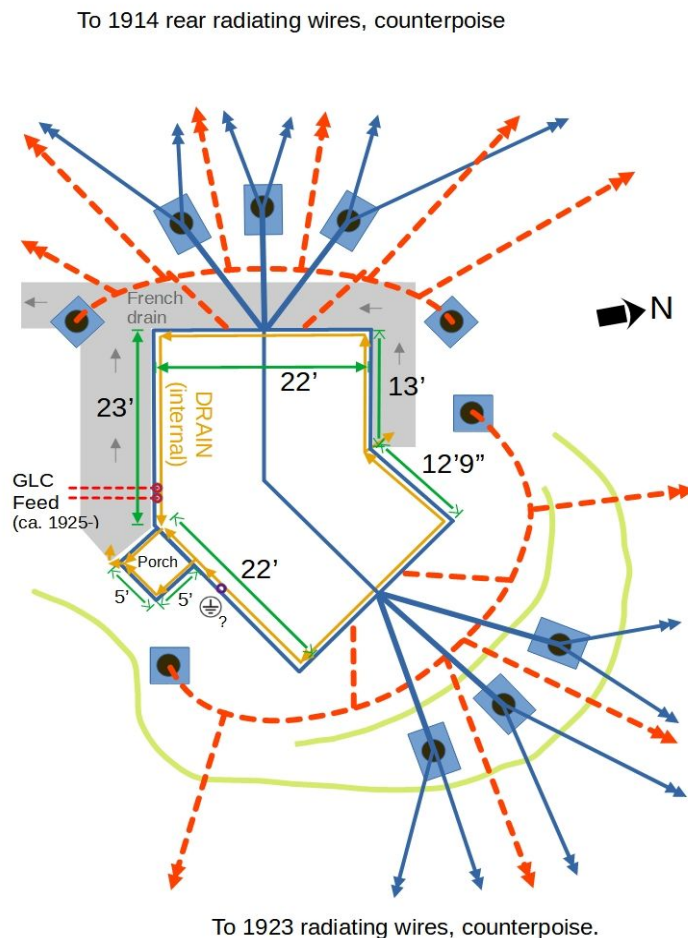
71. Schematic, not to scale, of the double ATI house and connections. Blue lines are connections to the radiating wires, dashed orange lines the counterpoise wires. Light green lines denote raised ground. From field and archive work for the present study, 2022-23.

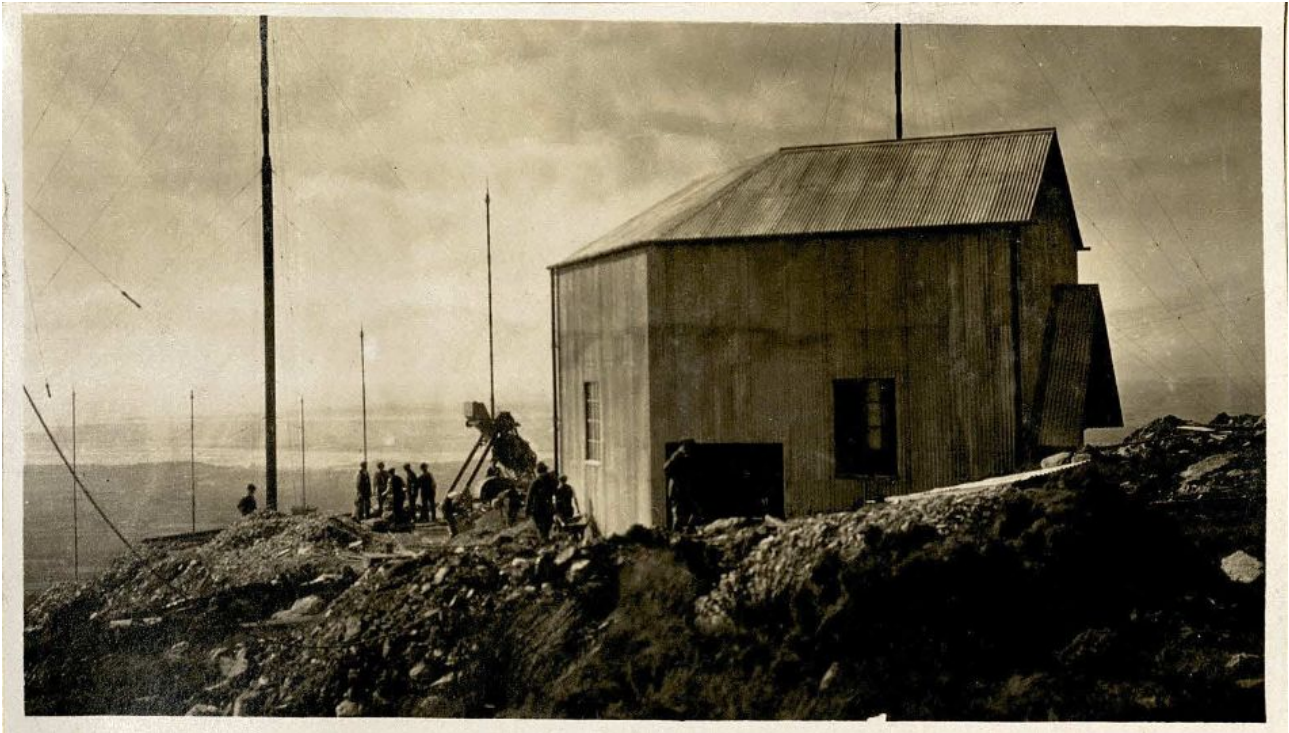
72. A very atmospheric photograph of the double inductor ('ATI') house during construction in early 1923, taken from the east. MS.Photogr.c.243, photo 711/x. The dark line across the building appears to be an old water stain on the image. Note the slack wire running steeply from ground at lower right; this may be evidence the 1921 pylons are still in place. A rod-insulated wire is also seen and may have been for tensioning, acting forwards, but removed from its pole.

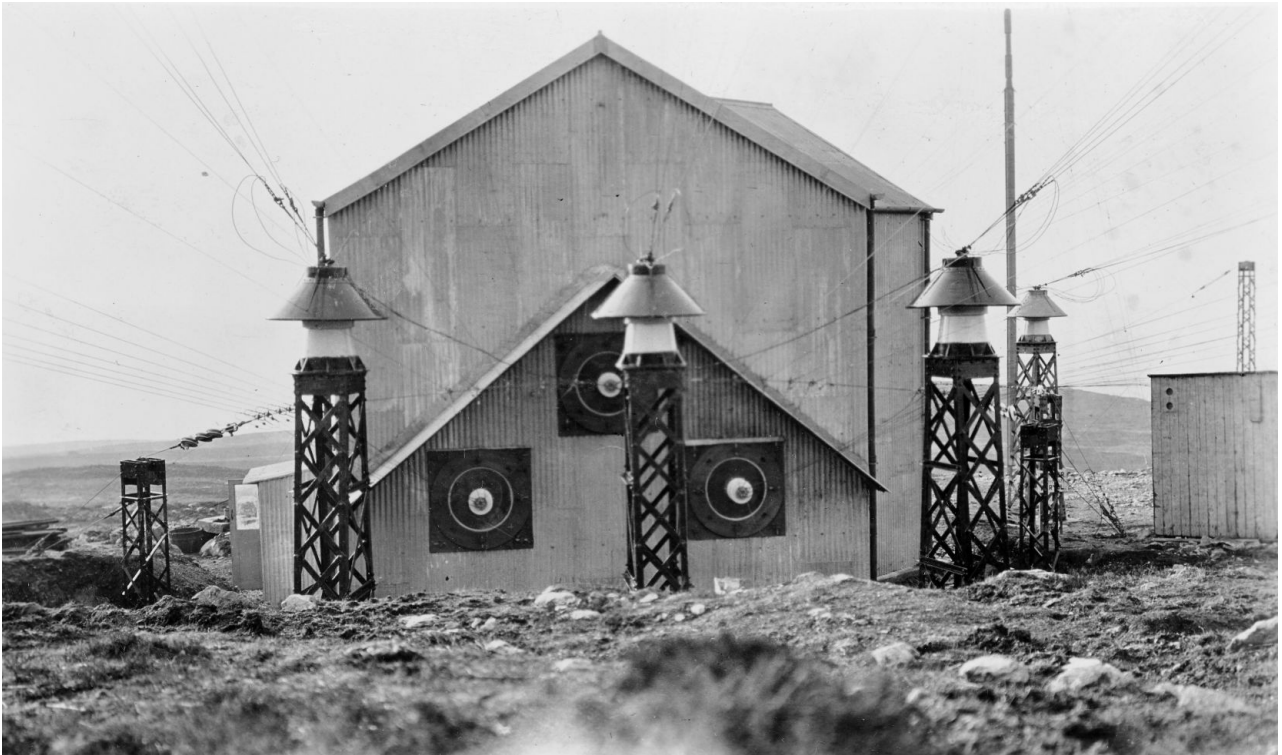
73. Double ATI from the north-east (MS. Photogr. c.24, 745/x). The three lattice supports in the foreground were set on concrete bases on an elevated, rocky platform between the foreground and end of the building. The central base was sought and confirmed during fieldwork (see 75). Bodleian Special Collections.

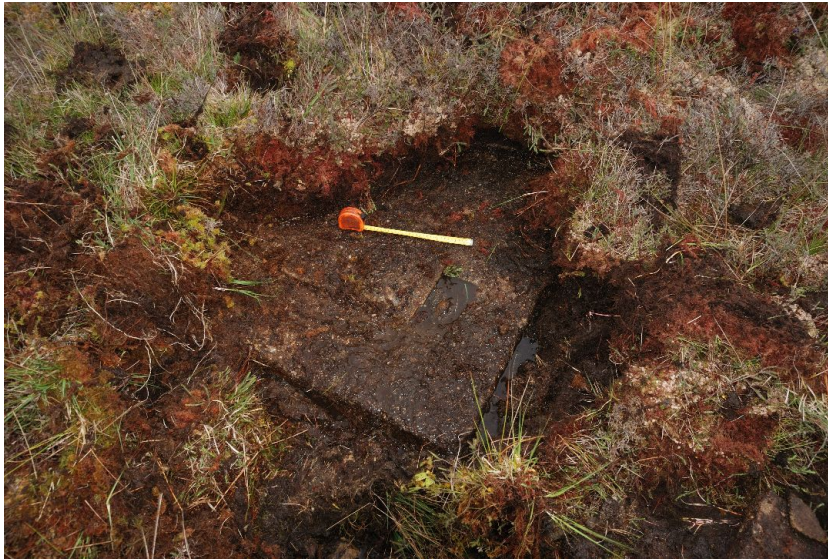
75. Light surface excavation revealed the base, with steelwork impressions, for the central straining lattice mast for the 1923 extension at double ATI (see 76). Yellow tape element open to 1ft.

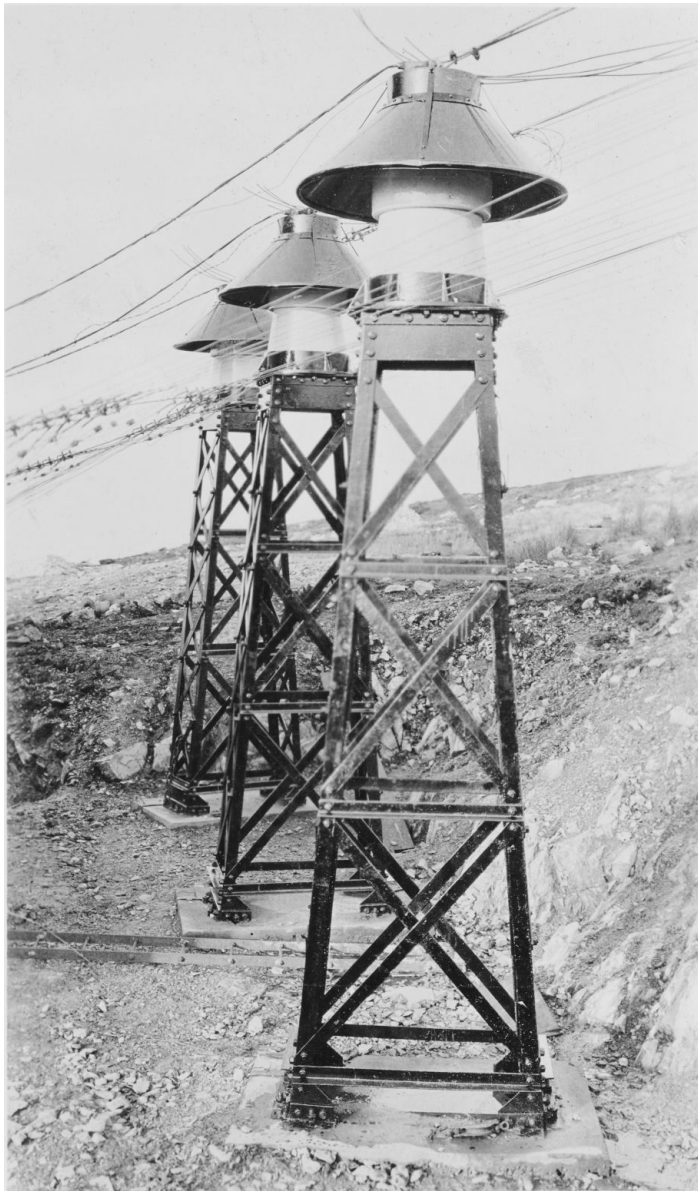
76. Straining towers of the upper (double) ATI, serving the 1923 extension. Bodleian Special Collections, MS. Photogr. c.243, photo 748/x. Lattice base measurements (nearest facing length in photo of 1156mm or 3'9 1/2") permitted scaling and a determination of an exact, 12' height for the steel lattice. Wires to the hat are the antenna feed, the catenary of wires below being the counterpoise connections. The towers are seen to be grounded via copper straps at their furthest left-hand corner in each case. The mounted insulator and rain hat added about 3'6" to the height. The ceramic fragments at C40 are consistent with the insulators mounted on the frame. Dated January 1924.

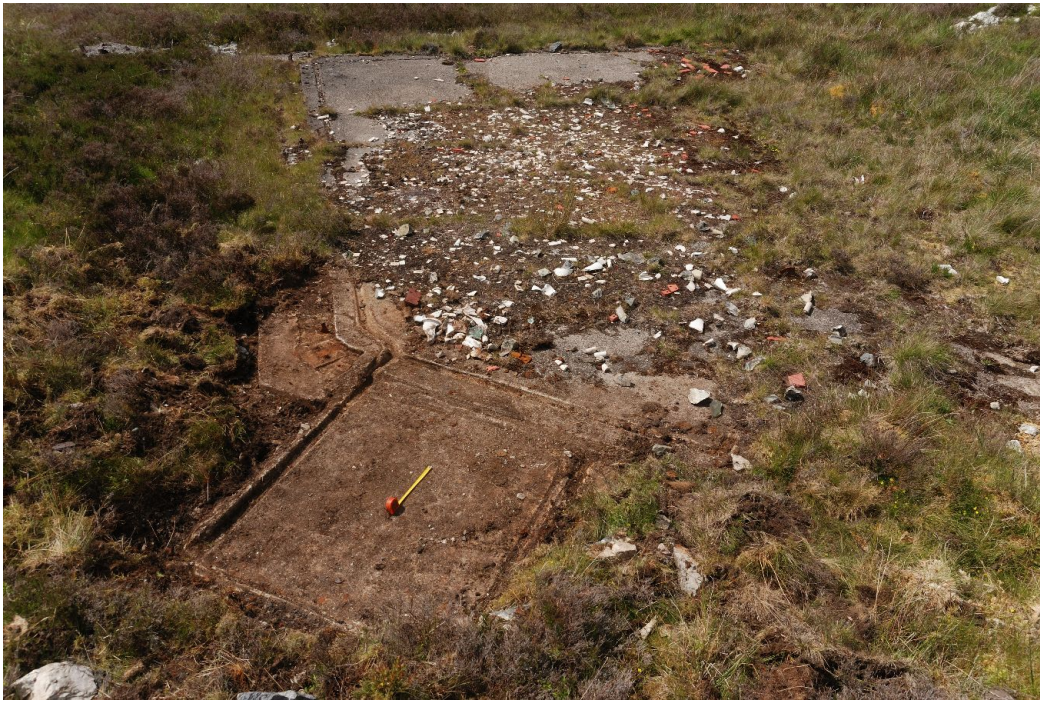
77. Light surface excavation revealed the porch base. Note drainage channels in concrete, which appear to have run on the inside of the building's skin. The drain for the whole building emptied at the lower far left corner of the porch. Porch is 5' wide (outer edges) by 69½" (to outer edge of drain channel). Tape open to 2'.

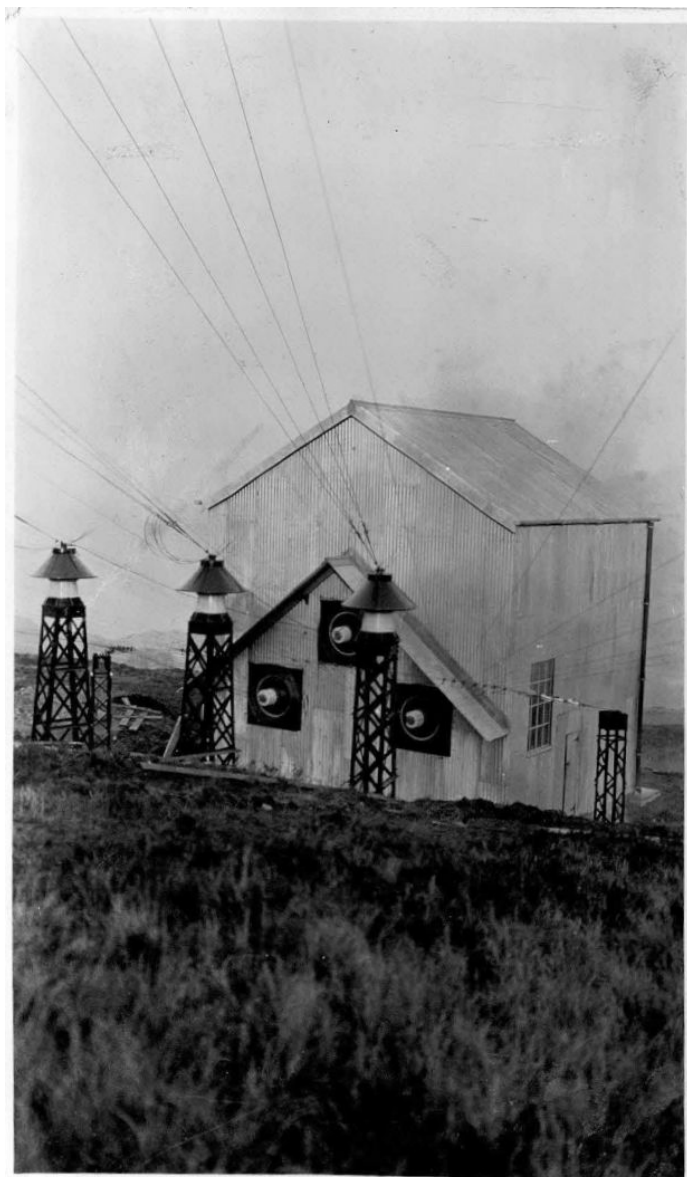
79. *The lower, single ATI house for the 1923 antenna array, seen from the south. Internal dimensions 22' x 22', externally measuring, at corrugated sheets, 23½' x 23 ½'. Bodleian Special Archives MS. Photogr.c.243, photo 744/x. As for the double ATI, the feed to the radiating elements are from the three 'hatted' towers, the counterpoise wires from a single catenary strung between the two towers to the sides of the inductor house.*

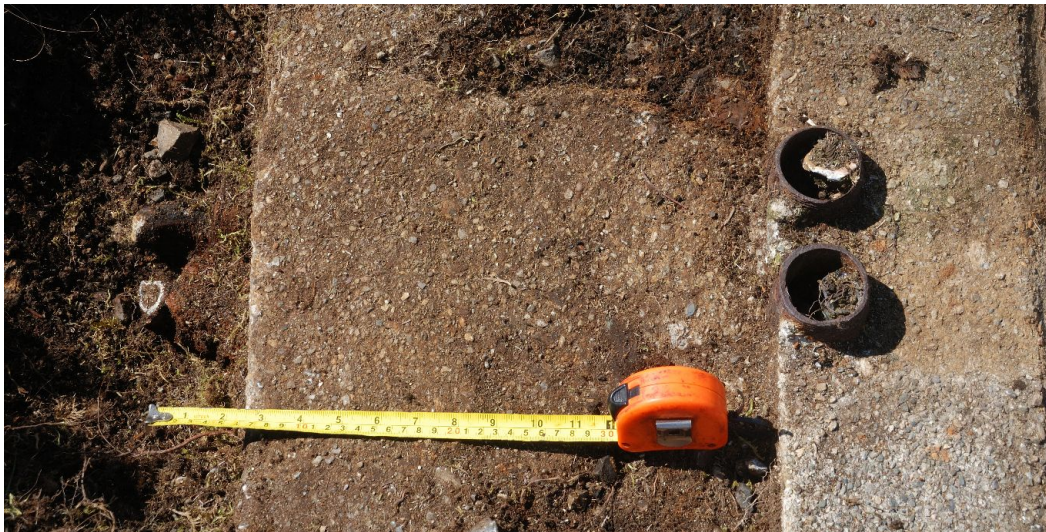
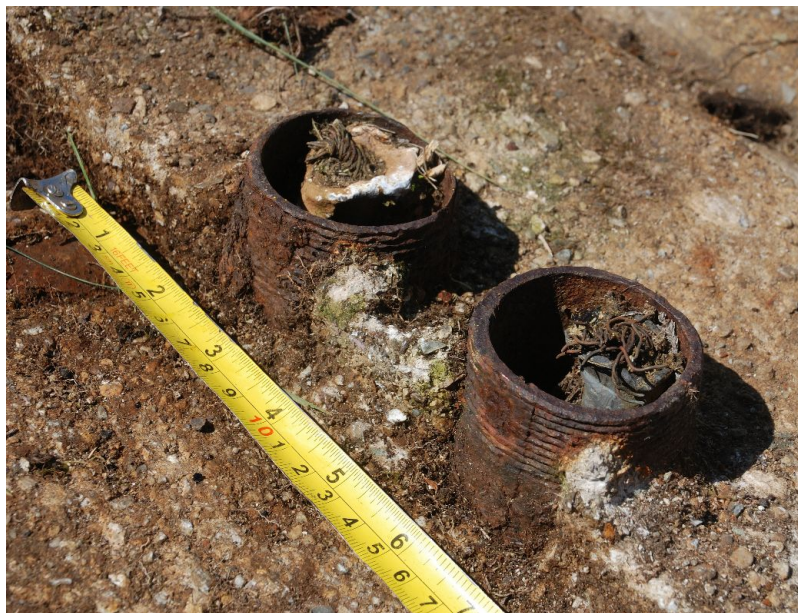
82. *Twin feedline entering the double ATI base, left, emerging within the building through iron tubes, right and **83**, below:*

The concrete where the pipes were installed appeared to have been cut into and then repaired, following the installation of the tubes that carried the shallow-buried wire through the base and up into the inside of the upper antenna-facing ATI building. The copper wire remains bright on light surface cleaning, and a layer of grease, still clean 83 years after the wires were cut, seems to have been part of the cable waterproofing. The feedlines were buried at 5 inches at entry into the building base. The route beyond this depends on which antenna they actually fed, which is currently uncertain.

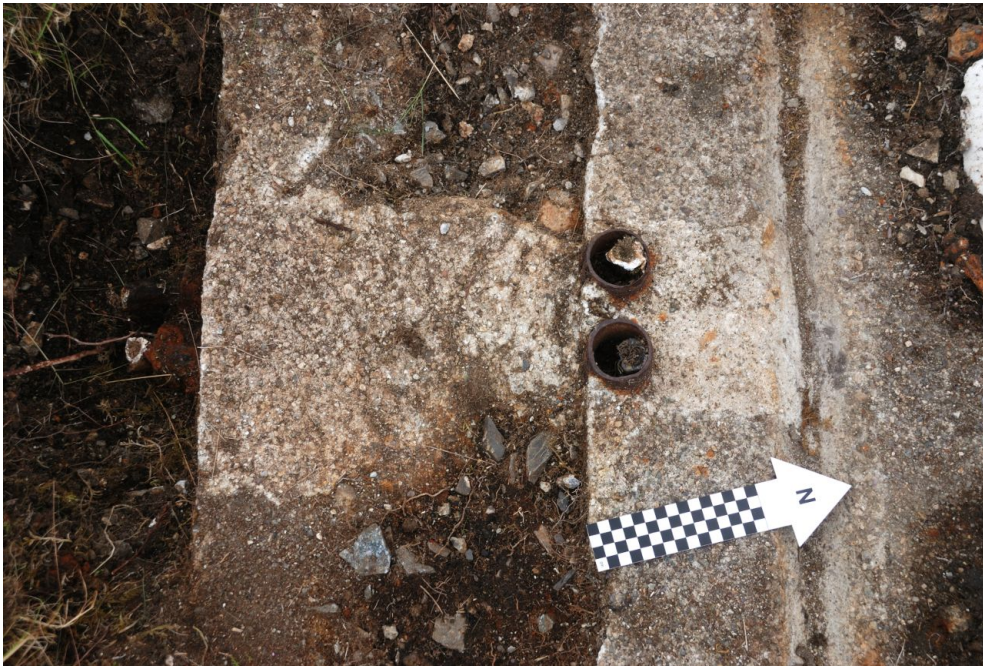
84. After a couple of days' drying, the much brighter concrete (and distortion of the outer edge of the internal drainage channel) clearly confirms the original 1923 double ATI concrete base was cut into (ca. 1925) in order to install a new feedline. Steel tubes, externally threaded, OD = 2¼", lead cable sheath diameter ca. 30mm. An additional wire (lead cable sheath diameter ca. 15mm), possibly the connection to the GLC (lower) earth screen, to the east of the porch, in the MUU (upper)-facing part of the ATI house (**85**, below), seems to have been in place from 1925. Tube (unthreaded exterior) for this cable is OD of 2½", ¼" wall thickness. The hole for the cable to emerge from the base was found, but no trace of the cable remains.

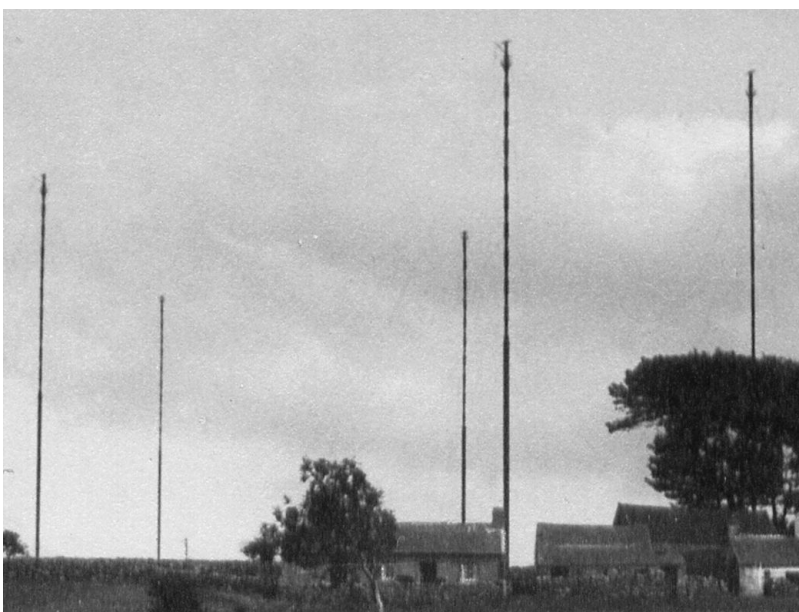
90 a. Circa 1925 image from the Hayward collection, showing masts 1 and 4 (two leftmost, northern) with arms extending to the north. These do not appear in earlier images of this array and it may be the arms were standoffs for hanging the GLJ antenna, which is known from Woodward's drawings to have been located to the north and for which no evidence of mast bases can be found. Original taken by R.N. Barrington, then Engineer-in-Chief at Carnarvon.

Woodward’s drawings give a good indication of where to expect any mast bases for GLJ to remain relative to N^o. 1's masts, but none are now evident. The aligning of the ends of GLJ, relative to the northern line of masts, might suggest that a triatic could have been run down from the mastheads, and GLJ slung from it; two images (see 90a) found in 2024 do show arms extending to the north of at least two of the northernmost masts. These do not appear to have been present in the earlier iteration of the then MUU antenna and it may be these arms were standoffs related to GLJ's rigging.
