Marconi's Carnarvon Station 1912-1939

Archaeological Reconstruction
and History of a Trans-Oceanic
Wireless Site

John Rowlands

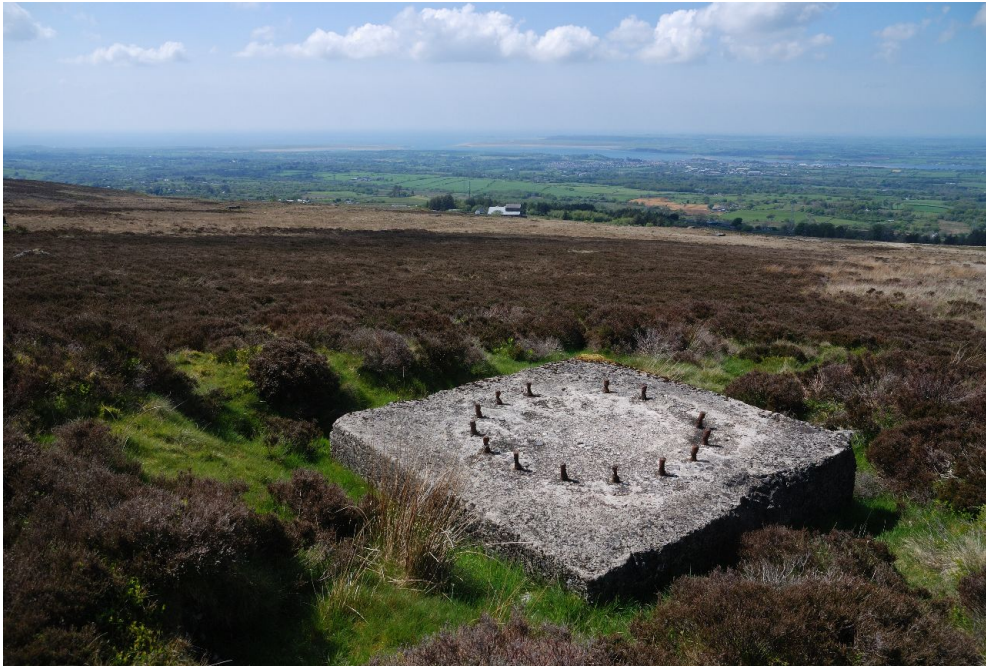
95. Concrete baseplate mounting block (Mast 6), with 16 bolts of 2" diameter at 14.5" centres protruding 4.25" in a ring 6 feet in diameter. 53.123082°, -4.182320°.

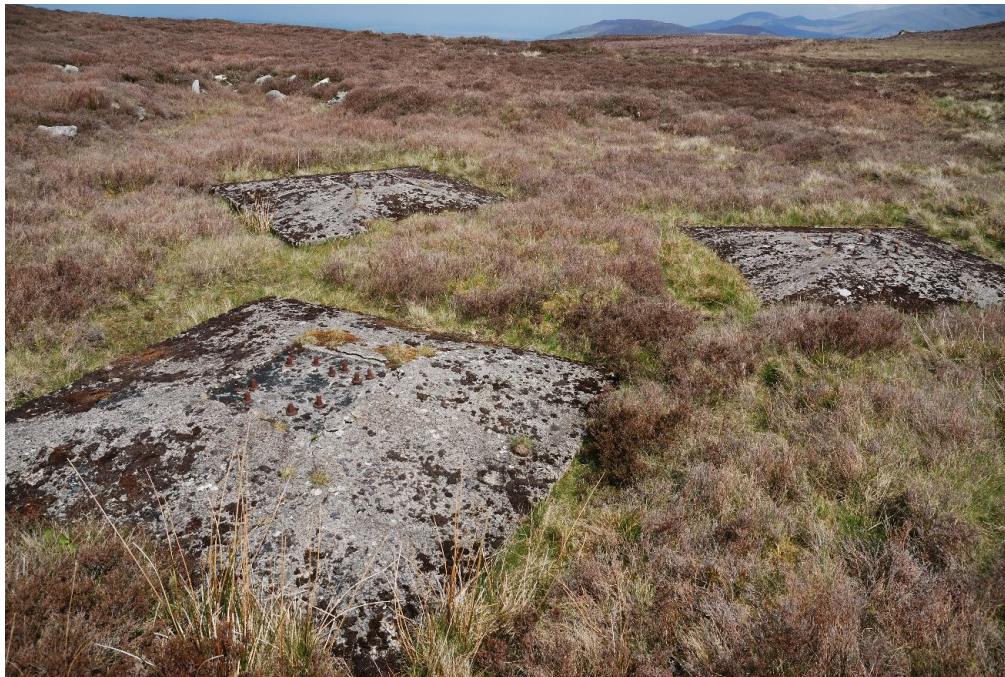
96. The six, 1923 extension masts, running from the top of Cefn Du downhill towards Llanberis, were of very different construction to the 1914 antenna, each being a three-cornered lattice, 400' high. Each of the three concrete bases is ~98" (~8') on a side, of raised tops with a 26"x24" concrete depression made by a mast foot plate in the centre, where eight bolts of $\frac{3}{4}$ " diameter protrude 2" above the concrete. Each base has centres separated by 14'8". 53.121808°, -4.173193°.

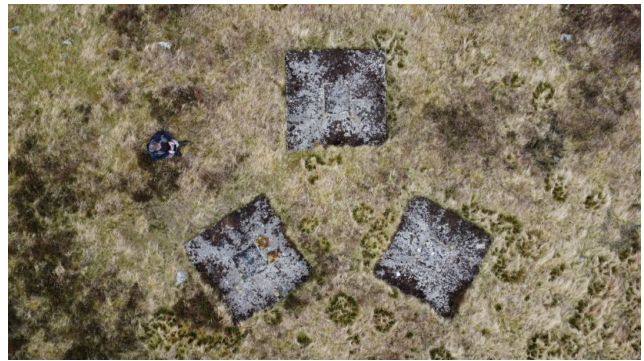
97. Schematic of 400' lattice mast base blocks. Measurements taken from Mast 11 base. **97a**, right: Mast 12 bases, seen in true vertical from a drone.

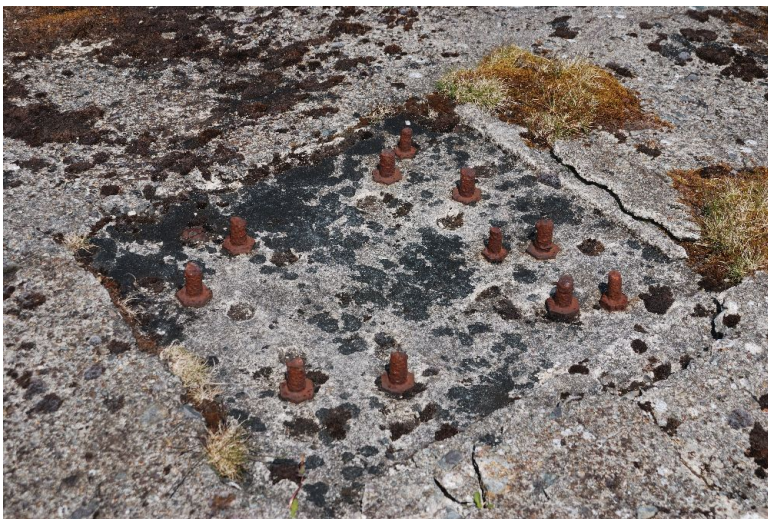
98. Bolts for attaching one of the three feet (Mast 12, foot A) of the 1923 extension masts. Central depression in base 26" x 24". This specific foot has the normal eight securing bolts set into the concrete, but also two, slightly smaller bolts at the inner side. All other pads show impressions of such bolts, which were presumably fixtures on the bottom metalwork of the mast that became fast in what must have been somewhat unset concrete at that point.

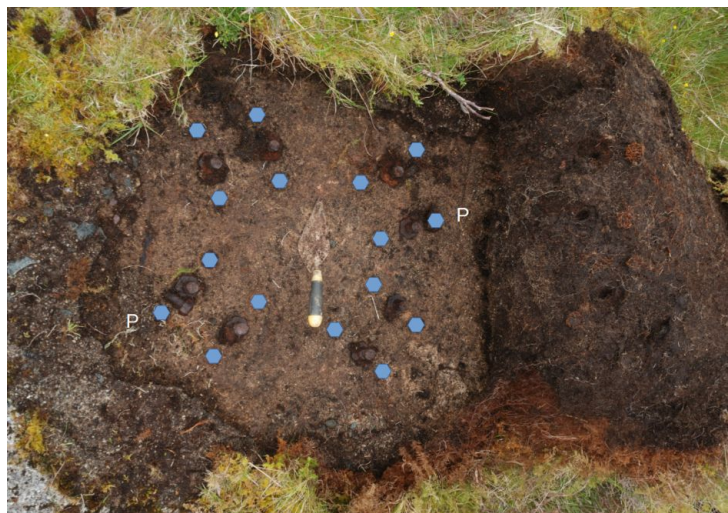
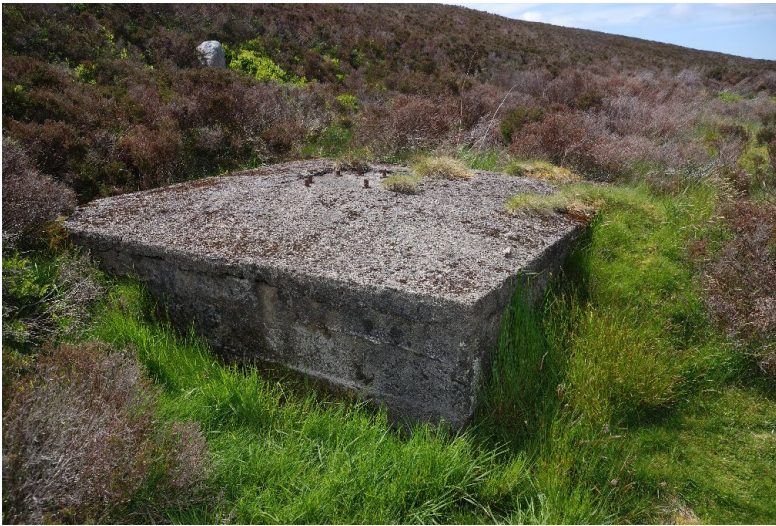
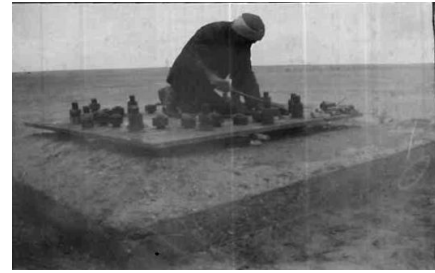
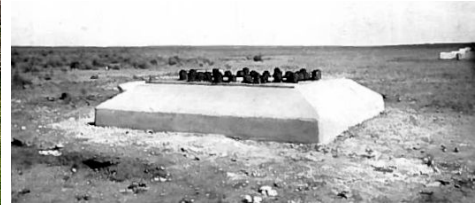
99. Profile of a 1923 lattice mast base block (one of three per 3-sided mast). As is the case for most of the concrete structures, the raised top surface, for drainage away from the metalwork, was evidently laid separately to the main block, and appears to be fairly weak in comparison. The studs, however, ran deep into the main block. Note horizontal shuttering impressions. Mast 14, footpad C, 53.123037°, -4.169589°. **Inset, top:** 1915 installation of mast plate at Abu Sueir, Egypt, prior to "grouting and plastering", clearly a generic and widely used Marconi site construction method, shown completed at **inset, lower** (MS.Marconi.219).

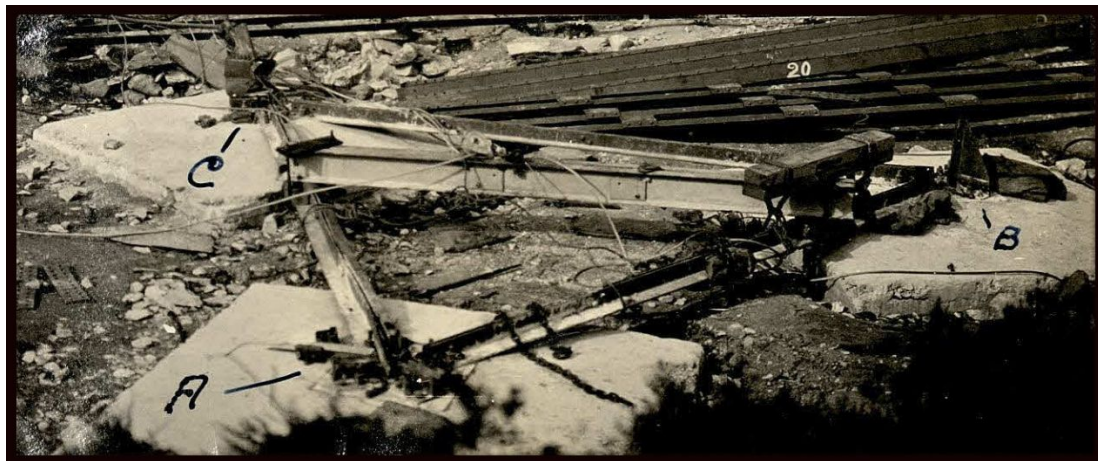
100. Detail of 1923 lattice mast base arrangements from a larger photograph (MS.Photogr.c.243, photo 729/x) following Mast 13's collapse. The hand-drawn labelling is contrary to the foot pad labelling scheme indicated by MS.Photogr.c.243, photo 734/x (see mast identification graphic at p.10, based on information in original caption for **104**), and is not considered to be the general identification scheme used across the site.

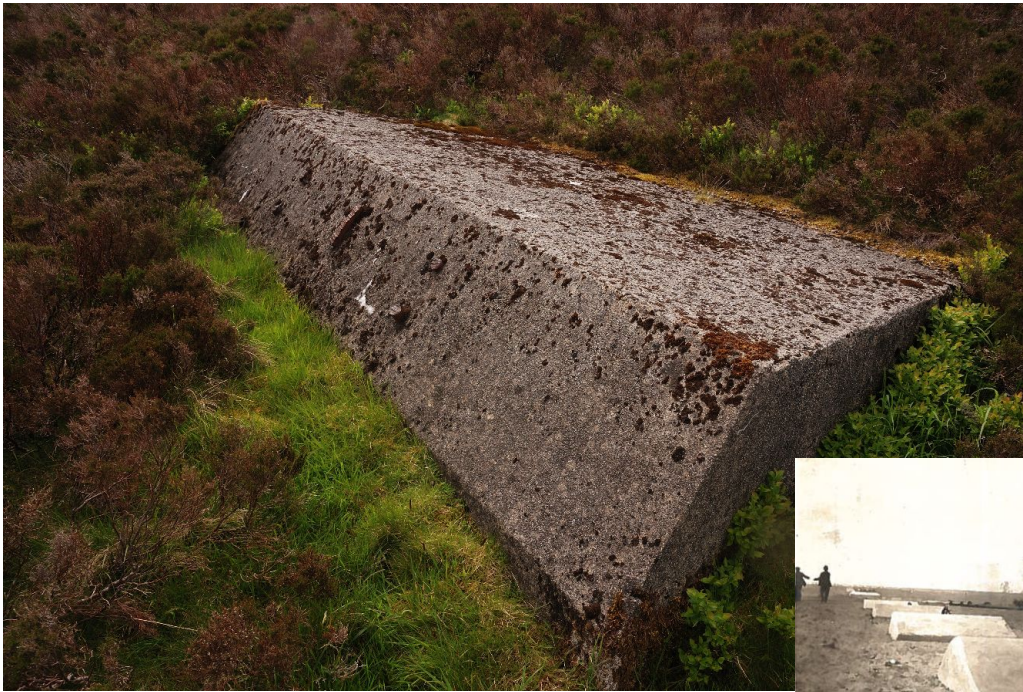
101. Single, 1923 mast stay anchor 14A, a form used earlier, e.g. in 1915, at Abu Sueir, Egypt (inset, MS.Marconi.219) and for MUU in 1914 (see **120**). All but two 1923 anchors still have two copper or brass screws of ¼” shank, 7/16” single slot head, one behind the other along the centreline towards the mast, cemented into the block, and protruding slightly (see **102**, below). A smaller anchor, probably for backstaying a counterpoise mast lower down the hill retains the only known intact copper earthing strip, secured by slotted-head copper screws, explaining their presence on the other anchors. 53.122647°, - 4.170550°.

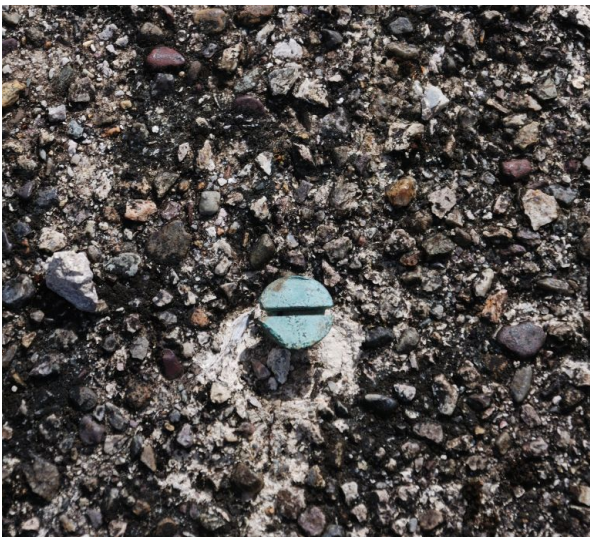
102 (left): Slotted, probably copper screw that once secured a copper earthing strip across the top of a 1923 stay anchor that ran to ground.

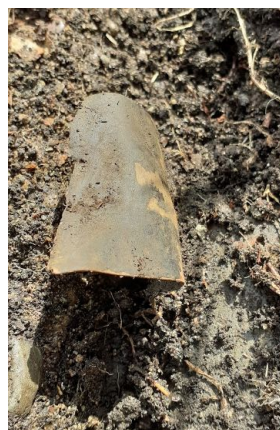
102a: At the centre rear of mast anchor 13a (17a), remains of the stay grounding strap, 54mm wide, were discovered. The metal, magnetic, is 'Copperweld' - steel with a bonded coating of copper, widely used for grounding purposes from 1915 onwards.

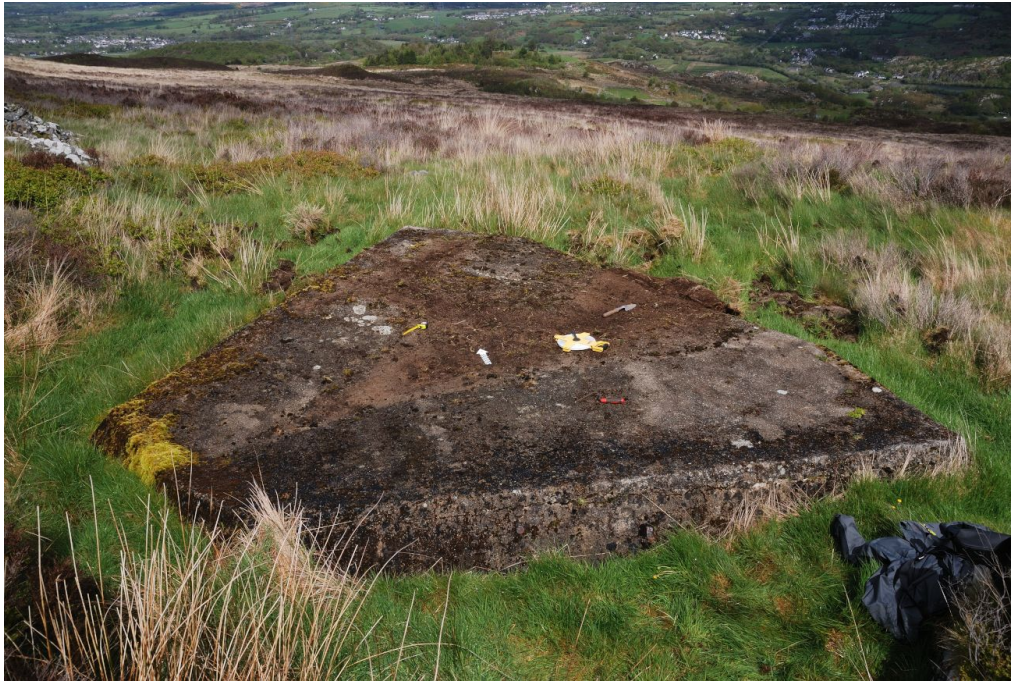
The three anchors for each of the 1923 extension masts, lying 300' from the masts, consisted of an embedded steel anchor plate, with two 'U'-bolts either side – all cut back to the concrete when the structures were demolished. The anchor beneath blockhouse 5, and that at the easternmost extremity of the antenna, is a double anchor, top surfaces gently sloping towards the centre.

103, above: double stay anchor (15C, long face to left and 16B, long face at foreground) at eastern, lowest end of the 1923 array. Its construction is seen in **104, below** (Marconi. Photogr. c. 243, image 734/x), the labelling allowing full understanding of the numbering system for the three anchor points of the entire array. 53.125478°, -4.166813° Lower centre, pointed end at **104** is lower left in **103**.

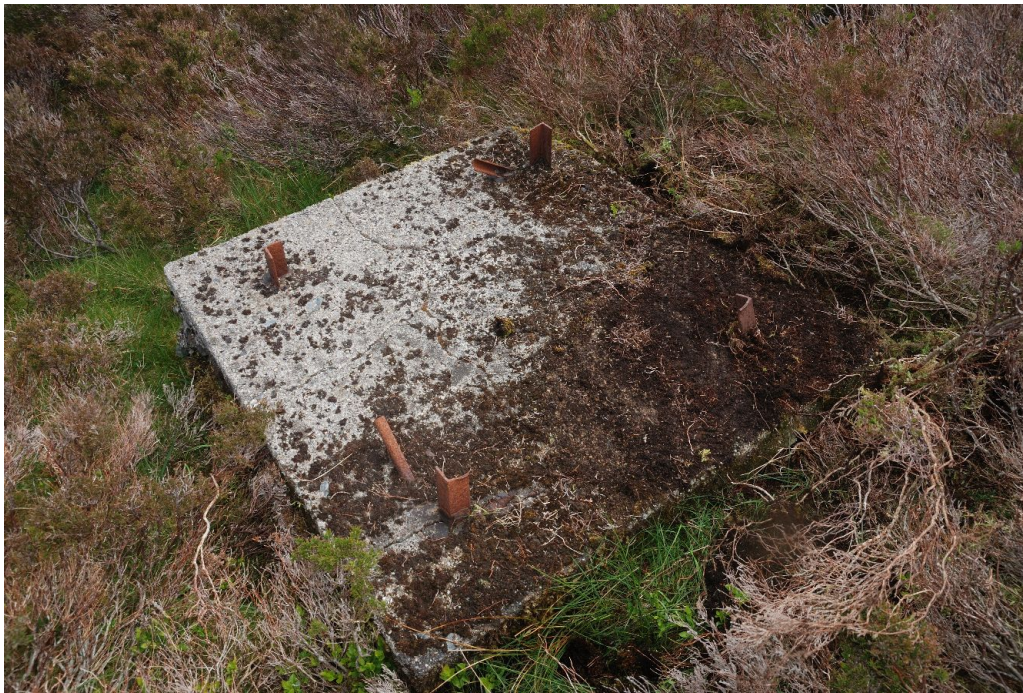
105. A clear example of a 1923 counterpoise lattice mast base, with remnant steelwork. Concrete base of 4'x4', lattice of sides 32" x 32".

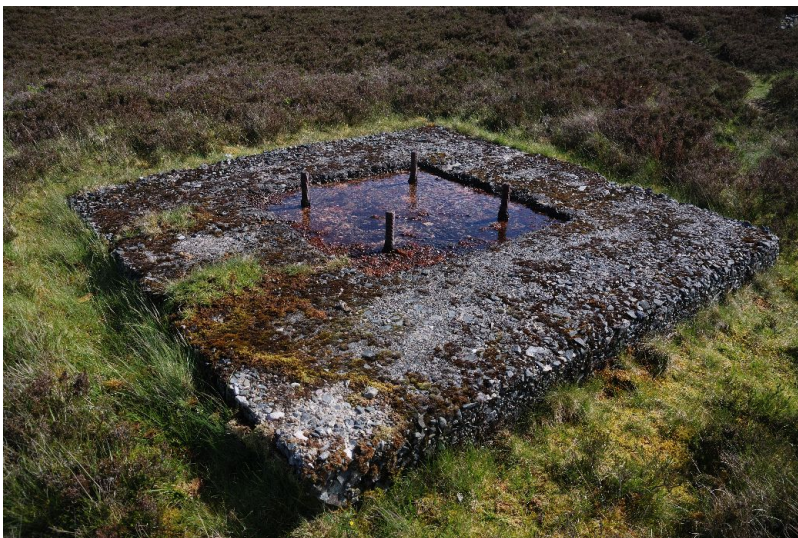
106. One of four ~8 ½' concrete base feet for one of two ca.1921 extension pylons (53.120347°, -4.175167°), each **pylon** centre separated by 600'. Each of the four **footplates** of each **pylon** was separated by 60'. At the lower (southerly) mast, the NE corner base had to be installed on what was apparently boggy or otherwise difficult ground, with bolts emerging from a concrete base in a deep excavation to reach firmer ground – see 107.

The ~500ft rearwards, linear extension of ca. 1921 to the original 1914 antenna needed two large lattice pylons. Their height is not given anywhere. Their size, being 60' on a side, was probably sufficient to ensure self-support under antenna wire strain and there is no evidence of anchoring points for them. Each of the four foot bases of concrete is ~8½' square (varying slightly, between 101¼" and 103 ½"), the inner depression, about 2" deep, where the foot plate of each corner of the mast was anchored, measuring between 42½" and 44" square, and thus the foot plate probably 3½' square. The pylon was secured by four, 1.5" diameter threaded bolts, their centres 27" apart, set deep into the concrete, projecting between 7" and 9½" above the depressed concrete surface. No photograph or description of these pylons is known, but they were almost certainly tapering in form (see 58).

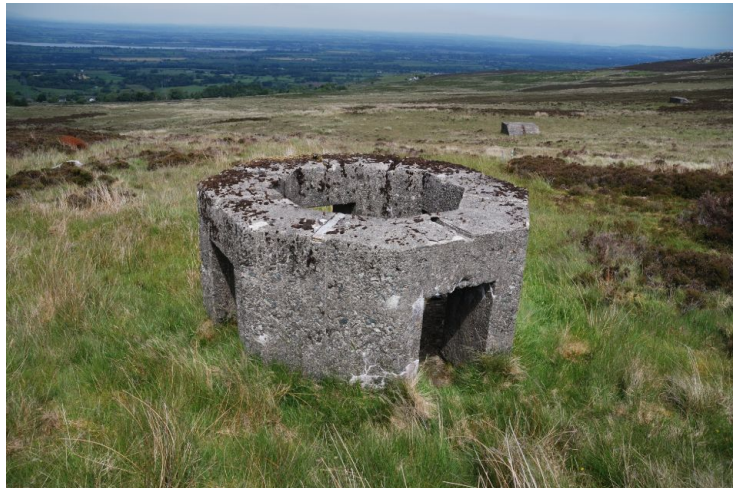
108 (right). Octagonal base, which once supported an inductor. Its position, to the immediate west of Mast 7, is unusual. Its form and tracks leading to it suggest it was present from early on. Roughly at mid-point of the MUU array, it is thought most likely to have been associated with the grounding system.

26 yards to the west of the third, southern antenna mast base (Mast 7), lies an 'orphaned' octagonal concrete base of initially obscure function. This has openings of 31" x 19" in four sides, with narrow slots of 17"(l) x 2 1/2"(w) x 1/4" (depth), one with a timber former still in place, at the top centre of each face. Small, approximately 3/8" diameter bolts protrude 3/4" above the top surface perimeter. Vertical timber shuttering impressions reveal the construction method. A seemingly identical base type is seen at Marion, MA in the United States, but erected using horizontal shuttering. Late in this study, it became clear from similar structures at SAQ station (Grimeton, Sweden) that these were bases for large inductors. Tubular (not rod-type) ceramic insulator fragments of brown glazing lie around the base.

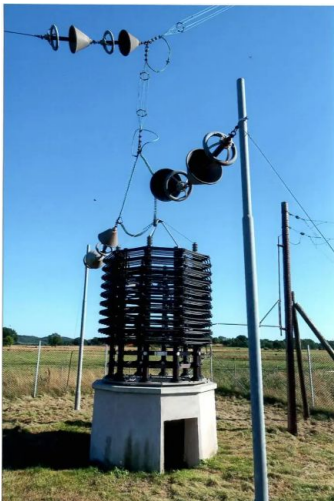
108a, left. Octagonal inductor at VLF station, SAQ, Sweden, serving to match the antenna radiator wires seen leading down from the support towers at centre right. Image courtesy Eric P. Dollard. Also see rear cover for an image of one of Carnarvon's inductors.

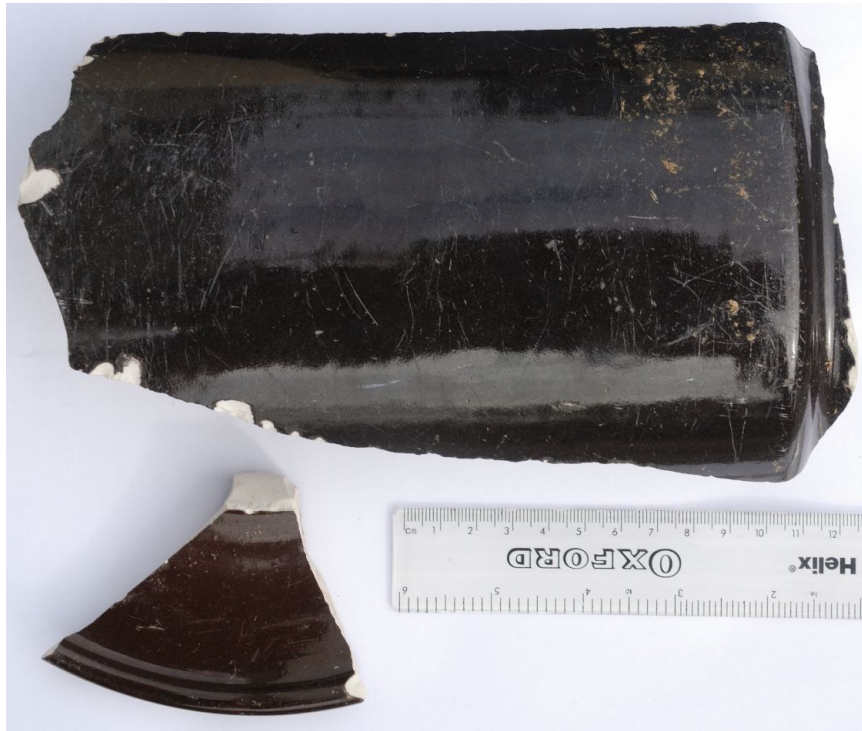
111. *Brown-glazed ceramic insulators found lying next to the octagonal concrete base.*

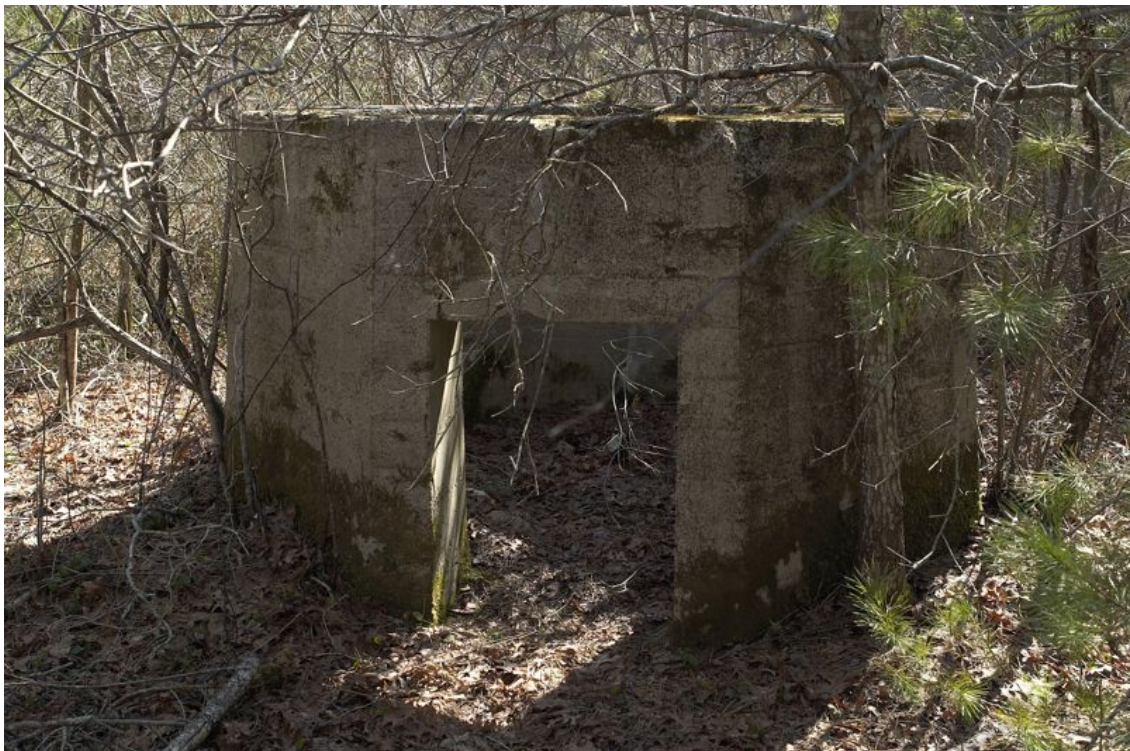
112. *Other than the use of horizontal shuttering to construct it, an apparently identical octagonal inductor base at the Marconi station of Marion, MA, USA. Courtesy and © 2008, M. Howells via Sippican Lands Trust.*

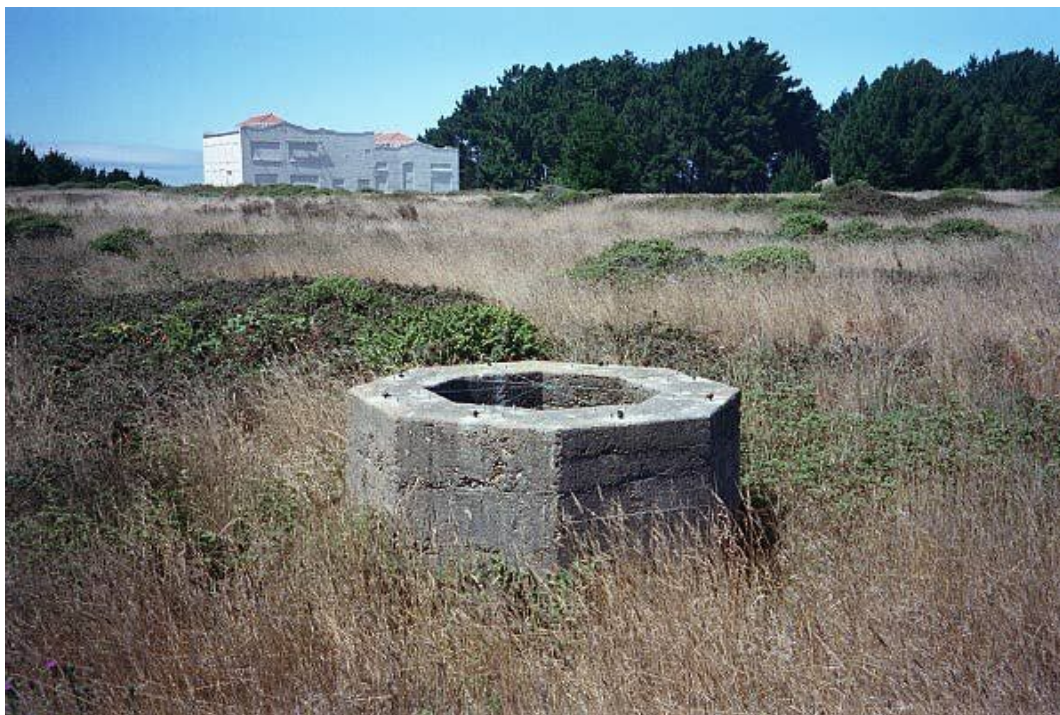
113. *Octagonal inductor base with no side openings at Bolinas, CA, USA.
Image courtesy California Historical Radio Society.*

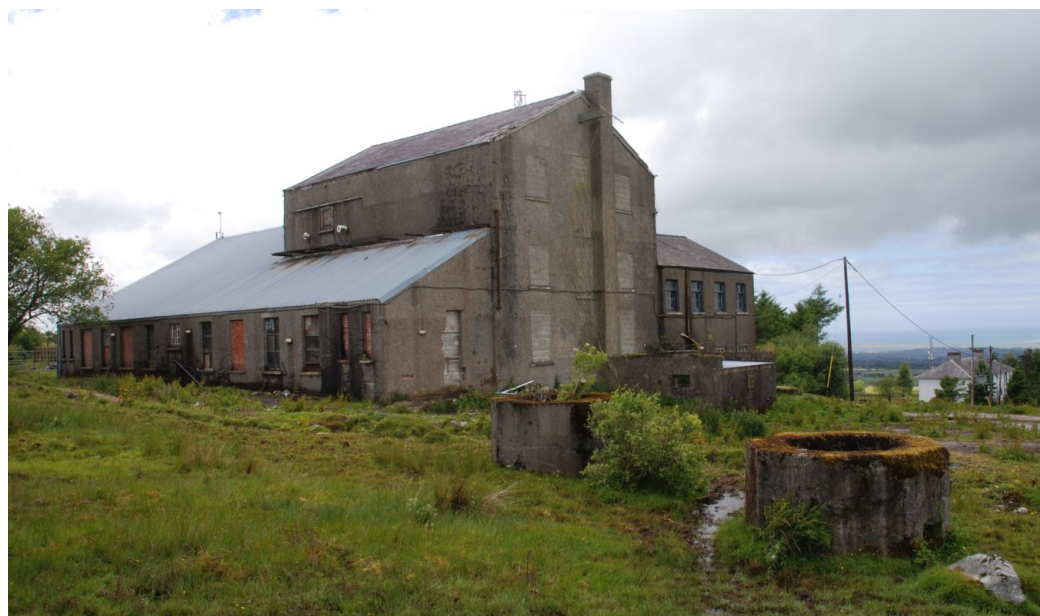
Five other octagonal bases exist at Carnarvon, all of them to the immediate east of the transmitter house. These have either one or no apertures. All seem to have supported inductors. One octagonal base lies, tipped on its side, near to the SE corner of the transmitter house.

114. *Octagonal inductor bases to the north of the transmitter house (on domestic land, access by kind consent of the occupiers). The nearest base, far right, is seen in a poor photo to support an inductor (see 116), and thus predates the 1925, GLJ 'third' antenna.*

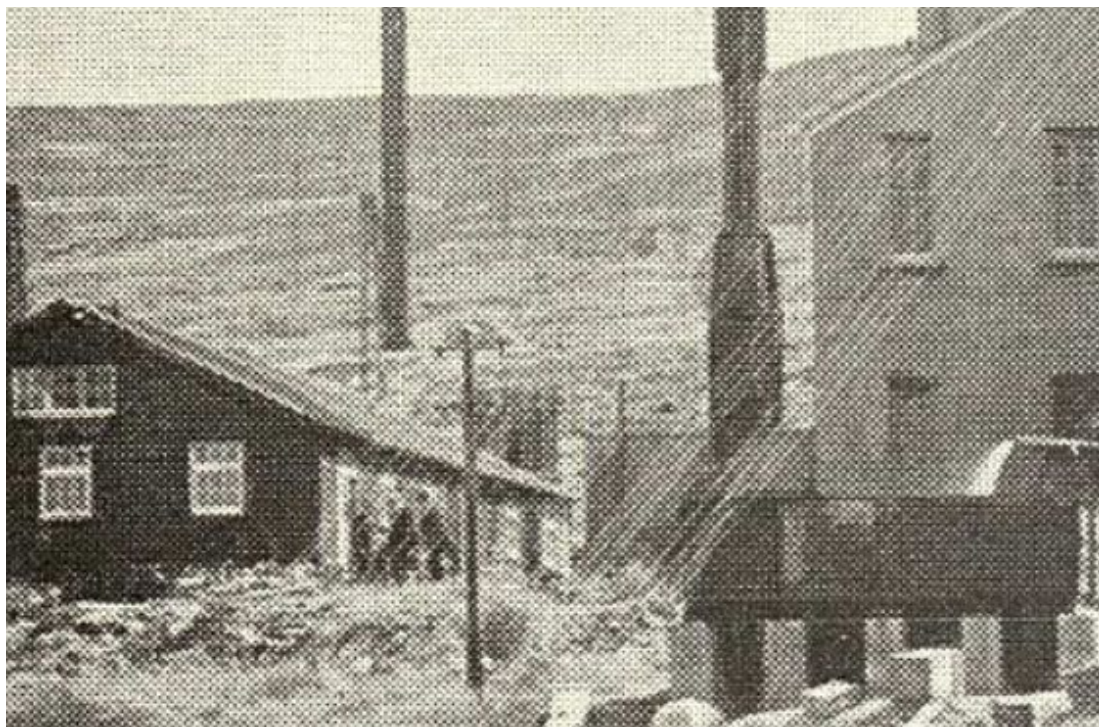
116. Detail from a larger, poor quality image that nevertheless distinctly shows (centre, just behind and to right of the telegraph-type pole), one of seemingly two earth system tuning inductors per side of the transmitter hall at the position of the octagonal base in foreground in **114**. Bodleian Special Collections MS.Marconi.198. See also rear cover image, discovered in 2024, for much better detail of the opposite side inductor.

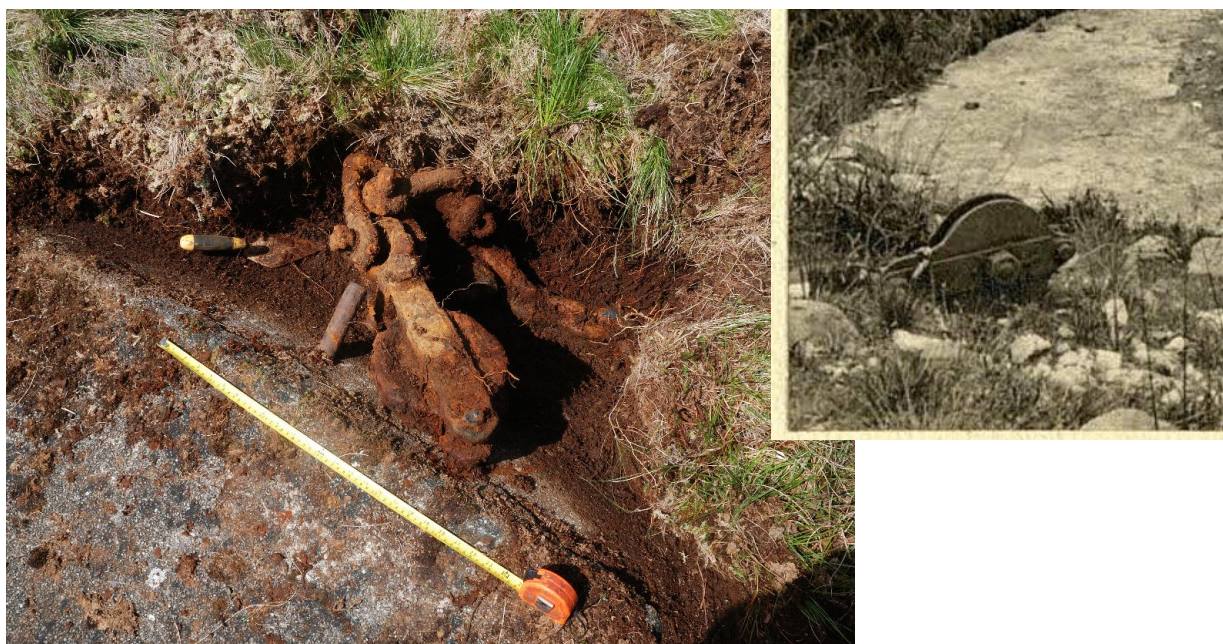
117. *Pulley, attached to a series of shackles and a substantial chain still in position next to a base with a cut loop attachment, seemingly forgotten during salvage. A similar, but not identical pulley is seen in Bodleian Archive MS.Photogr.243, photo P.2093 (inset detail, top right). Its purpose in relation to the 1923 antenna is not yet certain, but initially appears to have been related to backstaying of the elevated counterpoise masts. Pulley wheel = 8" diameter, clamp body 1 3/4" thick, top running width 27mm, inner running width 9mm, running groove depth 3/4". Shackles 9 1/2" height, 2 1/2" inside width, 5" external width, securing pin 2" diameter head, 3/4" central hole. 53.120944°, -4.172144°.*

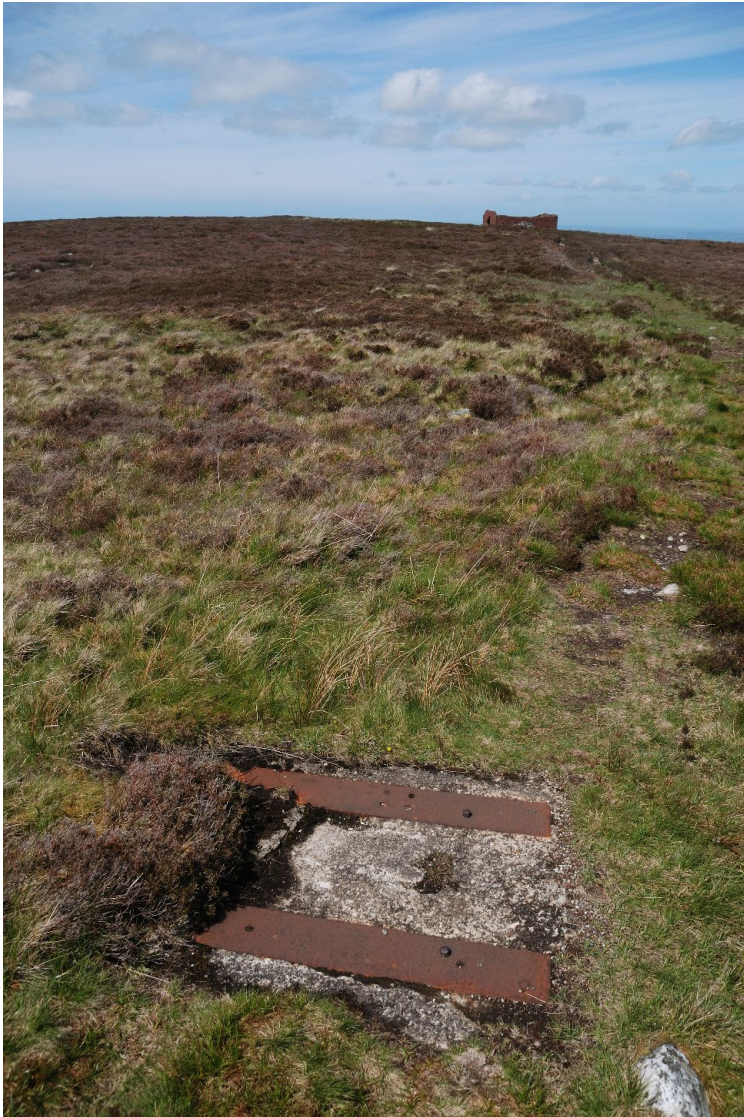
118, left, at 53.121666° , -4.172803° . Near trackways, seen at three points at the summit of Cefn Du, small concrete bases with thick iron bands, two having a wide copper earthing strap fixed to a bolt, are found. These were bases for short lattice masts with a sharply pyramidal shape, probably related to the counterpoise system. Similar masts nearby are seen in photograph 65 to have a square section. Work to elucidate the distinction between the two types is continuing. The earth strap depicted at **119** is ~265' to the NW of Mast 11, at 53.123509° , -4.175266° . The earth strap is lost or only small fragments remain for the other bases of this kind.

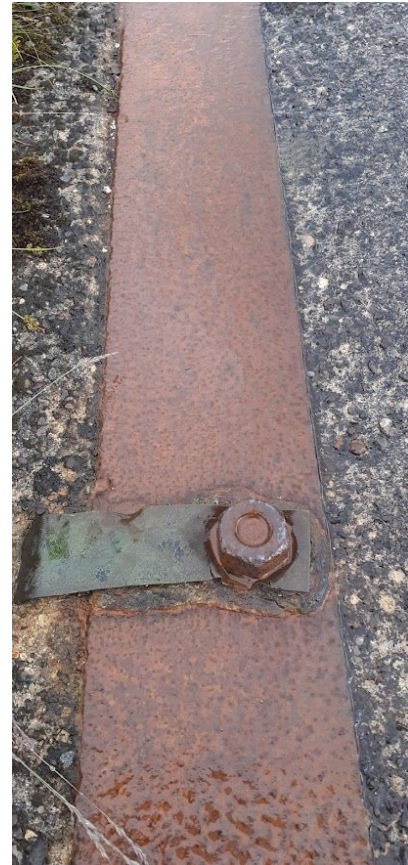
119, above.

Across or near to the trackway, seen at two points at the summit of Cefn Du, small rectangular concrete bases with thick iron bands, with one securing bolt having a wide copper earthing strap, are found. The purpose of these was obscure, until a photograph of the summit of Cefn Du in 1923 was discovered. This seems to show a small lattice mast positioned at the location of the base. This was reinforced by the finding of broken white porcelain insulators around that base.

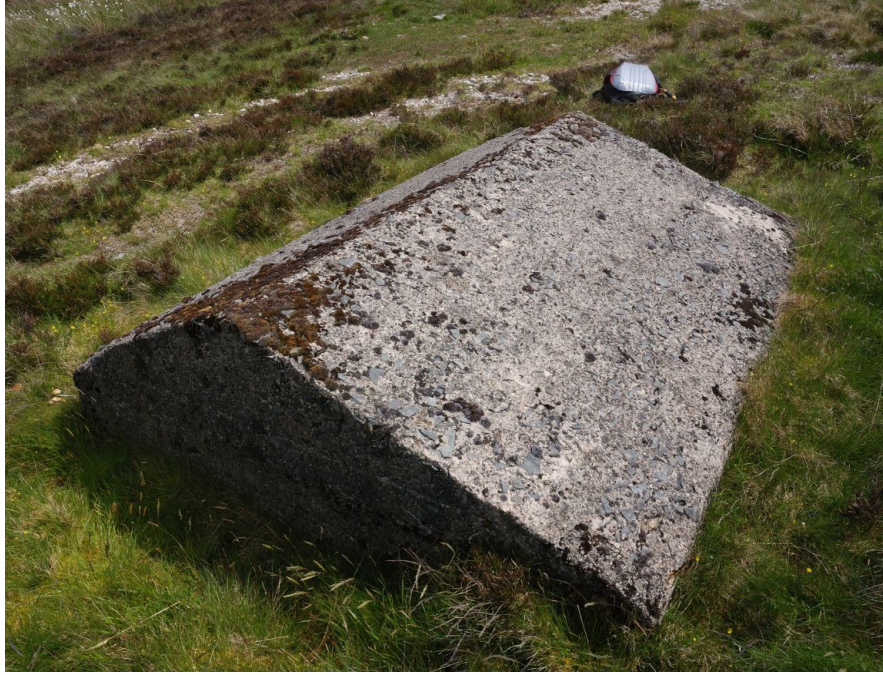
120. Anchor blocks are located to the north and south, opposite each pair of support masts for the 1914 antenna. They all have a (now) cut, substantial loop attachment. The purpose is not known with certainty, but would appear to be either additional head-straining stay anchors, or for tensioning triatic steel ropes between the mast heads. 138" wide along rear; 82", 10° sloping rear length, ~2' long 43½° sloping antenna-facing side. Southern boundary, between mast anchors 7A and 7D, at 53.121199°, -4.183082°.

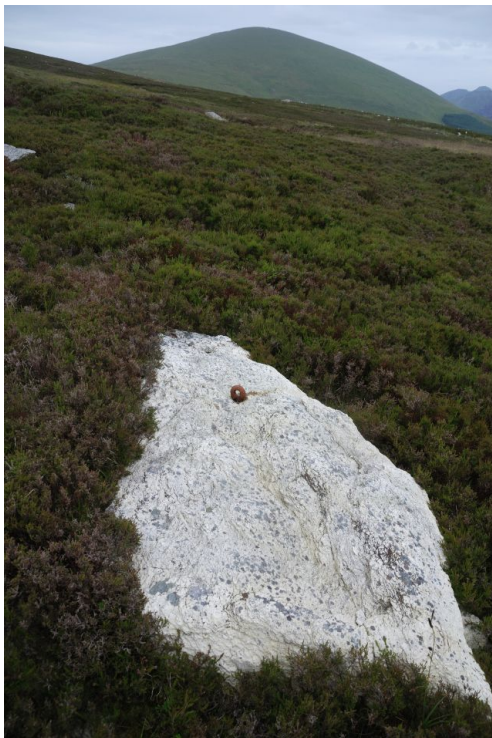
121. In this case, anchoring, probably of a small lattice mast, was more readily achieved by fixing an eye bolt to a conveniently-located, glacially-deposited rock. 53.121644°, -4.176221°.

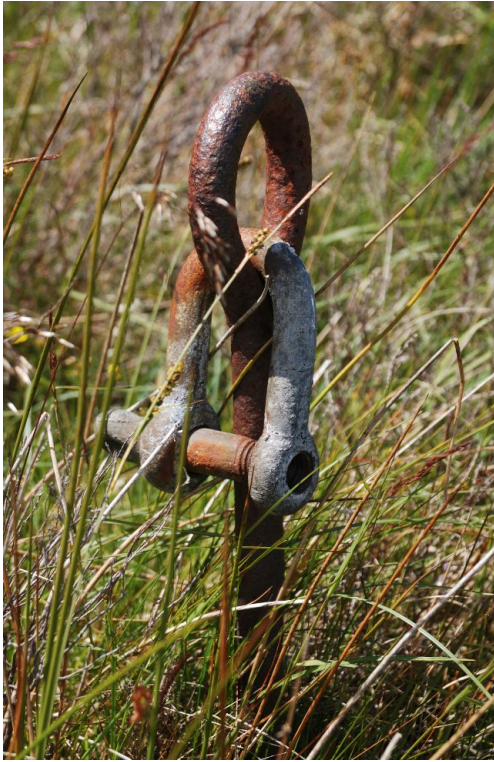
122. One of numerous eyed stay anchoring points found across both the 1914 and 1923 sites, in this example, with a rare and good condition shackle still attached. Only one is typically found next to counterpoise elevating masts, always at 9 yards' distance – a useful fact that allowed several overgrown lattice bases to be found that otherwise would not have been. 53.123447°, -4.168506°

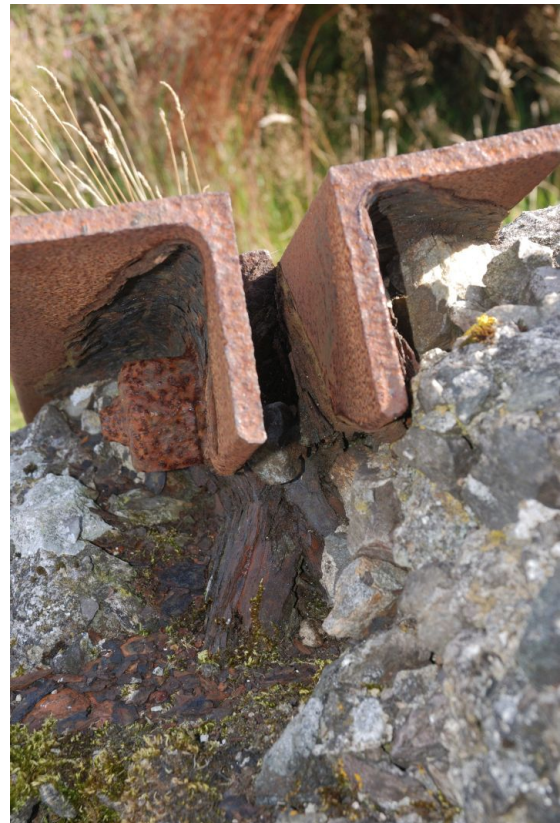
125. Entirely grassed-over when discovered, surface clearing revealed a large concrete base with corner bolts, iron spacers and two trackway rails protruding, leaning slightly towards the south-west. Thought to be a trackway winder base serving a trackway running downhill to the west, to a quarrying area behind the 1914 upper masts. Located immediately to the NE of 1921 extension, northern Pylon A. 53.123001°, -4.171694°.

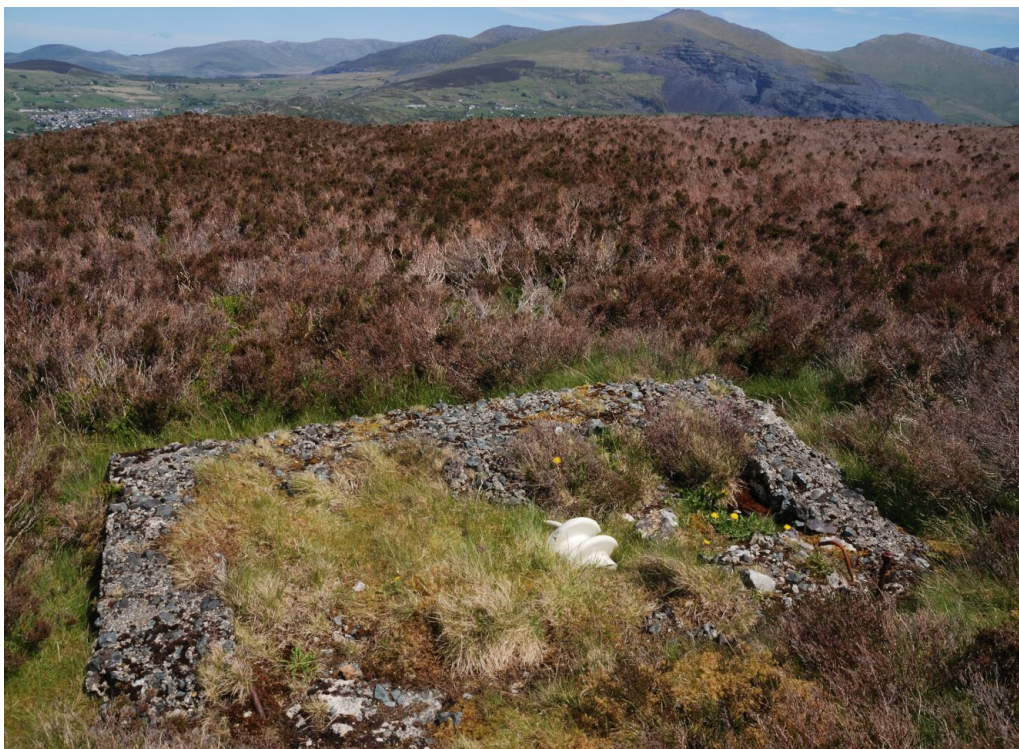
126. Rough concrete base lying near top of incline to lower 1923 extension site. Surface cleaning revealed that it incorporates substantial $\frac{3}{4}$ " bolts and impression of a machine base. It is thought to be the base of the incline brake pulleys. Note the remains of a ATI through-wall insulator, probably brought up from the single ATI at the foot of the incline during salvage operations in 1939. 53.123140°, -4.171421°

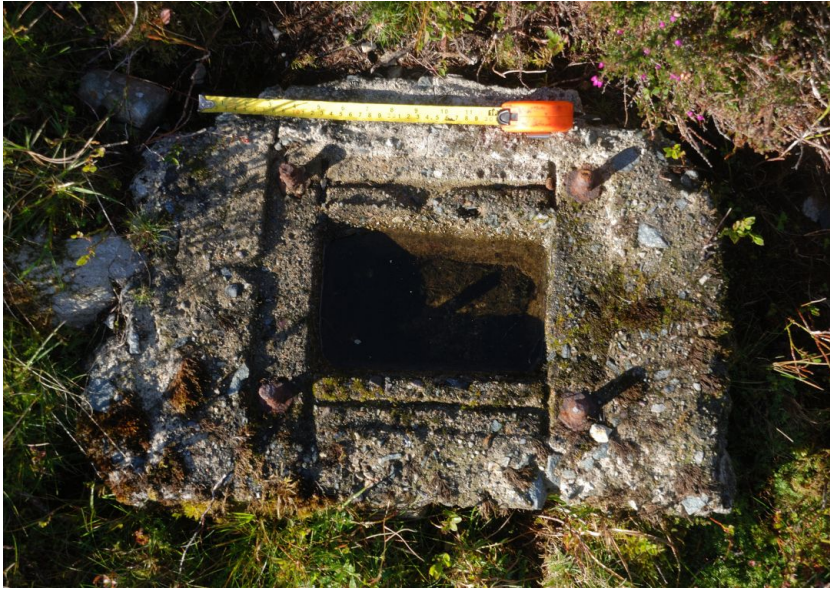
127. Deeply-socketed, small concrete base with four bolts. This lies at the top northern edge of the 1923 extension inclined trackway leading to the lower reaches of the site. It was not deeply-set in the ground and is quite loose now. It may have been a points or other trackway-related feature. Bolts separated by 14" x 9". Socket aperture = 9½" x 6¾" at top, 8½" x 4 ½" at bottom; 3" deep.

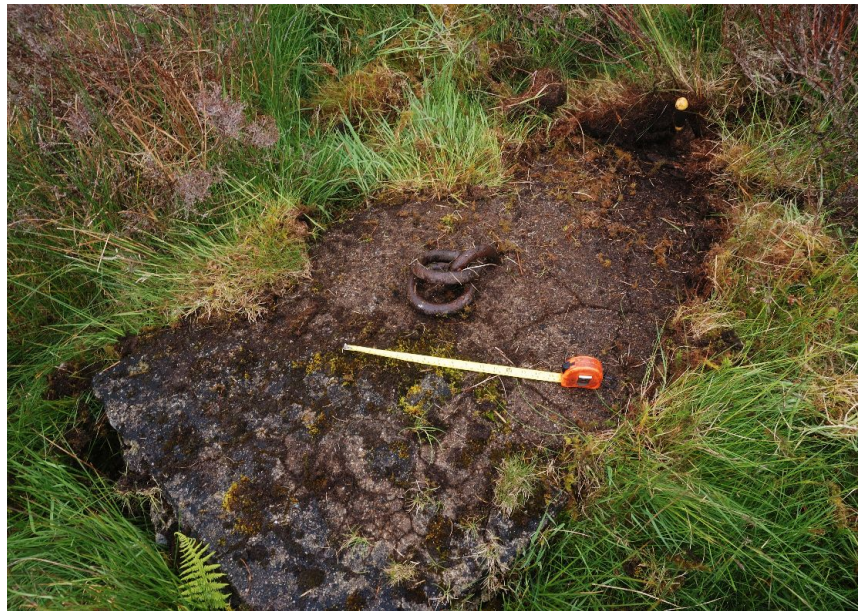
128. Small concrete base with central loop and two iron rings affixed, located 15 yards NE of Mast 16's base. It may have been related to triatic raising/lowering.

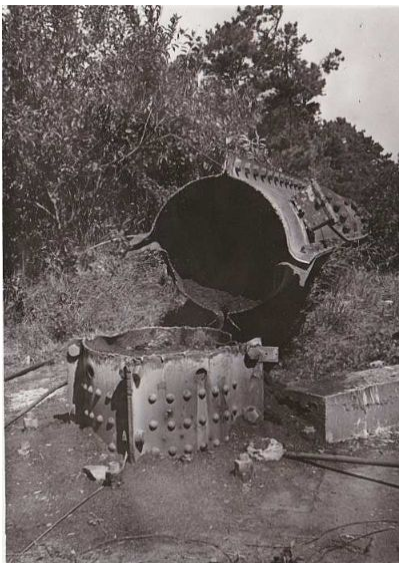
129. Felled four-section mast, usefully showing the fairly thin steel used for such supports, at Chatham, MA, USA. 1954. © Chatham Marconi Maritime Center, via Ed Moxon.

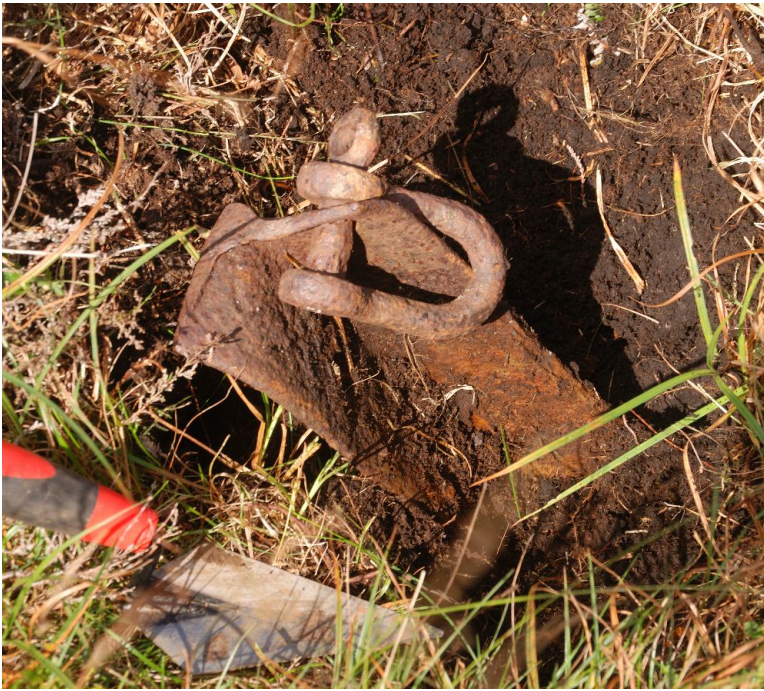
130. 'L'-section steel hammered into the ground, with shackle attached. There are a couple of these around the site, their exact purpose unknown. This example lies adjacent to anchor 6A for the 1914 antenna.

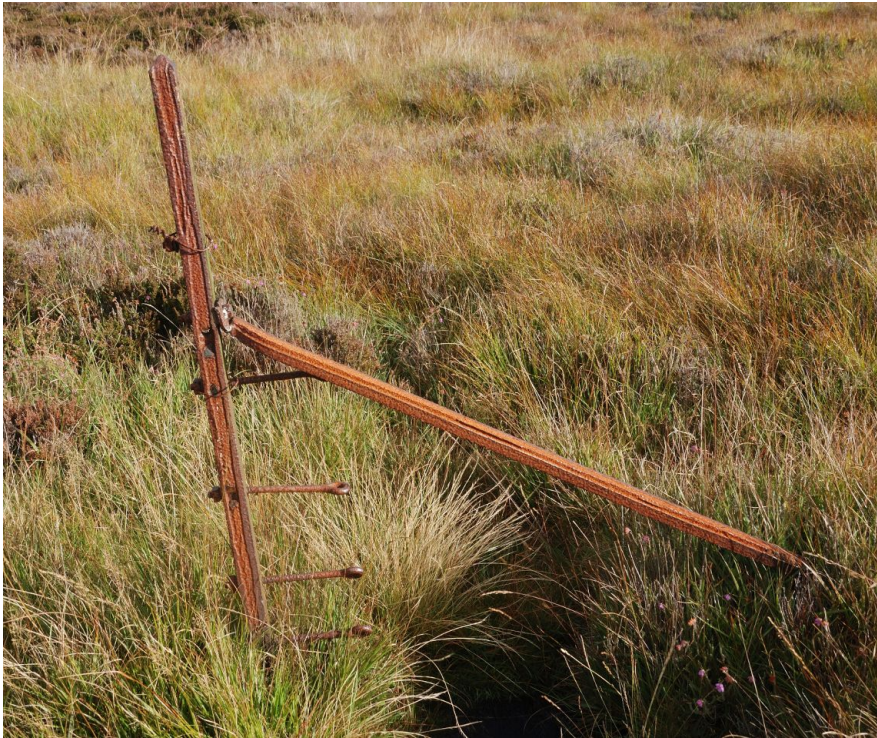
132. One of several remaining 1914 boundary fence posts and strainers, this at the upper northern end of the 1914 site. Upright post 4' above ground level, post 42mm x 42mm, stay 35 x 35mm; 7 x strainers, separated by 8".

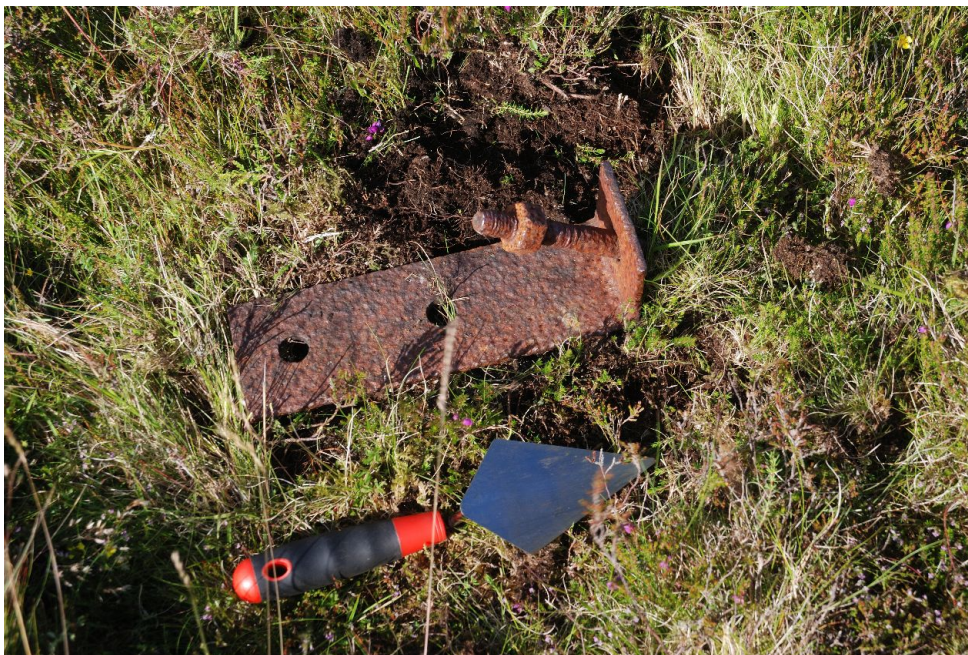
133. Corner bracket and ground bolt for securing a small shed seen at this position, near blockhouse 5, in the Marconi archive MS. Photogr. c. 244, photo 737/x (see 65). Trowel blade = 6"/150mm; 53.122301°, -4.173870°

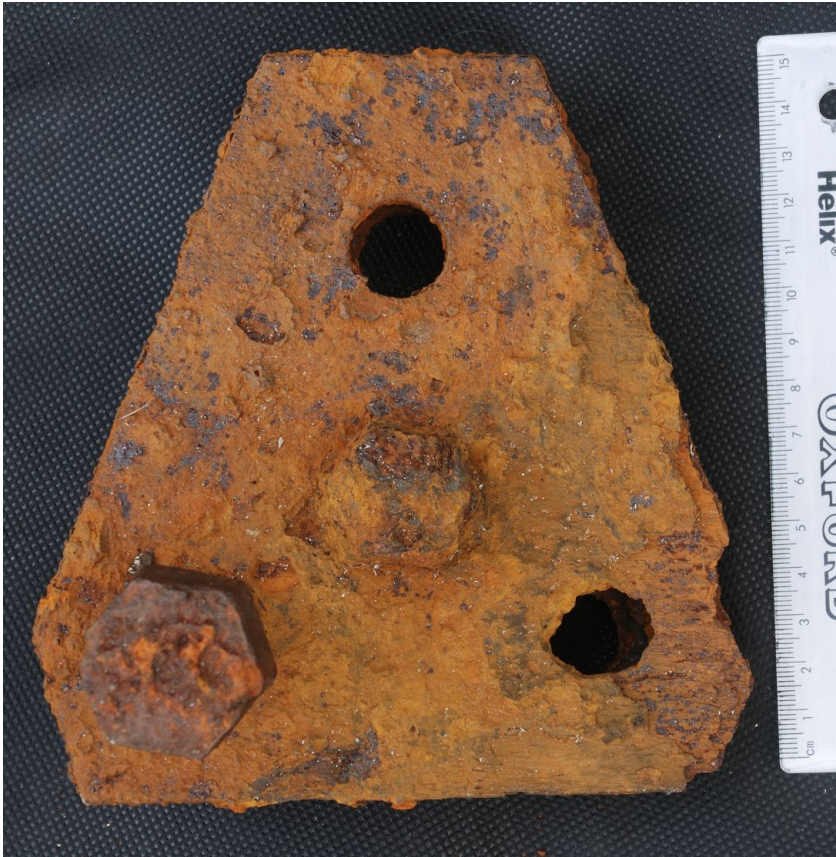
134. An anchor-to-two-stay attachment plate. The top hole bolted to the loop on the anchor, the lower holes, one with a bolt still in position, each attached a stay wire. This was found near the wall and below blockhouse 5 on the upper part of the 1923 extension site. It may have been one of the main anchor attachment plates. Found as bolt surface protrusion, at 53.122857°, -4.173596°.
