Marconi's Carnarvon Station 1912-1939

Archaeological Reconstruction
and History of a Trans-Oceanic
Wireless Site

John Rowlands

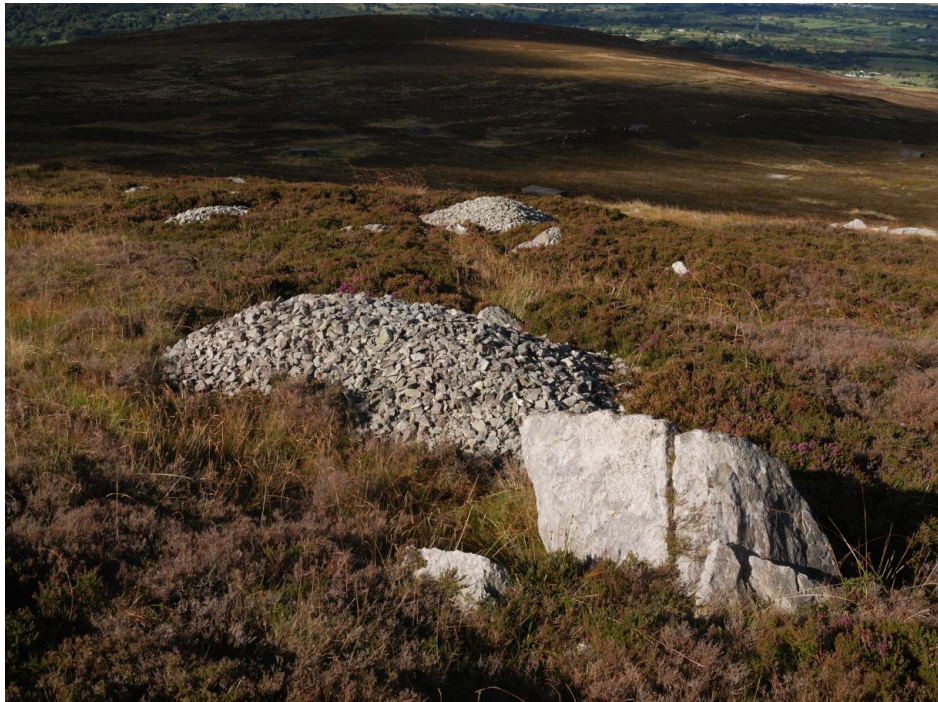
135. Glacial boulders reduced to trackway ballast on the spot. 53.121906°, -4.176516° (nearest pile)

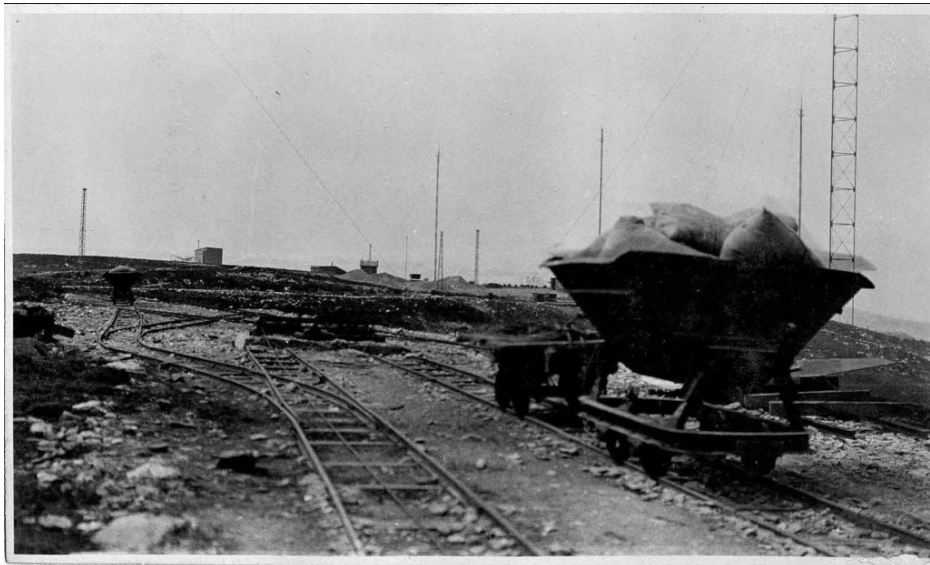
General view at top of Incline showing level run to main dumps arrangement of brake pulleys and cross over.

136. As per caption. The 1921 extension pylons would be taken in by this view of the busy area near the summit of Cefn Du (approx. 53.123101° , -4.171513°), but have clearly already been removed. June 1923. Bodleian Special Collections MS.Photogr.c.243, photo 735/x.

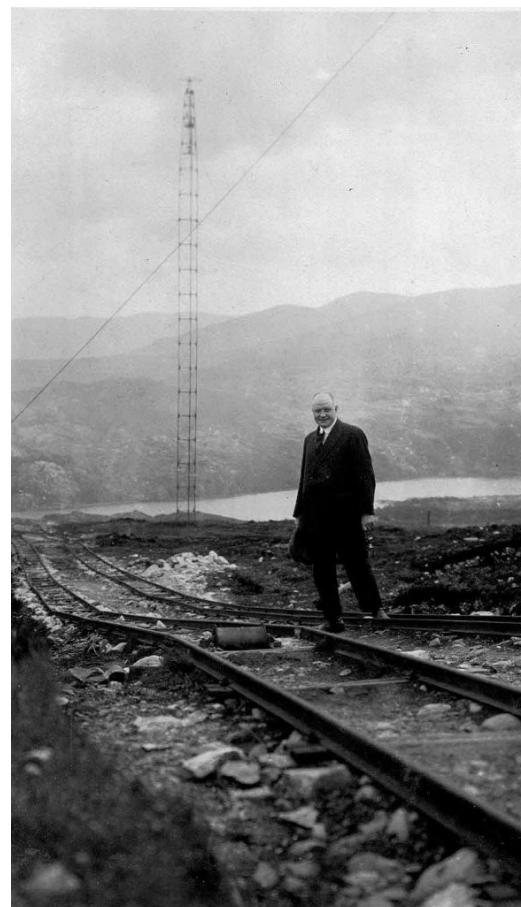
137. Along the incline built to the lower reaches of the extension. Mast 16 (the lowest, easternmost) is in the background, with a stay cable for Mast 14 across the top half of the scene. Note the incline wire rope rollers. The gentleman, who appears in the photograph at **138** and from his clothing, clearly not working on the masts, may be a manager or owner of Francis Morton and C^o., who erected the masts, or a Marconi engineer. January 1924. Bodleian Special Collections MS.Photogr.c.243, photo 720/x.

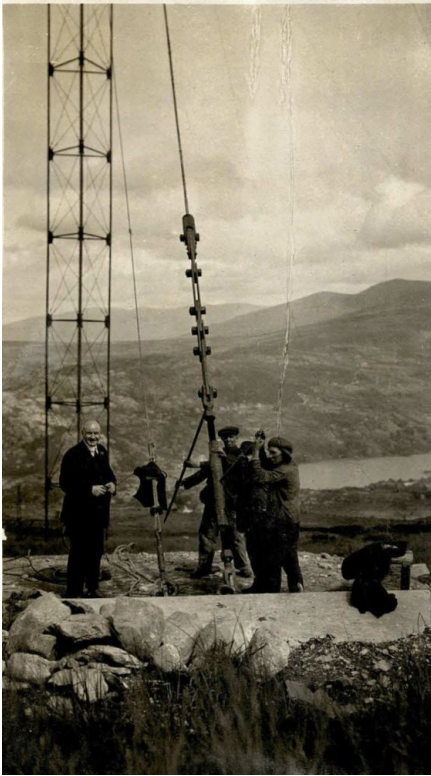
138. *Tensioning of one of the stay cables using rods to adjust the large threaded turnbuckles. Probably Mast 15, anchor A. Grounding connections and straps are not installed as yet in this photograph of January, 1924. Bodleian Special Collections MS.Photogr.c.243, photo 715/x.*

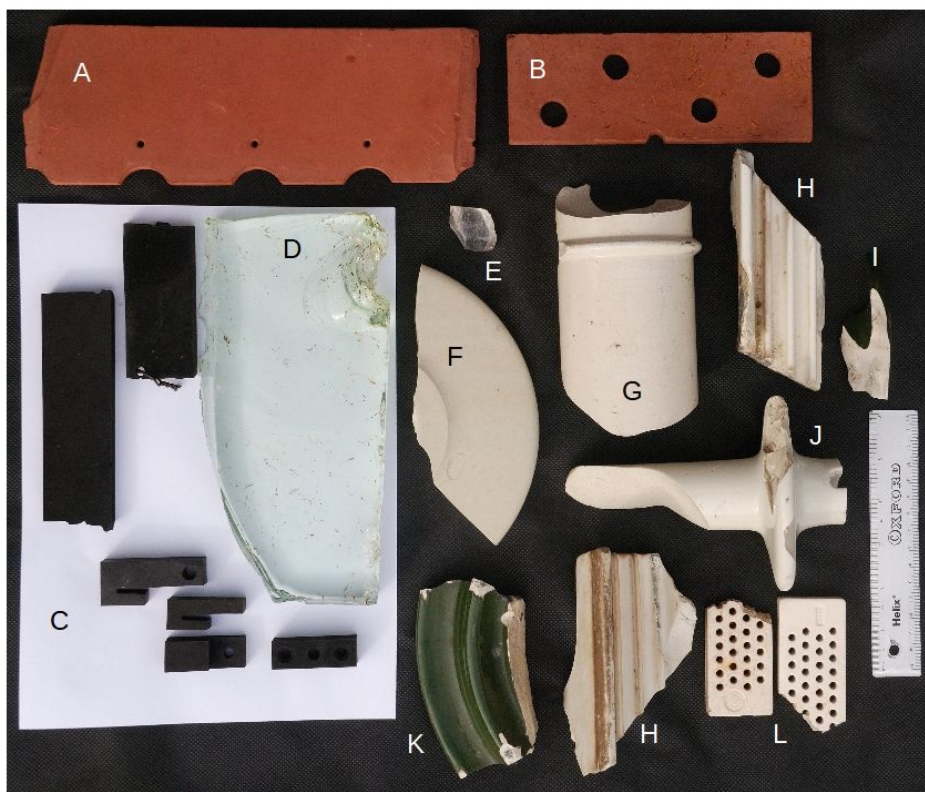
C1. A selection of ceramic fragments commonly found, mostly in relation to the ATI house sites. Rule = 15cm/6”.

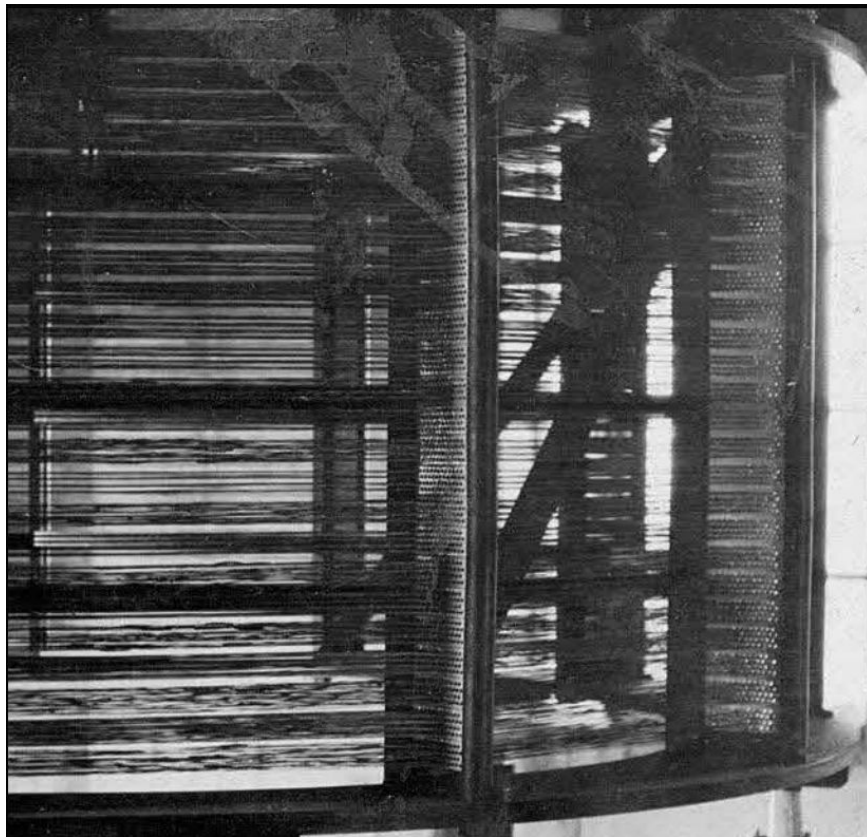
C6. Detail of '9176' insulators seen in their role as inductor wire spacers at the upper inductor house.

C5. Inductor, probably inductor 'B' in the GLC circuit diagram, making use of a large number of perforated ceramic spacers. Detail of insulators at C6, below.

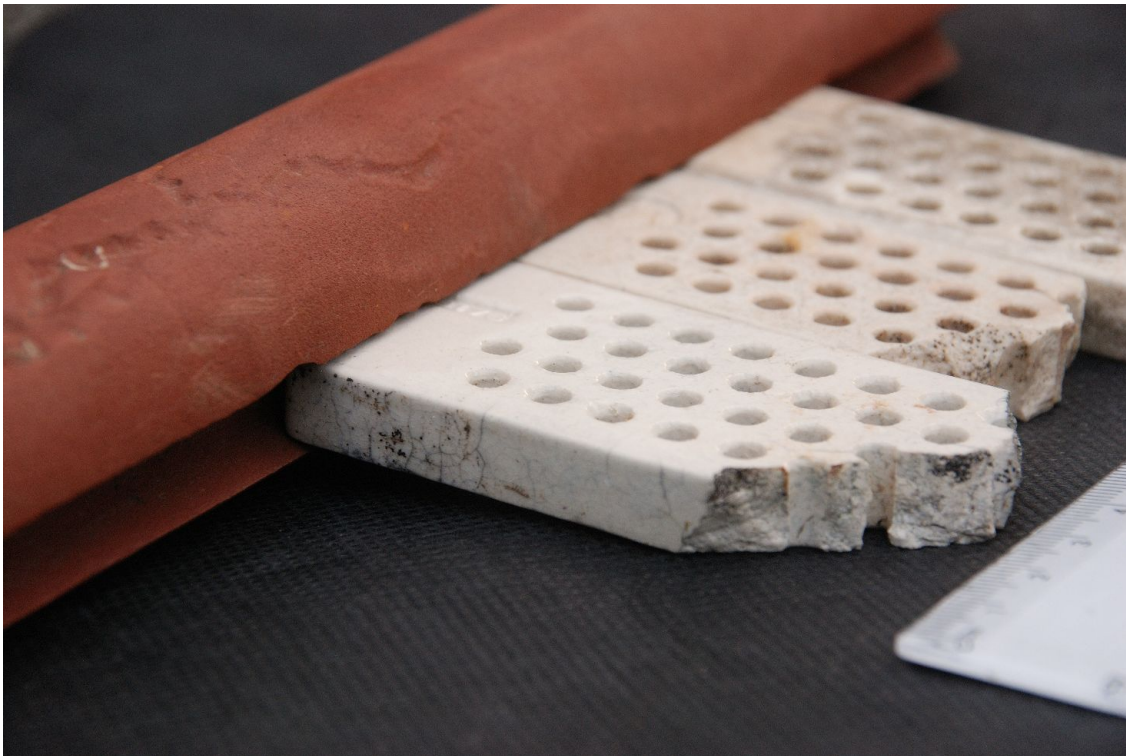
C8. Side view of the slotted spacer holder and how the insulators stacked together.

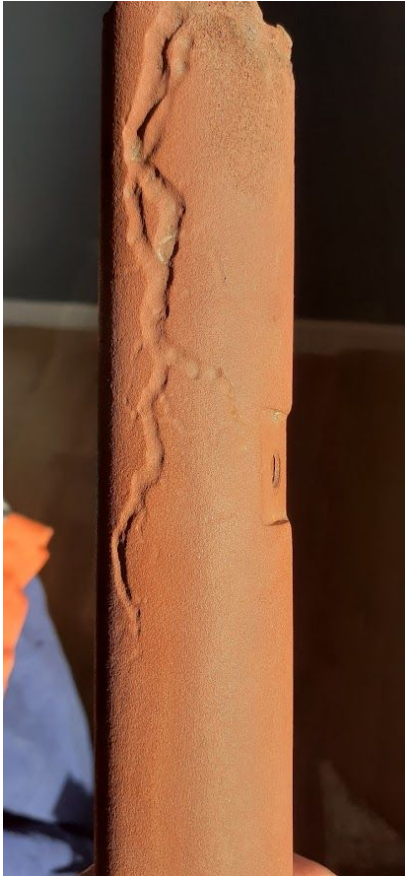
C9. *The slotted mounting insulator shows a distinctive fractal 'lightning' pattern eroded, probably over some time, into its surface, caused by electrical breakdown or 'flashover', which would not be conducive to best transmitting efficiency. Amateur radio operator, Kevin Porter, G6UCY, suggested that a damp environment may have provided conditions more likely to lead to flashover. This is entirely plausible, as the double ATI house is located on wet, boggy ground that was clearly anticipated to be a problem; an internal drainage channel was installed when the concrete base was laid.*

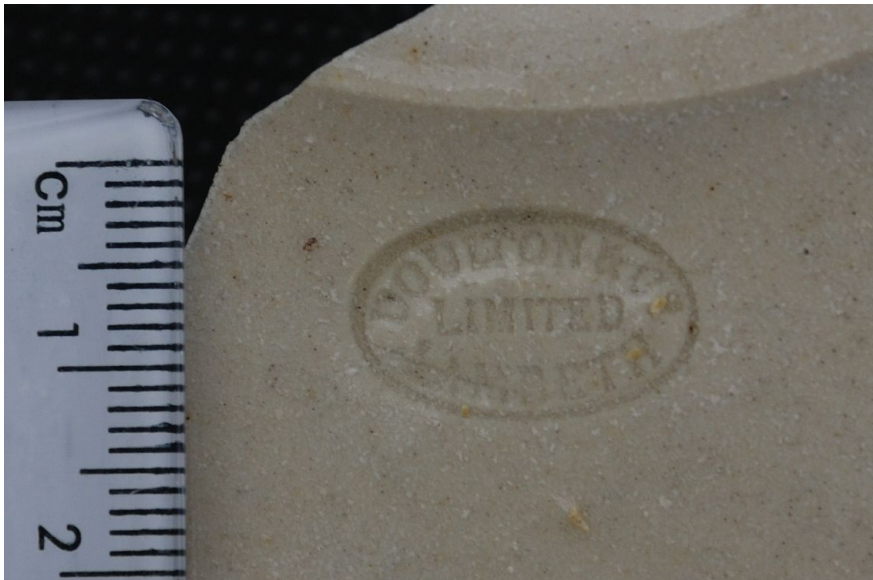
C10. *Doulton impression on insulator F.*

F: disc element of a larger insulator, bearing a Royal Doulton, Lambeth maker's impression. Found at double ATI house, potentially a 'reel' type insulator, widely used with radiating and counterpoise wires, multiple examples visible at the counterpoise strainers in image **73**.

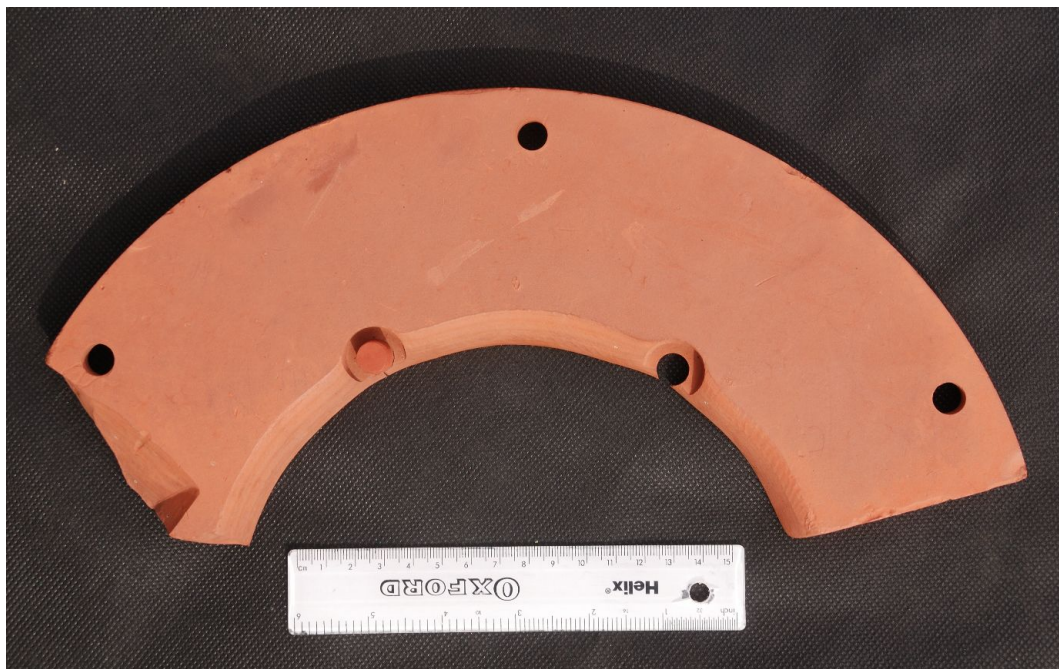
C12, below. Upper face. Width variable, 85-88mm; inner diameter = $7\frac{1}{4}$ " ; outer diameter = 14" ; thickness = 18mm. Scale = 15cm/6". Inner perimeter apparently hand-chamfered.

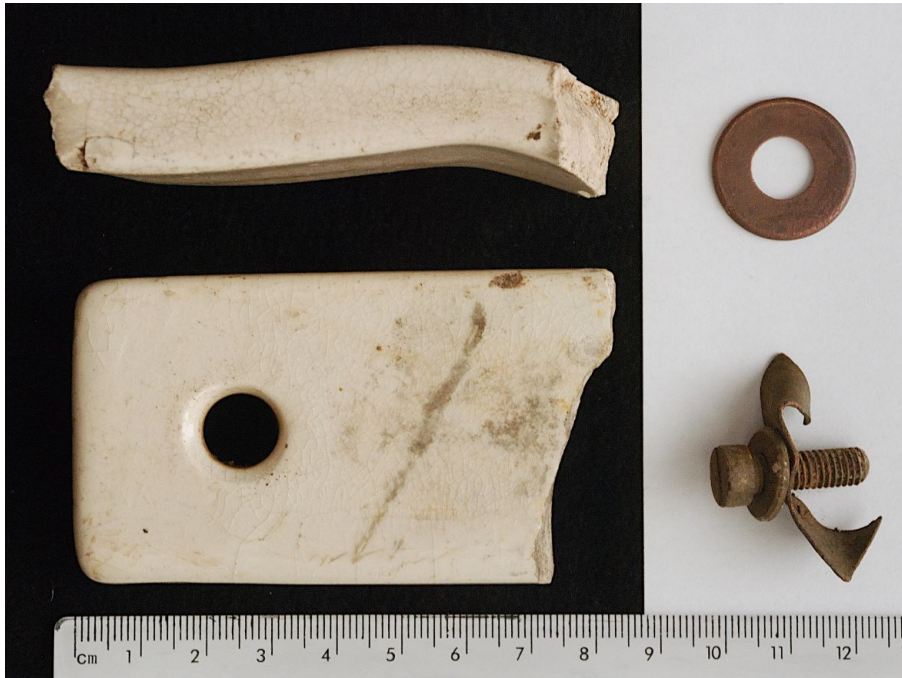
C14, left. Ceramic fragments from the upper ATI house. Images of the mid-1920s variometer at the transmitter hall indicate both were part of the same unit, a cable retaining ceramic that 'wrapped around' the cable. Right: copper washer from upper ATI house, and slotted-head bolt with washer and copper earthing strap from the lower ATI house.

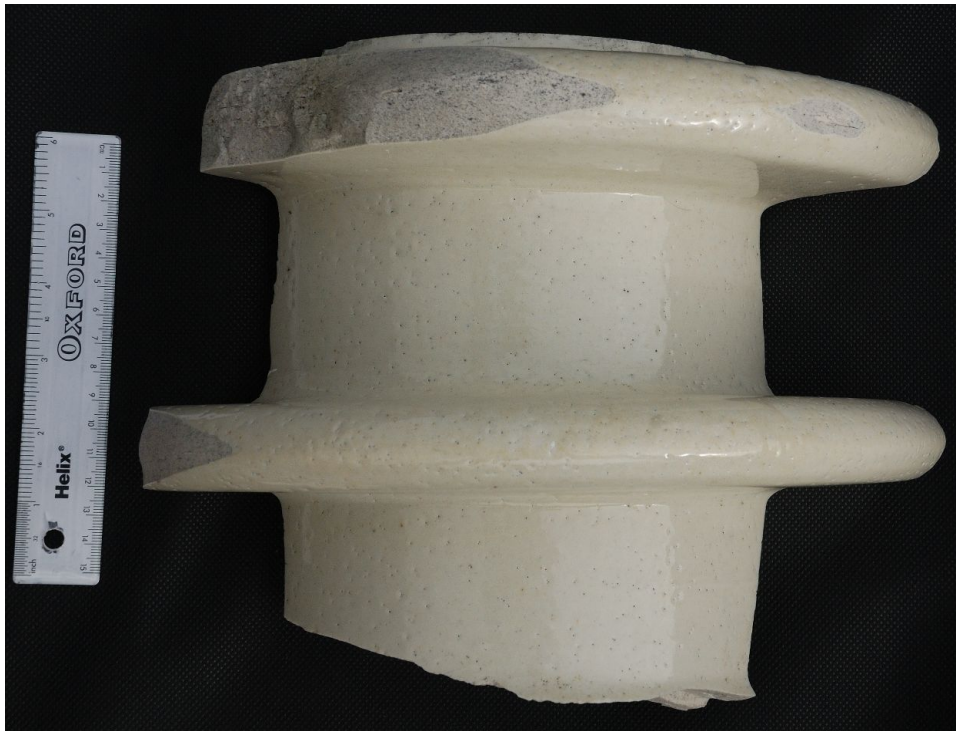
C15. A very large, cream-white glazed insulator found at a brake/winding base at the top of the incline for construction of the 1923 extension. This was one of the through-wall insulators seen in several photographs of the inductor ('ATI') houses; intact examples are still seen at the transmitter house. Connections were made to a metal plate with a conductor that ran within the insulator and thus passed through building walls. Its position at the top of the incline suggests it was one of the lower inductor house insulators, probably discarded as of no further use after being transported with scrap metal by rail truck to the summit of Cefn Du. Numerous fragments of the same type of insulator, but with a whiter glaze, were found buried in a nearby boggy pool (marked in context, below, at 53.123069° -4.171382°).

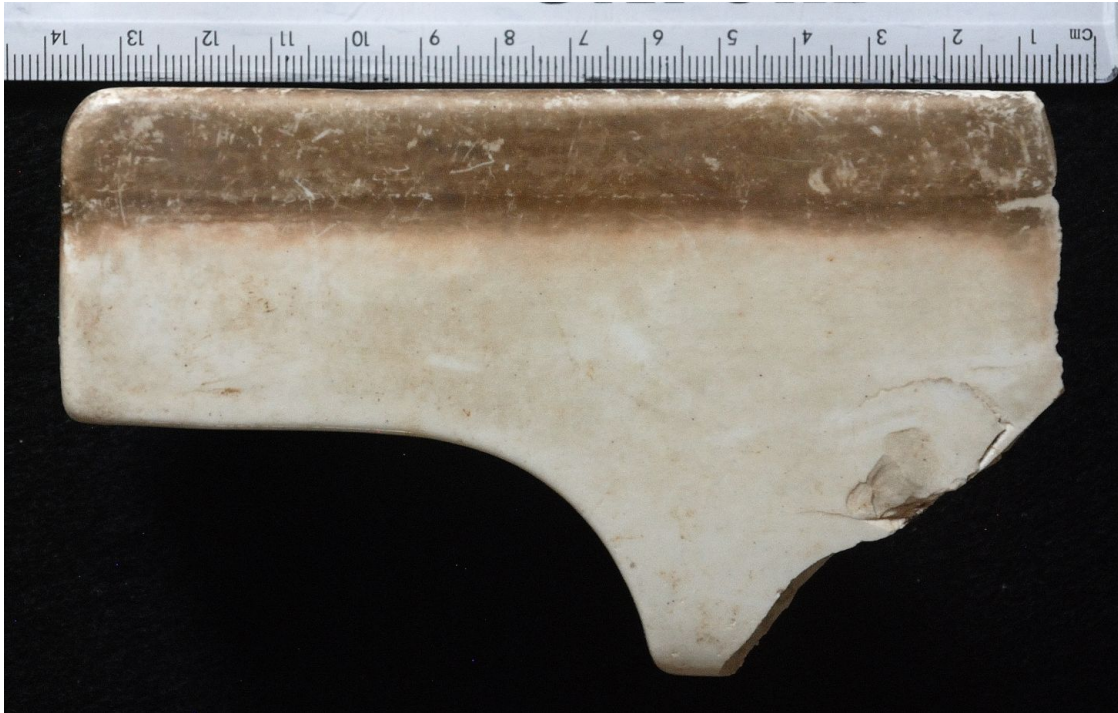
C19. Side view of one end of the insulator. No maker's impression has been found on any fragment to date. Scaling from images to fragments allowed the intact length of these insulators to be determined as ~2 feet at the top, ~16" at the bottom.

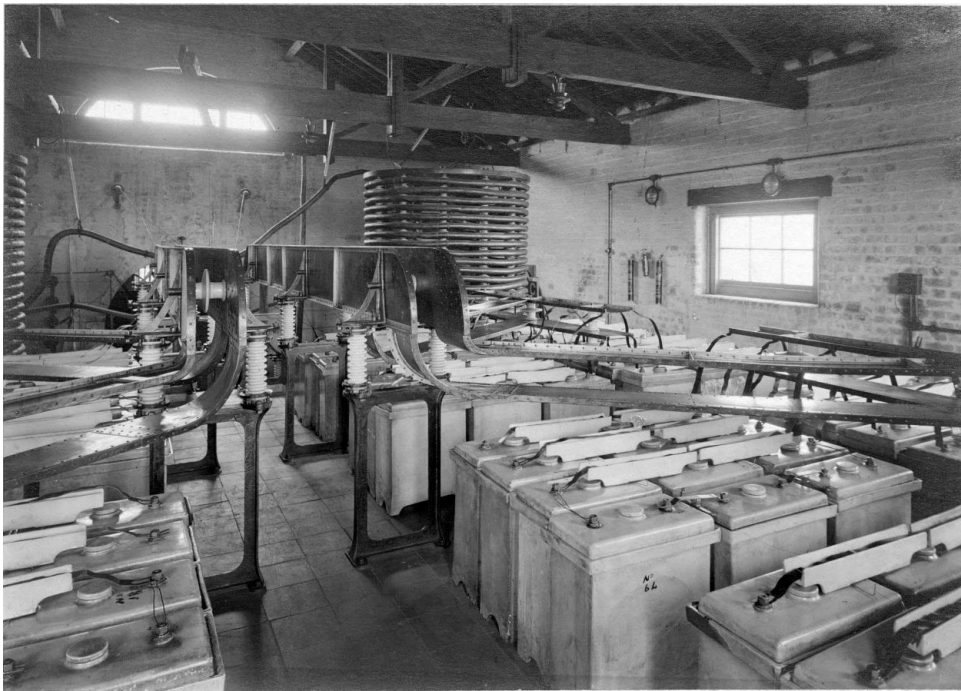
C20. The 'bridging' insulators seen at work, bridging glass-and-oil capacitor tanks of porcelain, in this case, in the transmitter building in 1918. The capacitors were a fundamental part of a resonating, so-called 'tank' circuit, acting in concert with the large inductor coils at background. Strips of copper conductor run inside the insulator channel. Image: Bodleian Special Collections, MS.Photogr.c.243, photograph number P.2072.

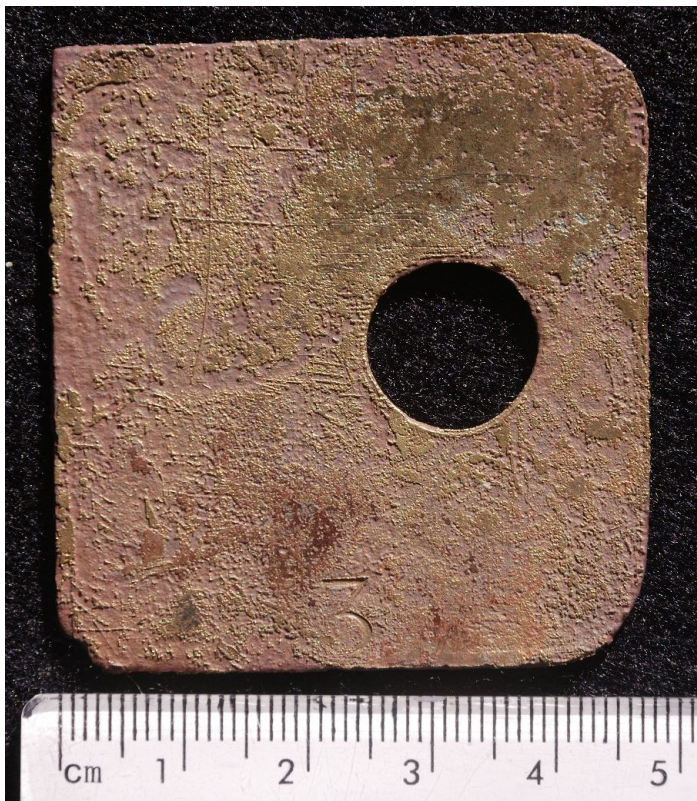
C22. Numbered connector tag, probably of an oil-and-glass capacitor from upper ATI house.

C21. Detail of glass-and-oil capacitors (Bucher, op.cit., p.304). What appears to be (C22, below) one of the connecting tags seen between the threaded lid bolts and a metal capacitor plate, bearing a number '3' was found in the ground at the outside of the entrance to the double ATI porch.

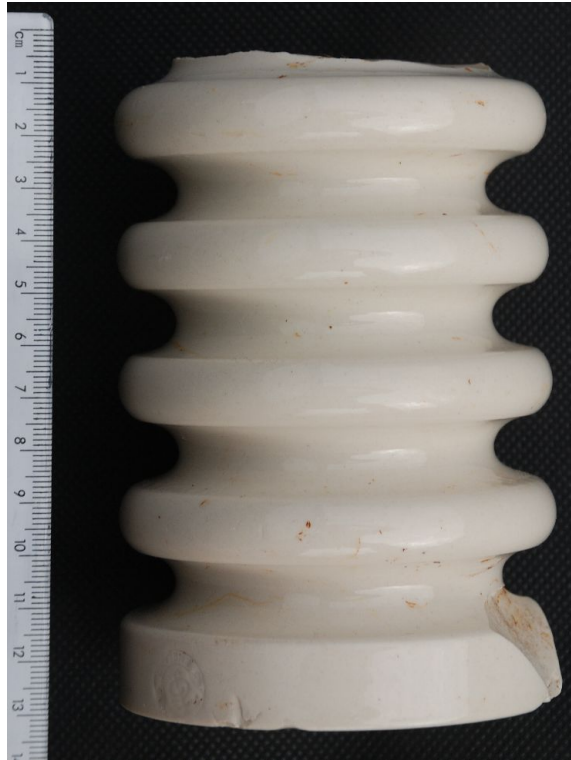
C23. Cylindrical ribbed insulator, bearing Taylor and Tunncliff impression (at lower left), found at the double inductor house. These had many uses, similar ones seen in use at **C19**.

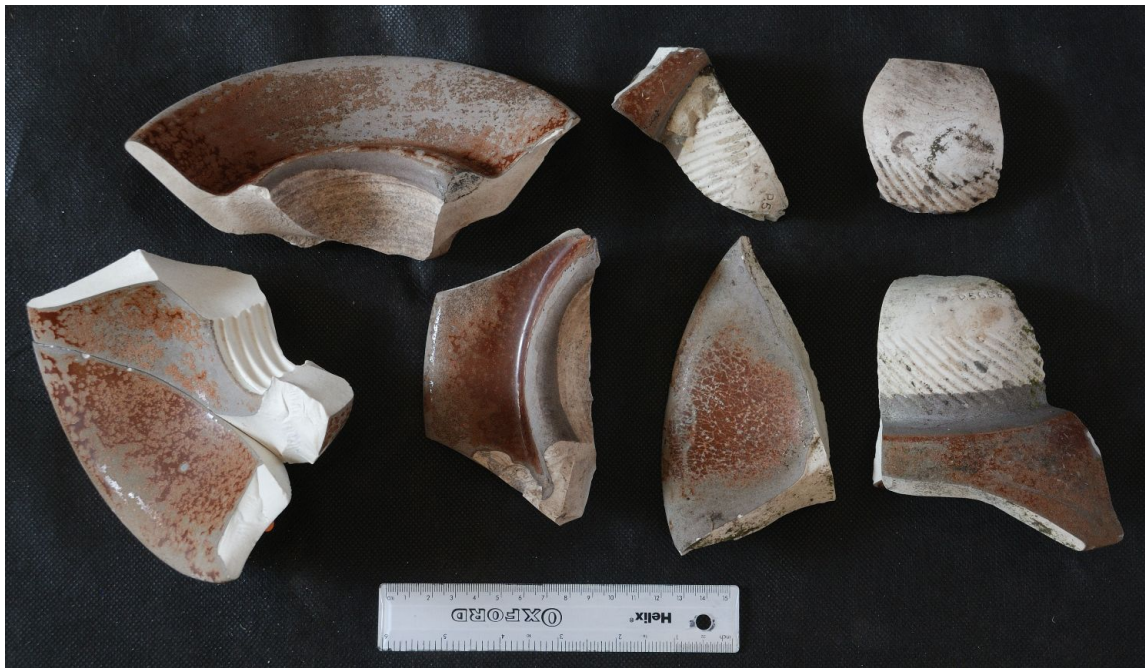
C24. Fragments, at least two pieces from the same insulator, where the outer brown glaze has severely deteriorated. These were parts of a nested 'pin' insulator, cemented together, and found close to a counterpoise lattice mast, upon which it is thought most likely was mounted. The larger fragment at far right has a maker's number, P.5656 (see detail, below). The top centre fragment has the same, but partial P.56... mark. A single top piece (not shown) bearing the same P.5656, has a groove of ca. 15mm diameter for receiving a wire, which may add to the belief this was a counterpoise masthead insulator, though the groove may not have been used.

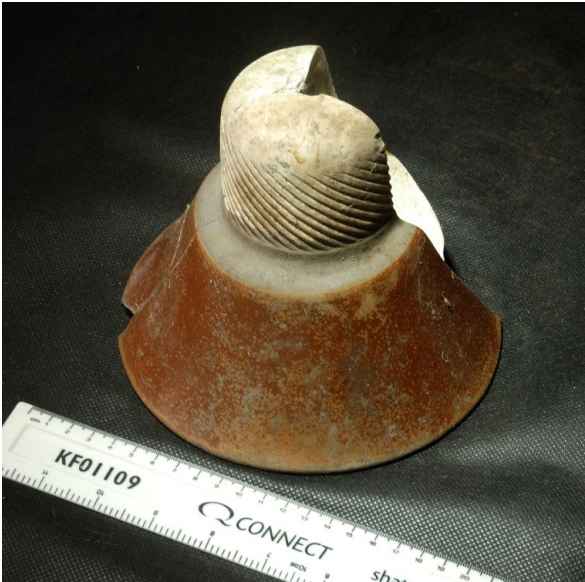
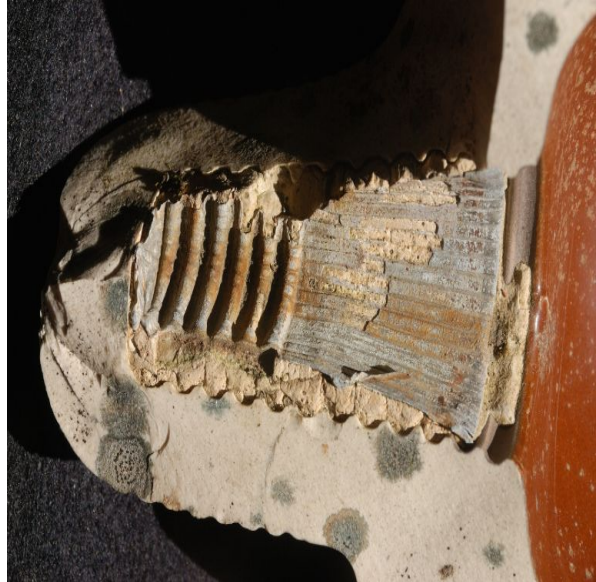
C25, above: Part of the P.5656, nested 'pin' insulator with a central threaded section containing cementing and a lead (metal) collar.

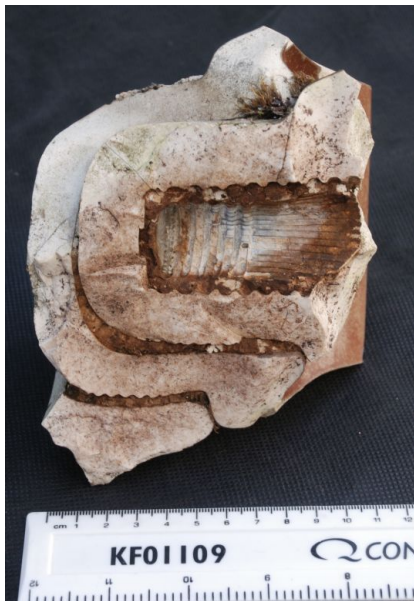
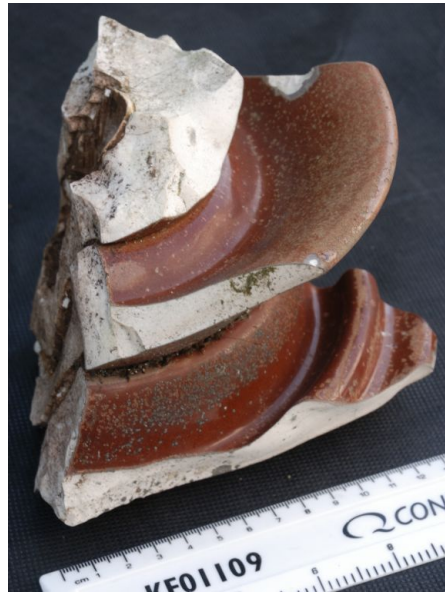
C26, a and b, below: some of the components still cemented together in a separate discovery. These probably formed part of the earth or feed line system.

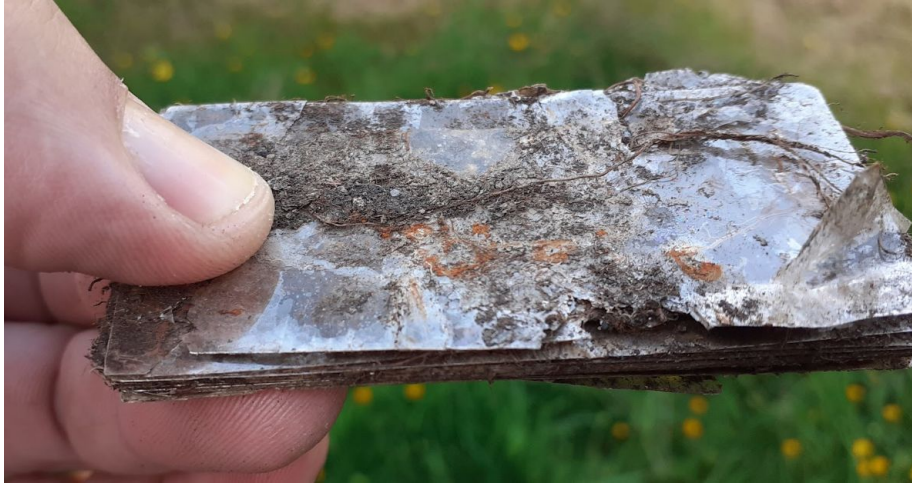
C28. Part of a mica sheet capacitor, probably a mica-silver type, as there are no interleaved copper sheets as in mica capacitors before this period. Length = 3", width = 1½".

A different class of ceramic was found lightly buried just outside the entrance to the porch of the double inductor house (C28-C31). Fragments of what initially appeared to be plastic led to a thick organised cluster of what was in fact mica sheet – part of a small capacitor. Mica-silver capacitors were developed in this period, and the mica may thus have had a thin coating of silver. Such capacitors were noted for their great reliability. Efforts are being made to subject the metal film to elemental analysis.

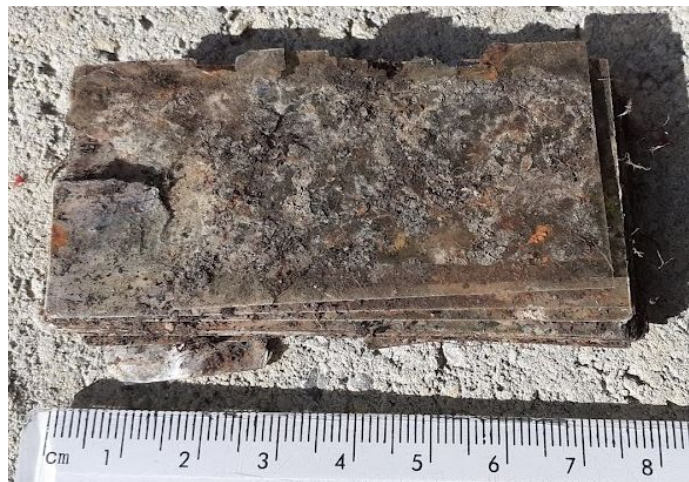
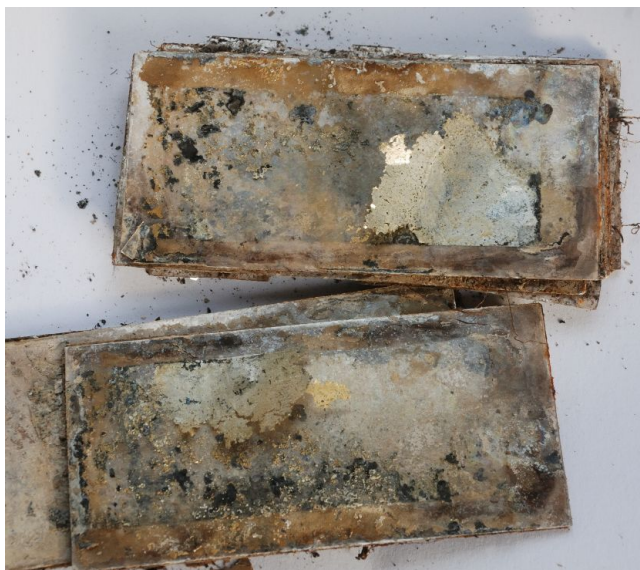
C30. Sheets of the capacitor, separated to reveal metal, probably silver foil plates, with detail at C31, below.

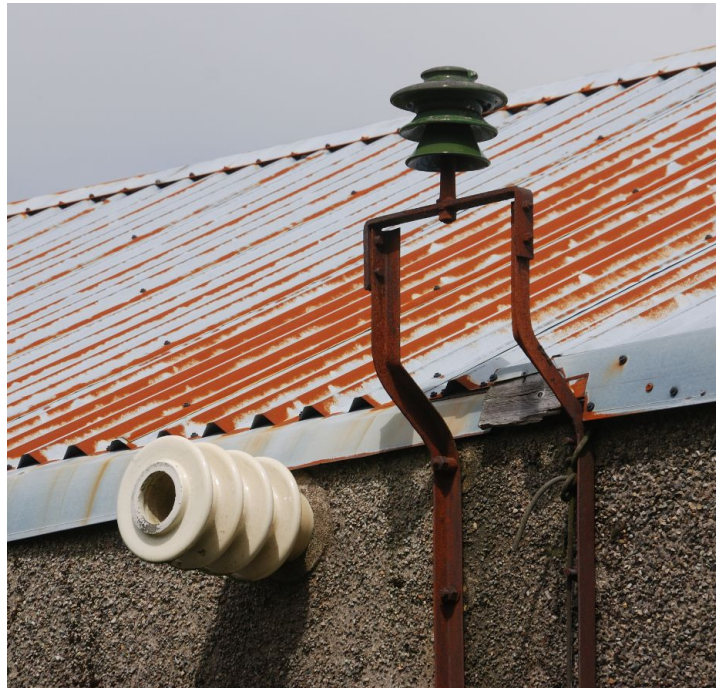
C38. At the southern end of the transmitter buildings, a large through-wall white insulator, of the same kind still seen at the eastern, antenna-facing elevation and at both, now demolished ATI buildings, remains in perfect condition. It may have been the connection to a later common earth point to the rear of the building. Alongside, a multi-part green 'pin' insulator, of currently uncertain purpose. A brown multi-part insulator also remains in perfect condition, mounted slightly to the east on the same wall (C39, below).

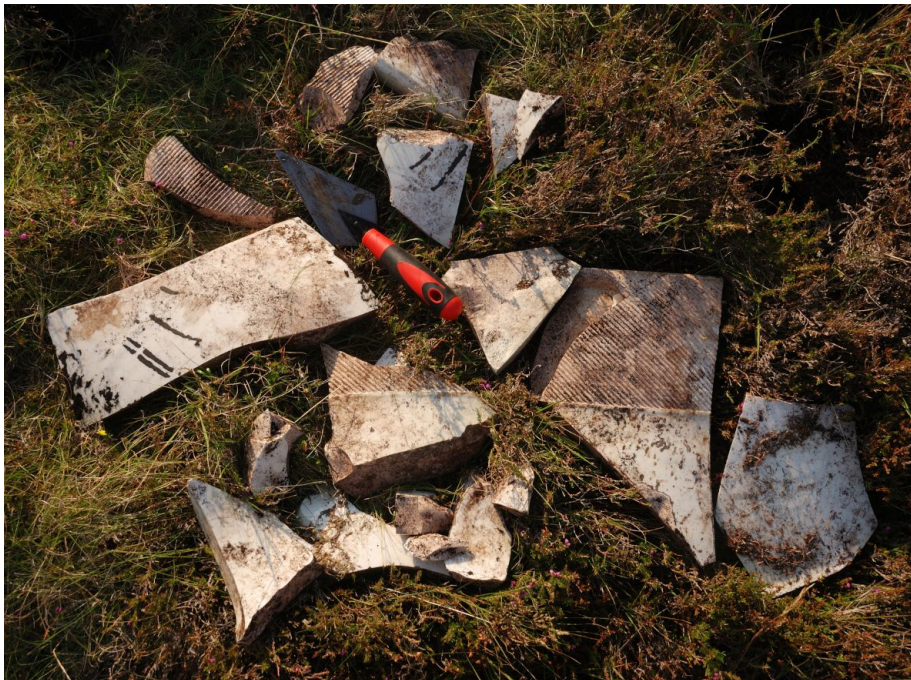
C40. *The very well-smashed remains, lying where they were dumped at dismantling, partly buried, found close to the eastern end of the upper 1921 extension mast base at 53.121758°, -4.175346°. The raised diagonal pattern in the largest fragment at right shows it had another component attached to it, as confirmed by discovery of small fragments with adhesive/cementing attached to them. Distinctive black ‘tarline’ marks are also evident on the large fragment at left of the trowel. The purpose of this insulator is not known, but it was substantial; the diameter at the upper end of the patterned surface being 14”. The curved nature suggests it could have sat on top of one of the ATI house straining towers. Alternatively, it may have been related to the 1921 extension masts, though this is considered unlikely due to the typical use of much smaller, ‘reel’-type insulators for that purpose. Further work is needed on the complex fragments. Trowel blade = 6”/150mm.*

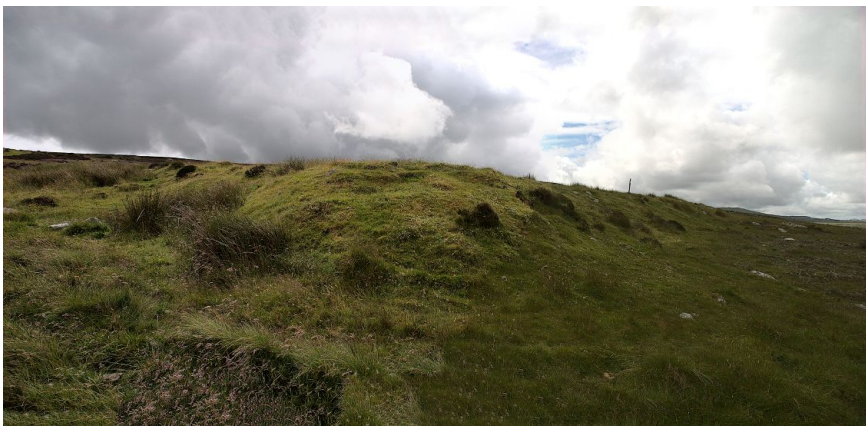
T11. Panoramic image, looking south, of the 50,000 gallon reservoir.

The transmitters, which all operated on what we today call renewable energy from the Cwm Dyli hydroelectric power station, required large volumes of water for cooling. For this, a substantial reservoir of 50,000 gallon capacity was built into the ground, 980 feet to the ESE of the transmitter building, and 135 feet uphill of it. It was also the supply for fire fighting (which proved critical in 1921). It is covered by a significant volume of earth today, but is presumably of concrete construction. This is an interesting feature worthy of future study.

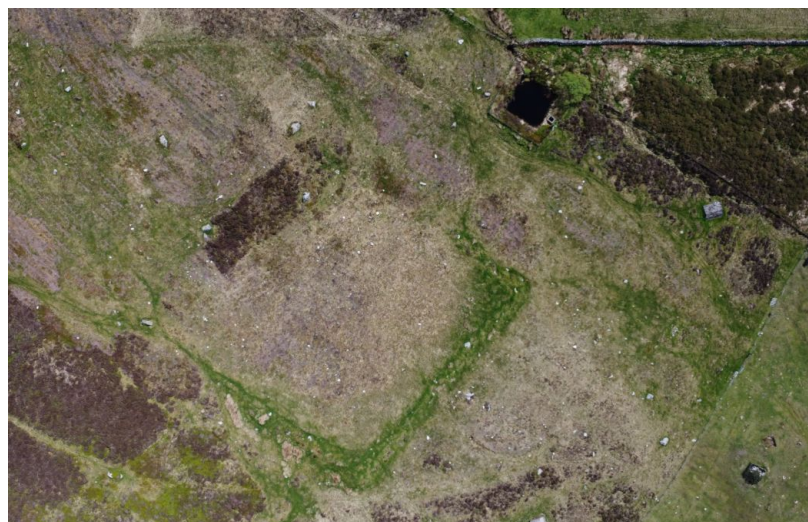
T12, right: aerial drone image of reservoirs, the largest of which is outlined in green grass growth around most of its perimeter. The smaller reservoir is at top centre right. The internal construction is likely to be multiple brick pillars supporting a concrete roof. There is a likelihood of that roof's collapse at some point.

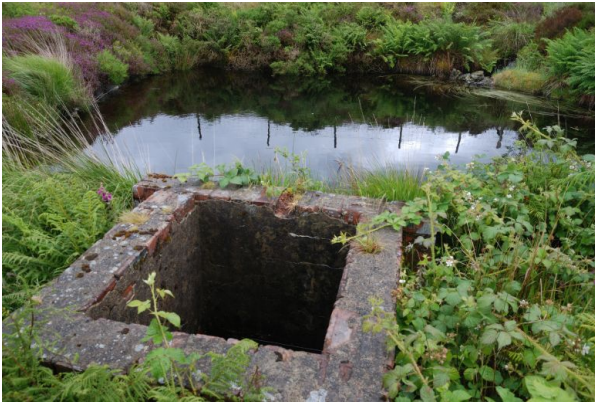
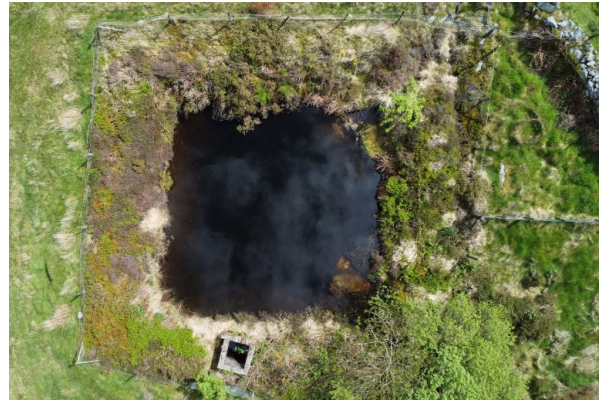
A very much smaller reservoir to the south of the main reservoir is of uncertain purpose (**T13, T14**, below, from west (to bottom of images)), and has a valve mechanism at 1.3m below water level. It is fed by a slightly diverted stream running to the south. It may be connected to the larger reservoir.

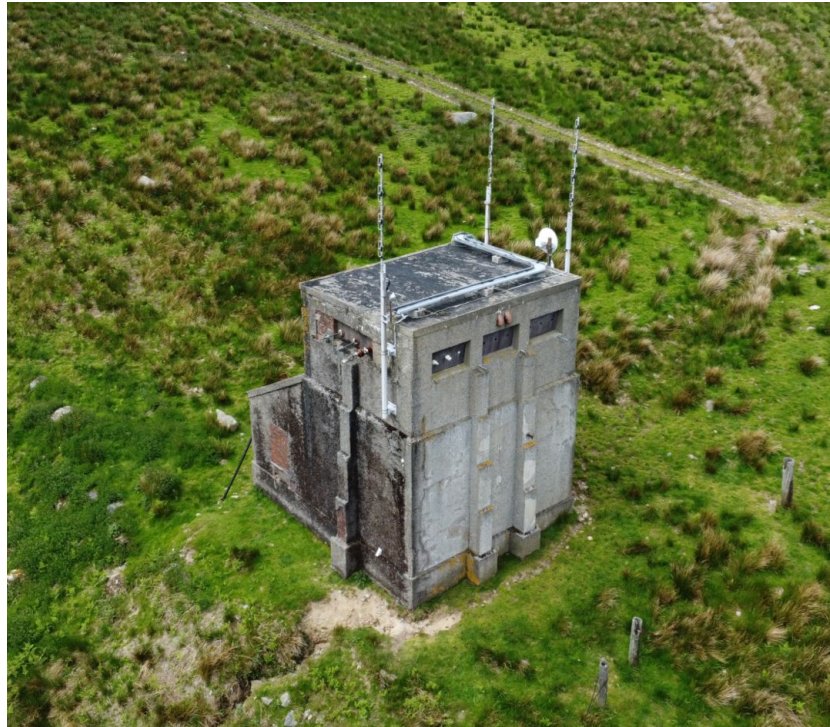
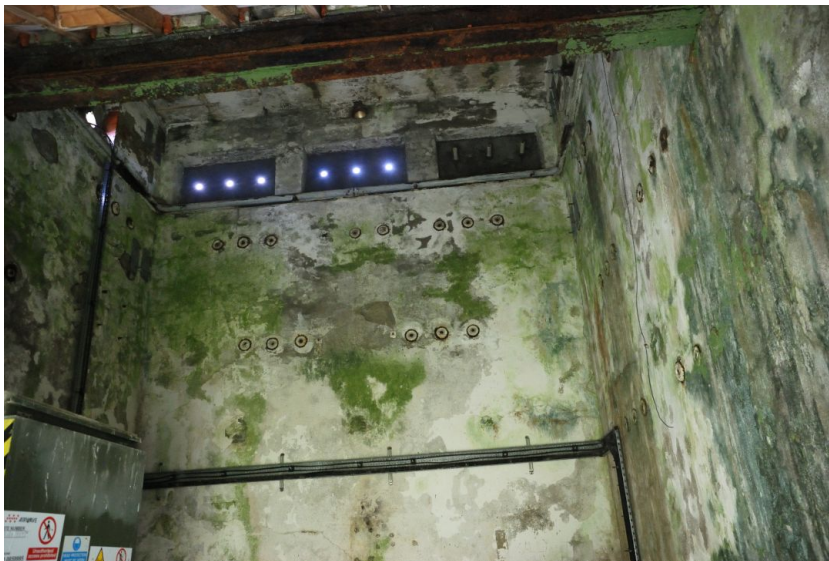
T19. Internal view of the Llanberis switch house. Insulators for the feeds were fitted to slate panels installed in wall openings. The pattern of standoff insulators on the three walls is very evident.

T20. One insulator survives in relatively intact state on the south east elevation. This was for the onward transmission, up Maesgwm and towards the Nantlle quarries. The feed for Marconi station was on the opposite, northwestern elevation.

The Llanberis switching house still exists though, again, it had not been recorded by the historic environment professionals, despite being a very obvious feature in the landscape. It has more recently been repurposed as an emergency services ‘Tetra’ communications relay station – thankfully without too much harm to the structure. Due to the present study, the switch house has now formally been assigned a National Primary Records Number (NPRN) of 800088 (SH5746358733).

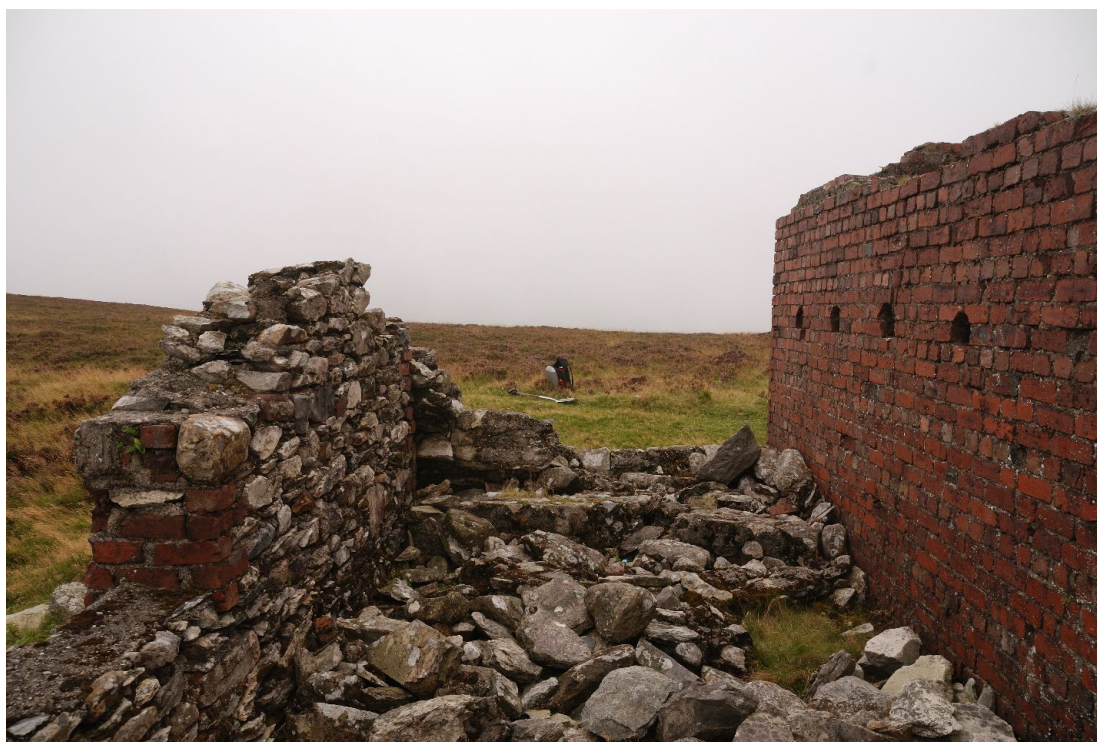
H1. *View from the NNE of the eastern elevation (right) of the brick blockhouse and the southern (centre) and eastern (left) elevations of the stone element. The camera is at firing hole aperture height, and projecting their viewing lines forward to the part-ruined eastern stone elevation shows the view out onto the wider site, for all of them, to be mostly or entirely obstructed by it.*

The stone element, even in its derelict state, still has the top of its eastern elevation higher than the direct sight line of the few firing holes still open. This would not be conducive to hitting the enemy, and is the first piece of good, but not conclusive evidence against the stone element being a 'cell' of an earlier stone building.

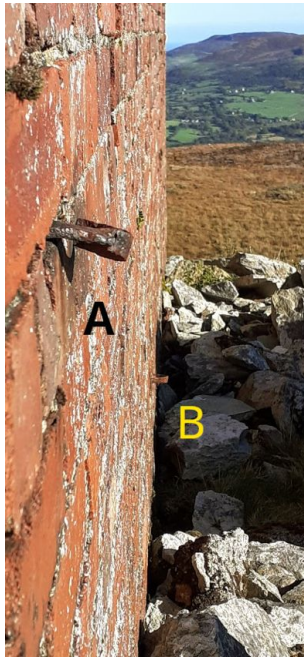
H2. *The eastern elevation of the brick element, viewed here from the south, has two gutter downpipe brackets remaining mortared between bricks, with no indication – such as hacked-out or replacement mortar, that these were installed at any time other than that of its construction. If the stone element was earlier than the brick, then the downpipes would have discharged internally into the stone part – an unlikely scenario, especially when the only practical roof form for the stone element at this point would be a single-pitch, 'lean-to' sloping flat roof where such downpipes would have been entirely unnecessary. No guttering is seen for either the brick or stone elements in photographs of 1923, which strongly suggests the stone element was a post-1914 addition. This is the second, compelling set of evidence against the idea of stone building predating the brick element.*

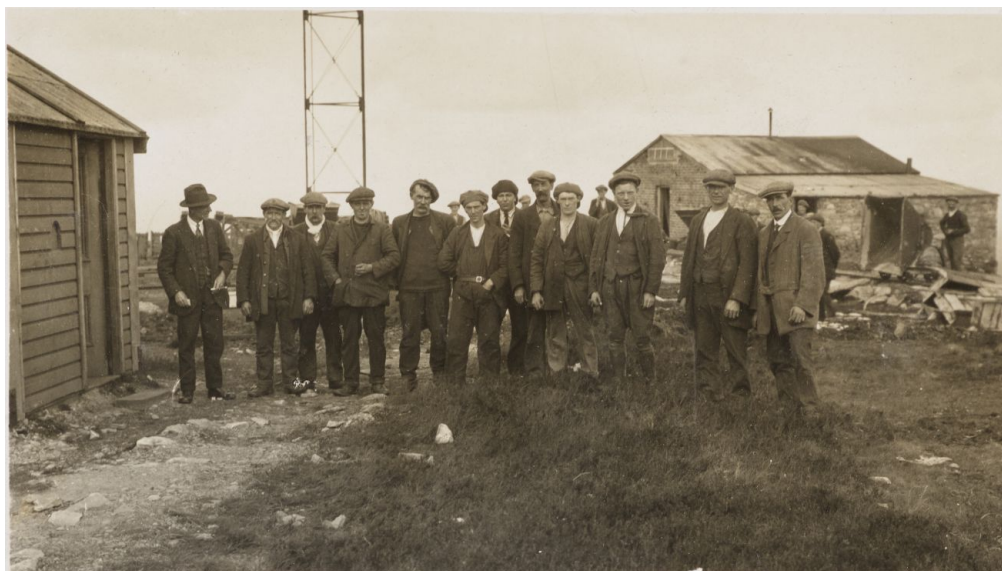
H3. *MS.Photogr.c.243, evaluation quality photograph 704/x, showing the brick and stone elements in use for work on the 1923 antenna extension. No guttering (nor space for it) under the roof of the brick element is evident, which clearly drained directly onto the stone element's roof – which also has no guttering.*

In 1923, we have conclusive evidence of the form and function of the stone element, in that it is seen in photographs 704/x and 706/x within Bodleian Archive folder MS.Photogr.c.243 to be in use by workmen during construction of the new antenna extension array.

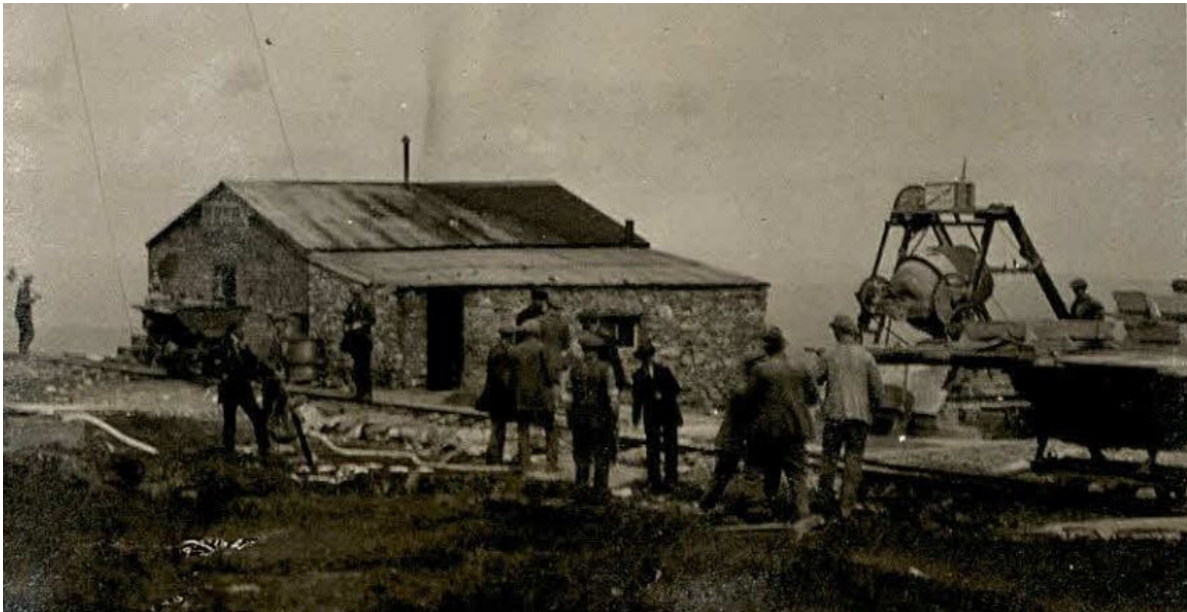
H4. Detail from MS.Photogr.c.243, evaluation quality photograph 706/x, showing the brick and stone element.

The firing holes of the brick element were blocked-up with cut brick and mortar, which is seen to be clearly different, later mortar from that used for the 1914 bricklaying. All the holes along the western elevation of the brick element are blocked-up. Blocking-up would defeat their original purpose, and so it is strongly suggestive of being done after the end of WW1. All the firing holes in blockhouse 2, the only other still standing, are fully open and show no sign of ever having been blocked. Again, this strongly suggests all the firing holes of blockhouse 5 were fully open until sometime after WW1.
