Marconi's Carnarvon Station 1912-1939

Archaeological Reconstruction
and History of a Trans-Oceanic
Wireless Site

John Rowlands

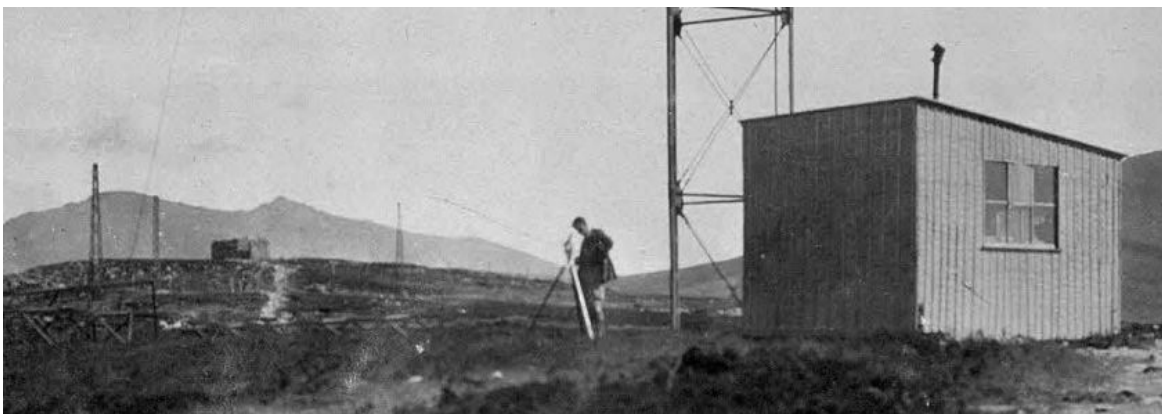
H5. Detail from MS.Photogr.c.243, photo 705/x, showing blockhouse 6, just to the left of the peak of Yr Wyddfa, already in an advanced state of decay by June 1923. Bodleian Special Collections.

There was no obvious use for the then isolated building between the end of WW1 and the antenna extension work, which began in early 1923; that year seems to be, by some way, the most likely explanation for the sealing of almost all the firing holes. By 1923, as shown in MS.Photogr.c.243, photo 705/x, blockhouse 6, at the summit of Cefn Du, had already lost its roof and was semi-derelict (storms tore the roof off a number of blockhouses almost as soon as they had been built (*Y Drych*, 20/5/1915, p.3). It is therefore possible that blockhouse 5, being similarly extremely exposed, required some renovation before being put to a new use.

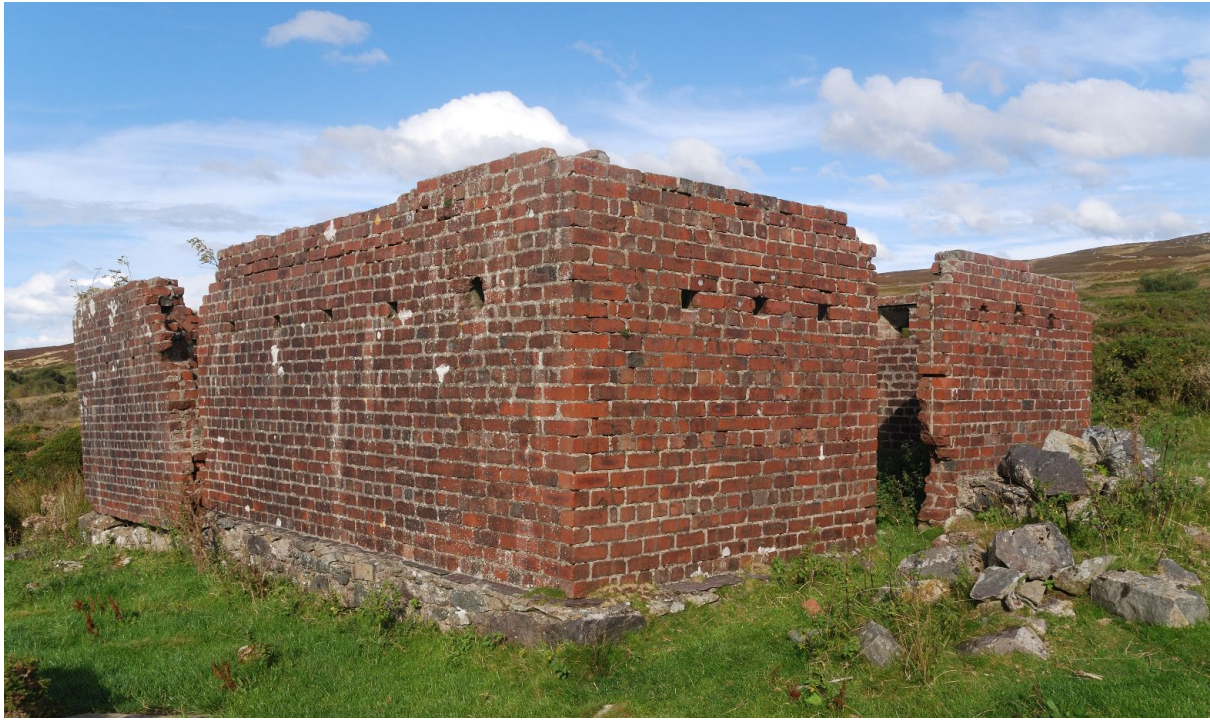
H7. *Blockhouse 2, showing stone base as for all site blockhouses, and that all firing holes remain open and were never blocked. It seems not to have had any use after the end of WW1, adding to the evidence that blockhouse 5's firing holes were blocked simply because of repurposing for the 1923 antenna extension. Most or all of the blockhouses had an open porch in front of the doorway.*

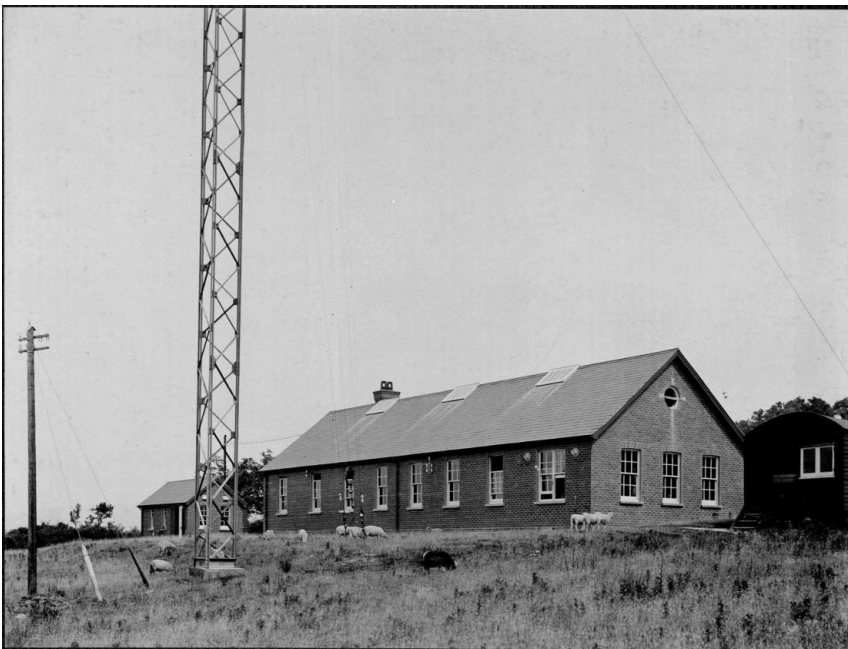
R1. *The main Towyn station building. The lattice mast might have been part of an initially single directional Bellini-Tosi frame antenna, but the details are unclear. Later accounts tell of two Bellini-Tosi directional loops, separated by $\frac{1}{4}$ wave (i.e. two mast structures separated by that distance, supporting two loop wires each).*

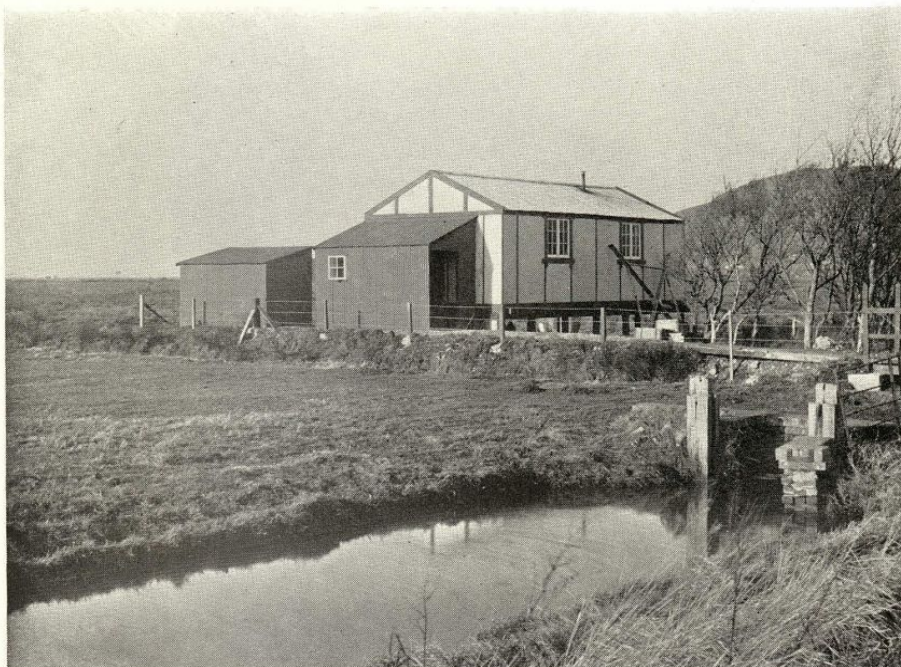
R3. Auxiliary station, centrally housing various control circuits for the later antennas. Ca. 1922 Marconi C°. pamphlet about Towyn, in MS. Marconi 198. Note the channel and high water level on ground only ~2m above OD sea level. A nearby embankment broke, flooding the Marconi station to a depth of three feet, causing “wireless men on boats” on 23/9/1922 – see

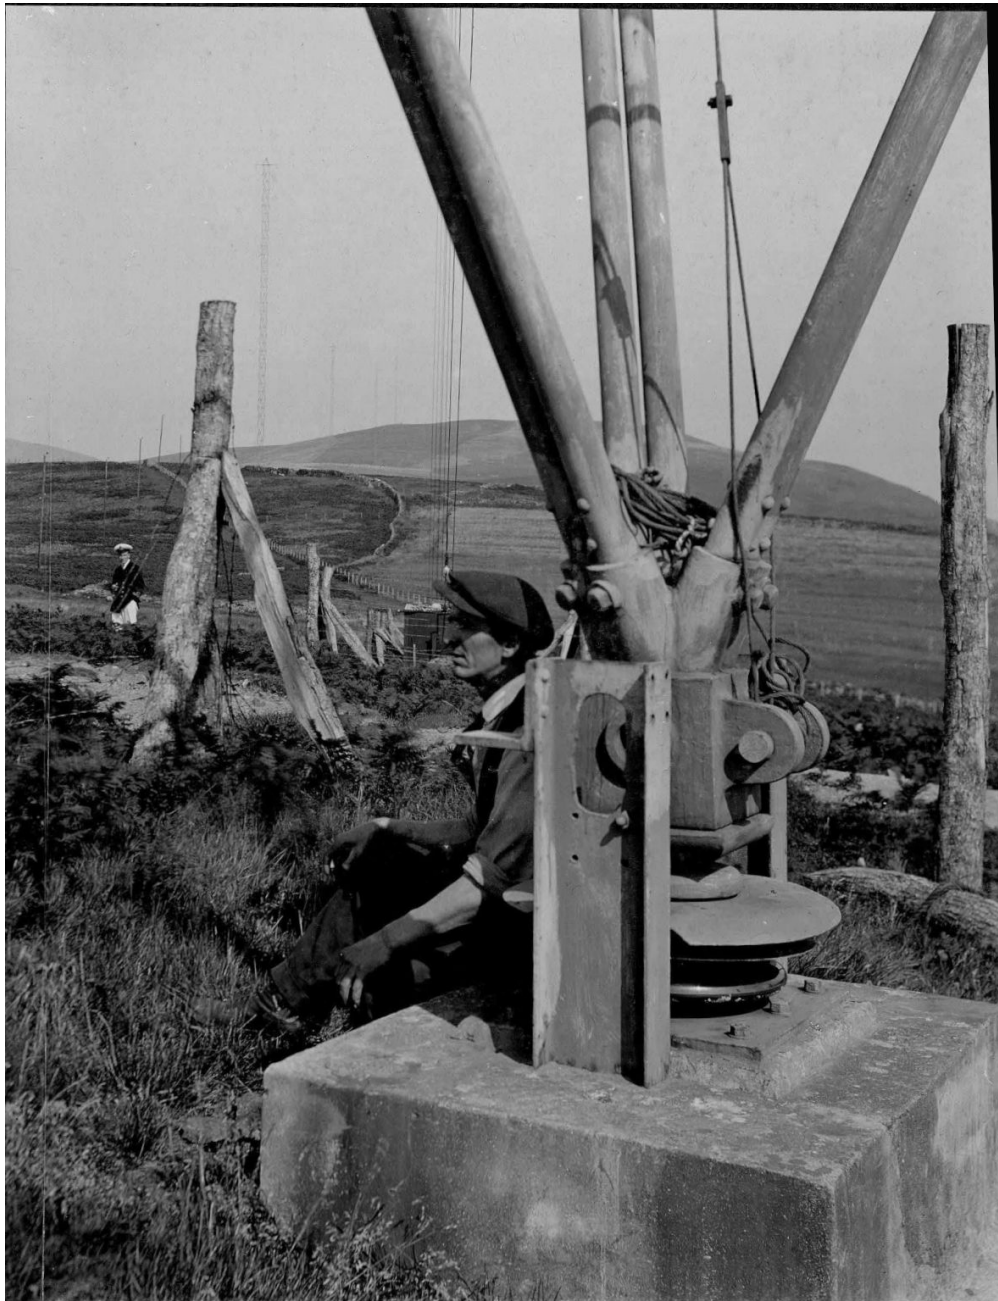
R8. A worker takes a break at the base of a receiving antenna support mast in this contemplative scene. Note the halyard, which is seen to run inside standoff brackets in other images. Four other lattice masts of the original, 'inverted-L' receiving antenna are seen to run up the hill in the distance. The top of the nearest mast seen in its entirety clearly has a horizontal arm. This supported a single wire either side; contemporary accounts describe it as a "two wire" antenna (Bodleian Special Collections, MS.Marconi.198), though electrically, it was one, connected at a common anchor point and then to the receiving sets. A man in naval uniform bearing the sleeve insignia of Lieutenant looks on, centre right, hinting at a WW1-era date. The mast converges on a tilting bearing. The steel uprights, with roughly-cut oval openings either side of the base mount would almost certainly have been a temporary pivot or securing point for erecting the mast at installation. Guy wires kept the mast vertical. The base remains in-situ, but the steelwork is now rapidly dissolving in the salt-laden gales. Bodleian Special Collections, MS.Photogr.c.243, photo P.2097, date unknown, probably ca. 1918. The distinctive curved field boundary, which is unchanged today, permitted the location to be confirmed as 52.581847° , -4.066318°

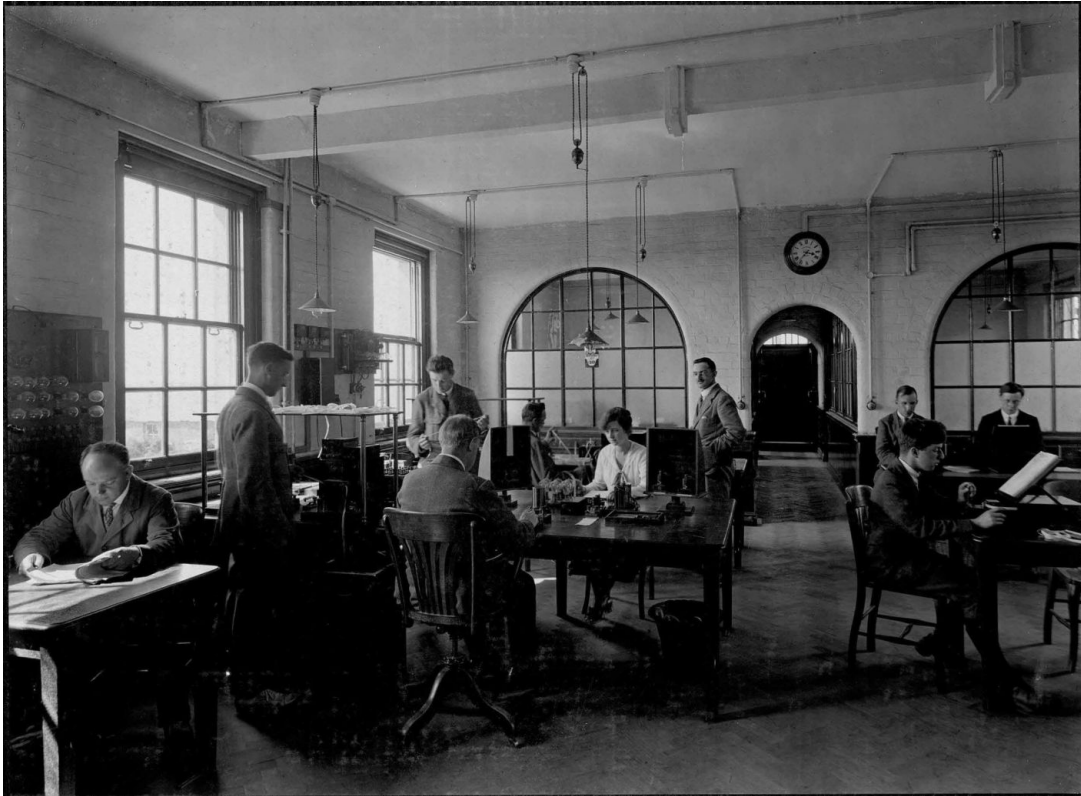
R9. *The keying room at Towyn for the Carnarvon transmitter. Bodleian Special Collections, MS.Photogr.c.243, photo P.2102 (page 7 within original photo album)*

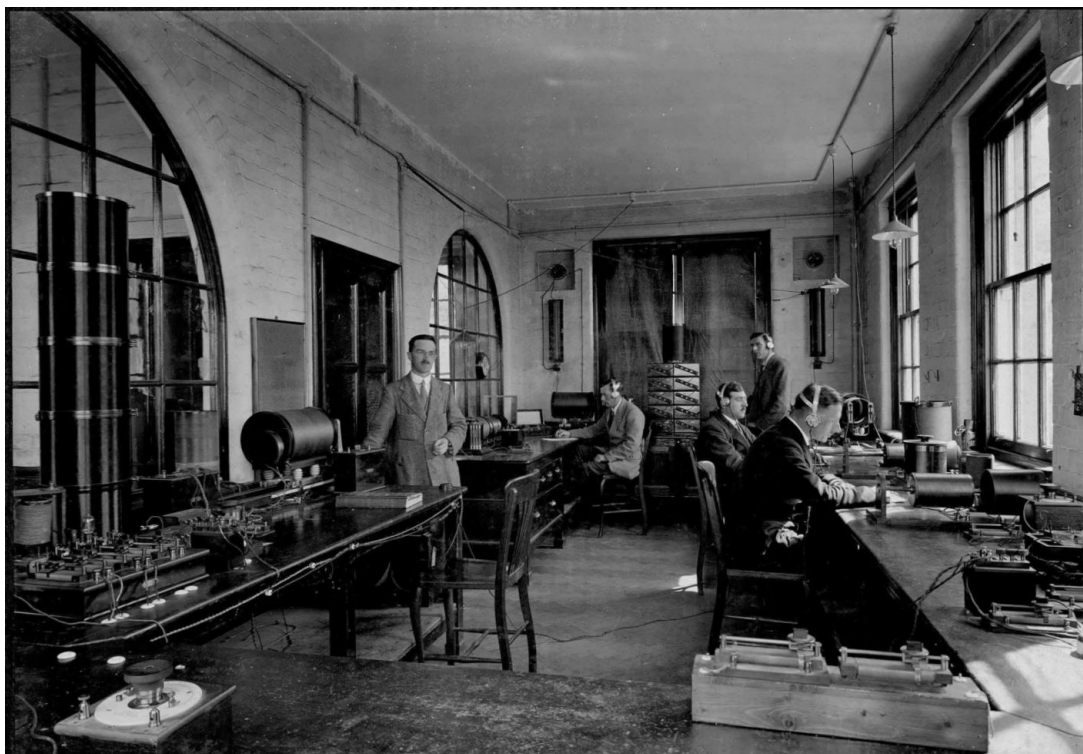
R10. *Towyn receiving room, the sunlight direction through the windows suggesting it was at the western side of the building. Bodleian Special Collection MS.Photogr.c.243, photo P.2106 (page 5 within a separate, original photo album in the same file).*

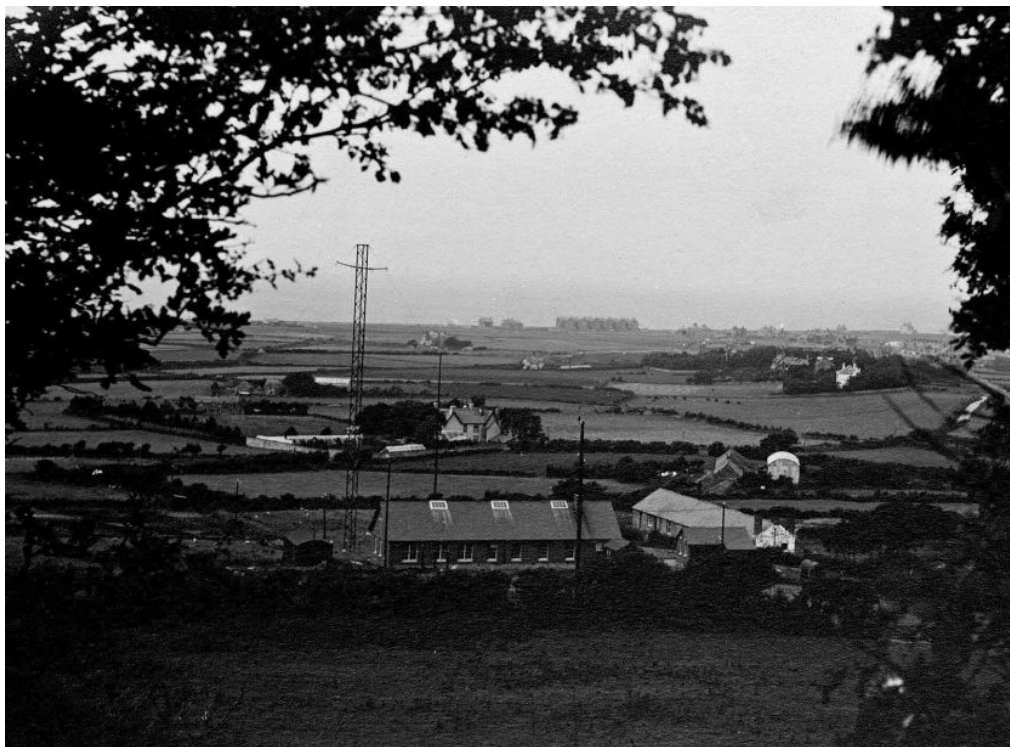
R12. Looking towards the coast at Towyn receiving station, with a frame antenna to the immediate left of the station (seen dominating the scene at left in **R1**). Bodleian Special Collection, MS.Photogr.c.243, photo P.2095.

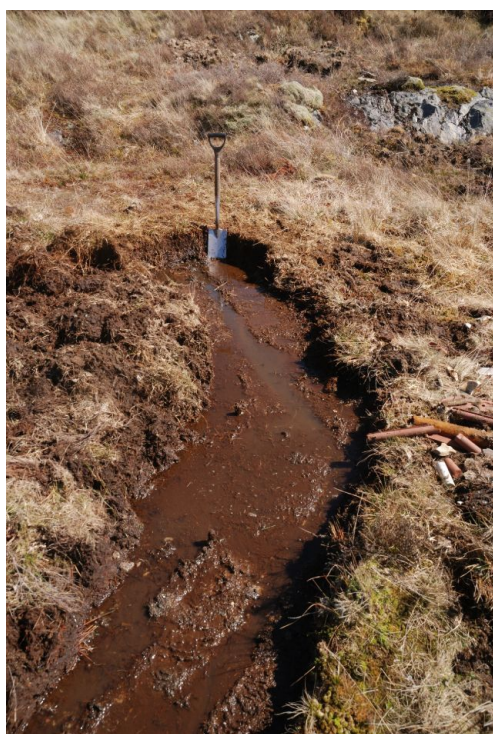
D3, left: the turn in the double ATI at the north-eastern, 1923 array-facing elevation, evident from the run of the internal drainage channel. The removal of this strip of overlying bog required some six hours' careful removal by small spade.

The approach to the porch itself consisted of fine grit which, towards the south, was markedly higher than the concrete ATU base and therefore unlikely to have been a drainage route. Clearance of the moss and heather to the south of the ATI base confirmed that the internal drainage from the double ATI, previously shown to empty at the SW corner of the porch, made its way into the 'French' drain running SE-NW along the southern edge of the double ATI. A not-insignificant drainage today occurs – and may well have occurred in the past – from the eastern end of the platform, under the concrete base, which is only some 20cm thick.

The schematic of the double ATI at 71 has been updated for this edition in order to show new understanding. This includes slight adjustment to one of the concrete measurements after removal of overlying vegetation that had earlier made accurate measurement by trial holes somewhat difficult.

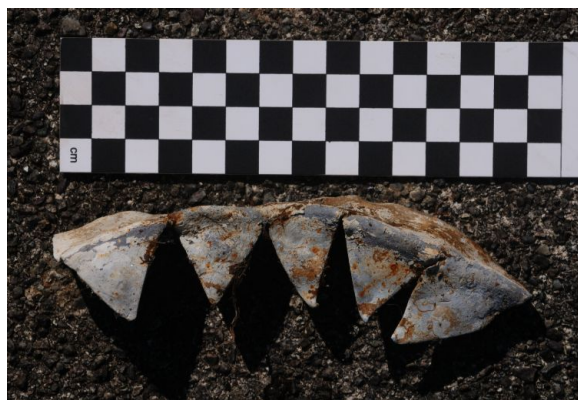
D5, left: roll-patterned glass from the westernmost window of the southern elevation of the double ATI, tentatively identified as Chance Brothers (Glasgow) Scintilla' Cathedral design, produced between 1911 and 1925 (the double ATI being installed in 1923). Right-hand image is a poor brochure-type sample photo, as presented by Sashwindowspecialist.com blog ('Old Window Glass: History of Textured and Patterned Sheet Glass'). Similar or identical glass was also used to partition Towyn receiving desks.

Small glass fragments, representing remains of the double ATI's windows, were recovered adjacent to their originally-installed positions. As noted in the main text and is indeed evident from close examination of the photograph at 72, the window glass was of obscuring, patterned design that prevented prying eyes from seeing the detail within. The warning sign of high voltage (see 73a) seem as much aimed at workers as any curious members of the public that might have been expected to drift by from time to time, notably when the site was no longer protected by the military as it had been during WW1.

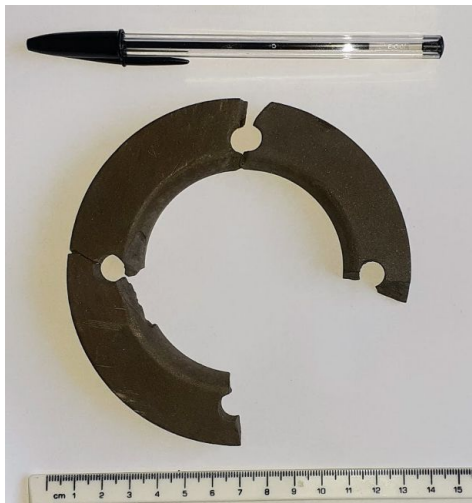
D6: Found outside the porch door area of the double ATI, partial ceramic ring with four bolt holes (upper right fragment is from a different whole), proved to be retainers for inductor base pillar insulators, seen in MS.Photogr.c.243, image 747/x (see 78 for entire photo).

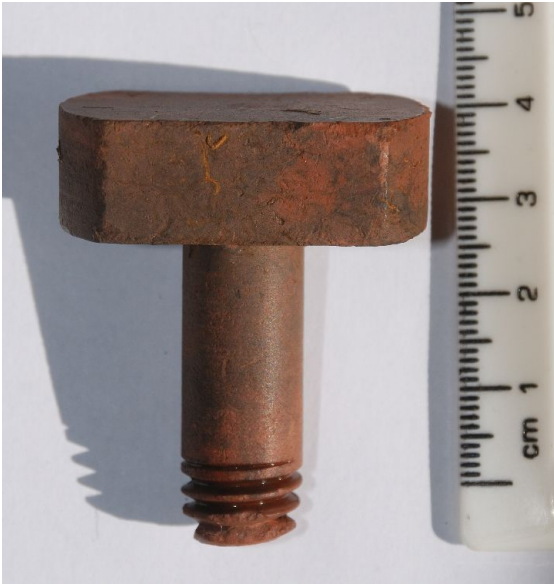
D7, left: found near the angled turn at the northern end of the double ATI, a ceramic, single-piece threaded bolt. The inductor ring above is seen to have such a handle on its bolts, but it is not entirely clear if they are exactly the same type.

D8, right: fragments of clear glass (3mm thickness) found with others in front of the porch door and almost certainly once part of that door's glazing, which is seen to be clear in photo 73. Scale in cm/mm.

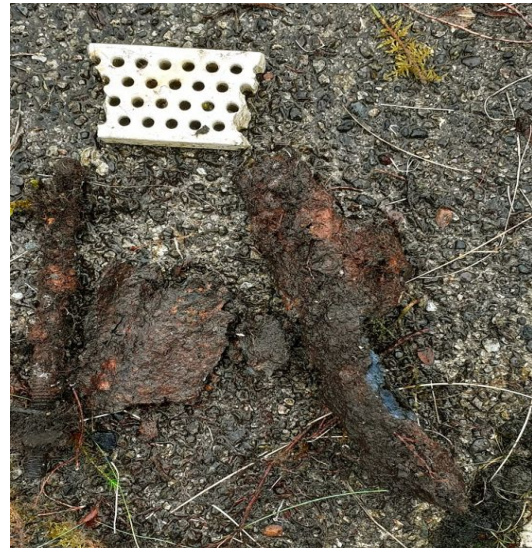
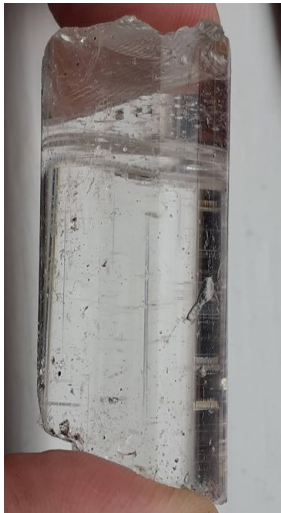
D9, left: (from left) – iron drainpipe fragment (2 ½" OD, 2" ID) from the NE corner of the double ATI, together with (also at same location) red unglazed ceramic slotted inductor pillars (see C7), white glazed ceramic rod insulator fragment, with a disc insulator fragment to its immediate right, a white glazed capacitor bridging insulator (top right) and several early thermoplastic insulators, possibly gutta percha, of uncertain function, but probably inductor-related, at far centre right. Tape open to 1ft.

D10, right: found at the double ATI, though almost unrecognisable due to 84 years' rusting in the acid, wet ground, these small fragments are of corrugated steel sheet which can be taken to be confirmation that, as for the single ATI, the double ATI outer skin was of this material. Curved steel washers found nearby also add weight to this conclusion. Asbestos internal lining was also found in abundance near the feedline entrance point and other locations around the double ATI house.

D11, left: fragment of cylindrical/rod glass insulator, precise function unknown. 24mm OD.

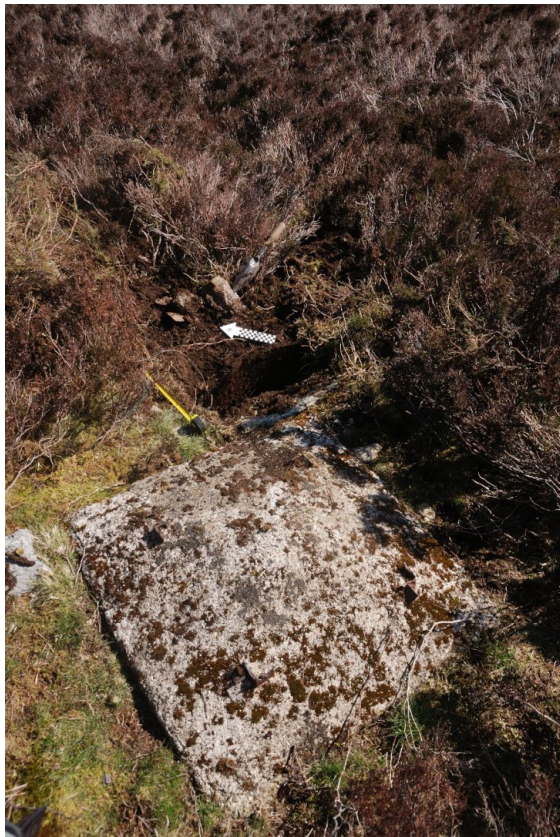
D12, left: 1923 support mast concrete base, with location of copper wire attached to surrounding galvanized steel plate, below scale arrow. The mast was offset from the pattern of counterpoise supports, and there are two other known examples. Their purpose is not yet known.

D13, below: detail of wire connection to plate, the upper plate edge highlighted in yellow line. Tape open to 1ft, north indicator scale in cm squares.

The 2022 discovery of a remnant stranded copper wire (see 53) at the base of a 1923 support mast (of unknown purpose as it was offset from the pattern of counterpoise supports), delving into broken stone ground proved to be too time-consuming then to excavate carefully. By April 2023, the weather was such, and the workload enormously less, that a morning was given over to pursuing the cable's path in the ground. The cable was fairly quickly found to run and be firmly attached to a vertically-emplaced galvanised steel sheet of ~2mm thickness. The sheet appears to surround the concrete base. The arrangement appears to have simply provided grounding of the mast itself. Another example of 1923 base, also lying outside the counterpoise support pattern, has the steel sheet much more intimately associated with the concrete, and has the appearance of having lined the hole into which concrete was later poured.

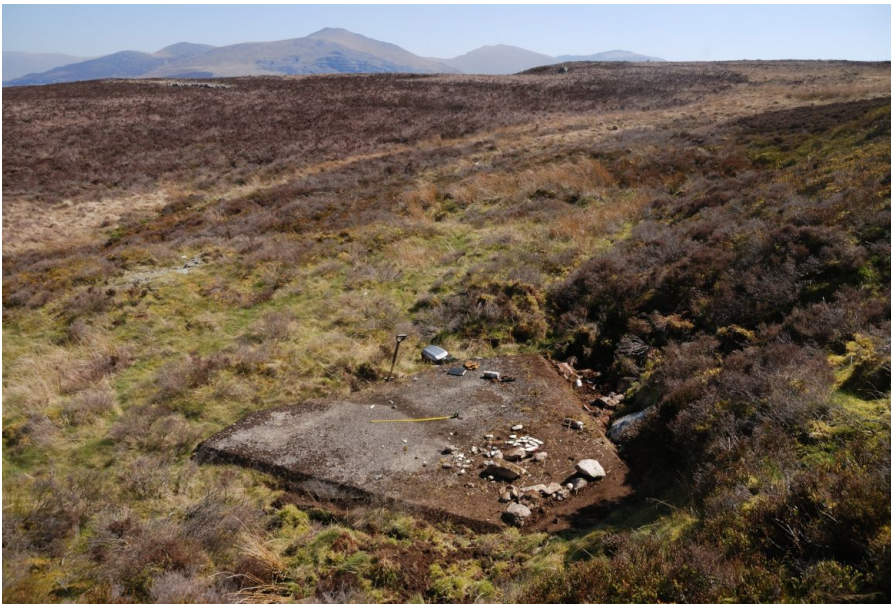
D15, left: 1923 upper double anchor block following moss/heather removal, looking east. The flat area in the middle distance is the trackway area seen in 139.

D16, right: tubular insulators once making the link between anchor block and guy wire via metal retaining fixings – see 50. Located at base of southern, mast 12 -facing, sloping edge of 1923 upper double guy anchor.

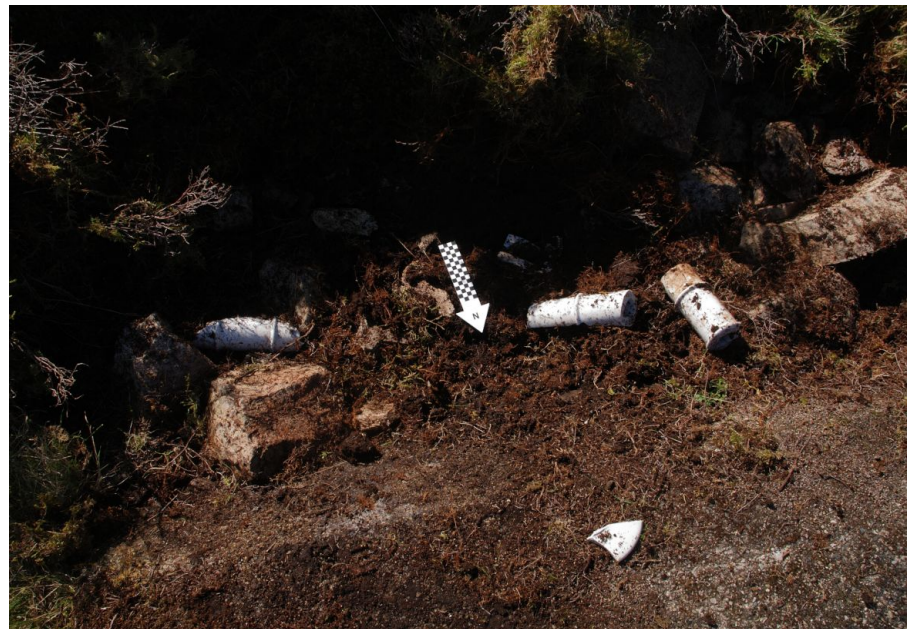
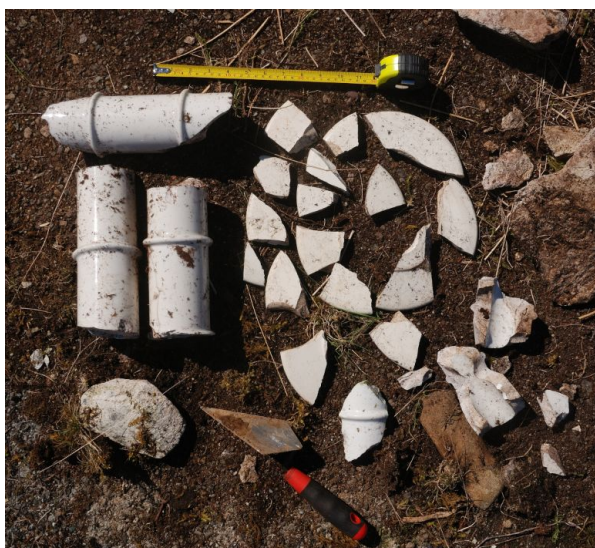
D17, left: tubular anchor wire insulators and disc 'reel' insulator remains. None bear a maker's mark. Tape open to 1ft, trowel blade = 6". 1923 upper double guy anchor.

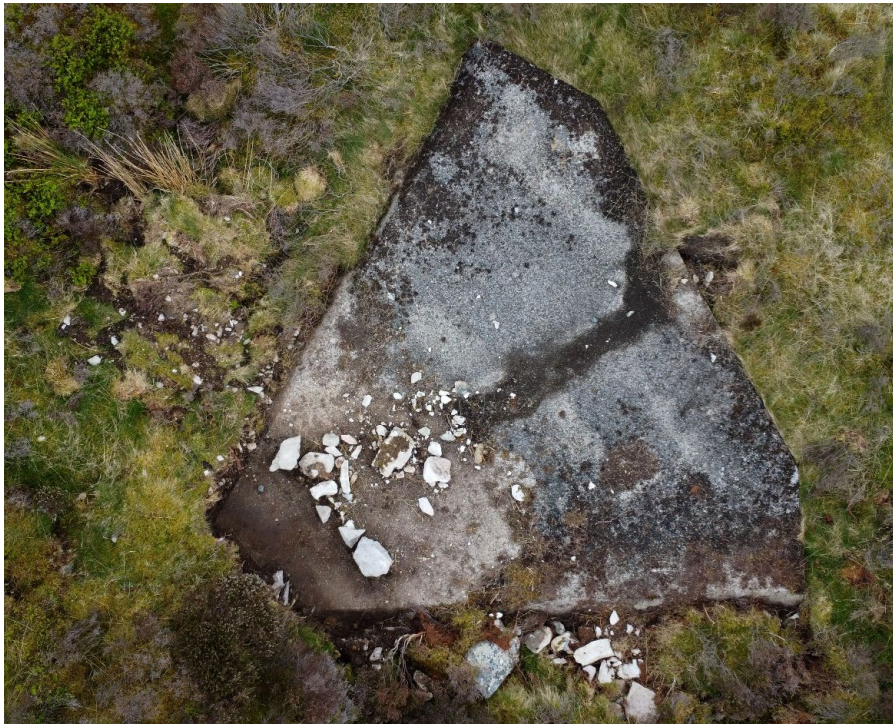
D18, left: aerial view of upper double anchor base for mast 11C (to upper left), 12B (to lower centre right). Dimensions as given in D14.

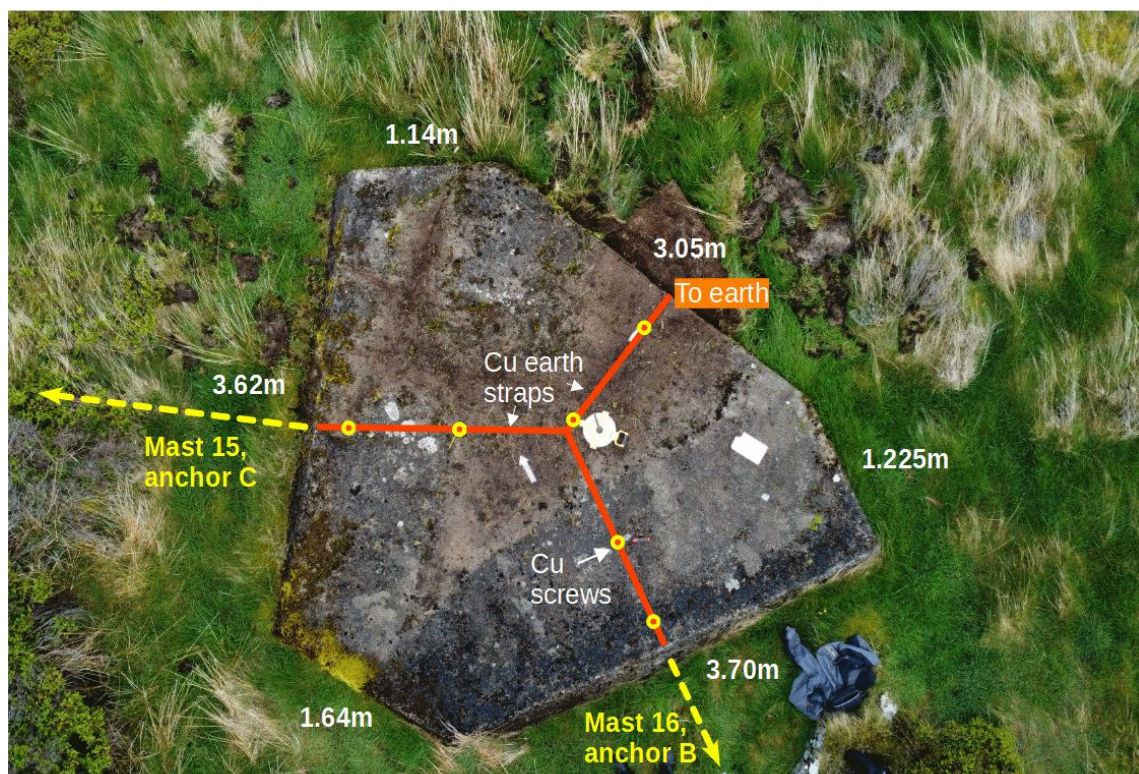
D19, below: aerial view of lower double anchor mast base for mast 15C, 16B. The earthing arrangements were the same for the upper double anchor and all guy wire anchors had such earthing, ultimately terminating in a galvanized sheet inserted vertically into the ground a short distance from the anchor.

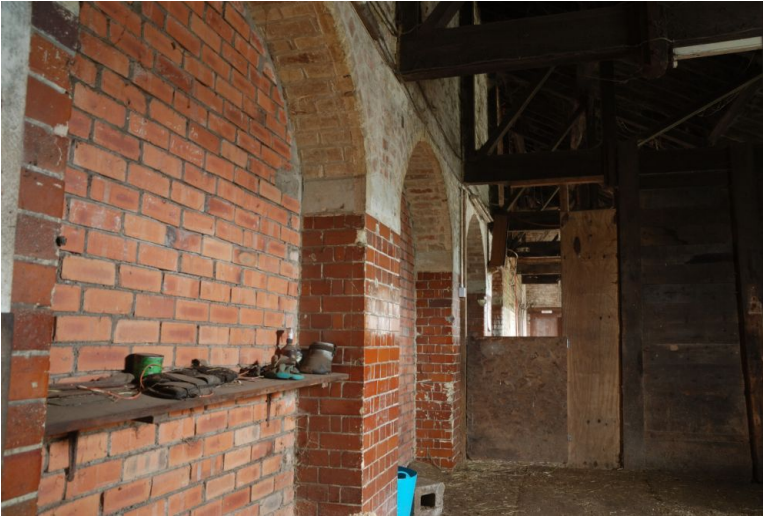
D20, left: Interior vitreous glazed brick arches at the eastern, antenna-facing side of the transmitter hall. The arch infills are modern and now form part of a horse stable. The roof truss timbers are original and currently in excellent condition, though roof damage now threatens the long-term integrity of the building in general.

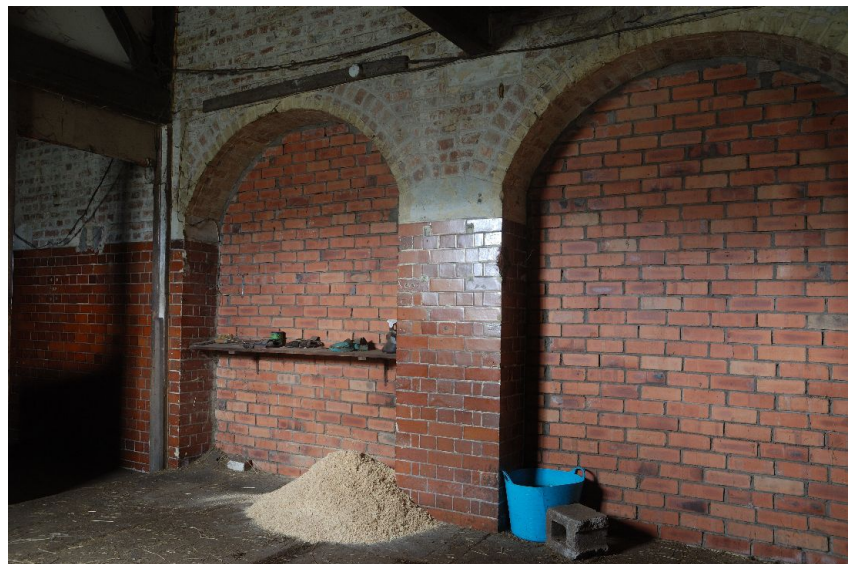
D21, right: the same arches as in D18, but taken from near the windows at the eastern elevation of the transmitter hall.

D22, left: the northern side of the eastern elevation of the transmitter hall, facing the antenna. Note again the currently excellent condition of the original roof trusses. The flooring remains original, though the concrete machine bases have been removed entirely.

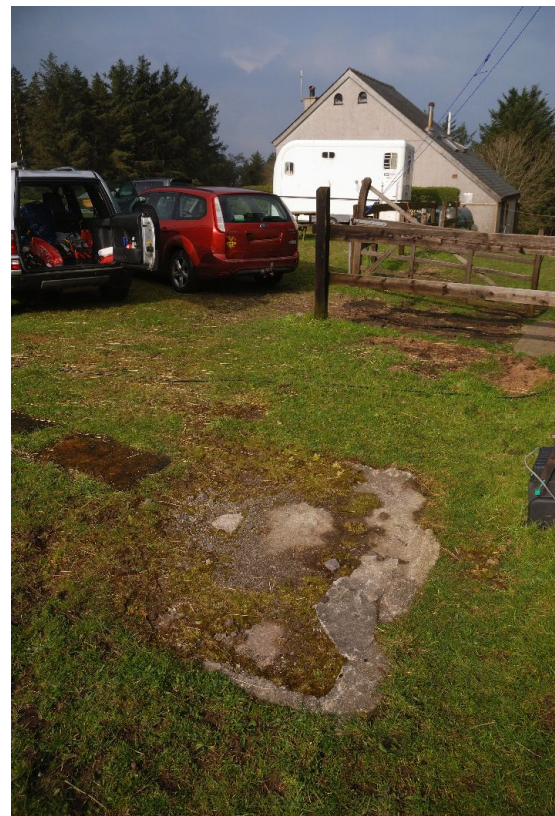
D24, right: *concrete base (foreground) with embedded vertical bolts, the base for an earth catenary tubular steel mast support. The power house building, now a domestic dwelling, is seen in the background and, in 2023, was externally clad in timber. Due to such modifications, the power house has failed to meet listing criteria and cannot be protected by law – another tragedy of long-term laxity within the Welsh heritage agencies.*

Immediately outside the steps leading to the first floor of the transmitter house lies a 6ft square concrete base with substantial, 1¾” bolts at the corners. This had previously somehow escaped the author’s attention, but is instantly recognised as the base for one of two half-sectional steel tube masts located either side of the transmitter house. These suspended a catenary over the building that strained the radiator wires to a common anchor to the west, near the accommodation block (see 56).

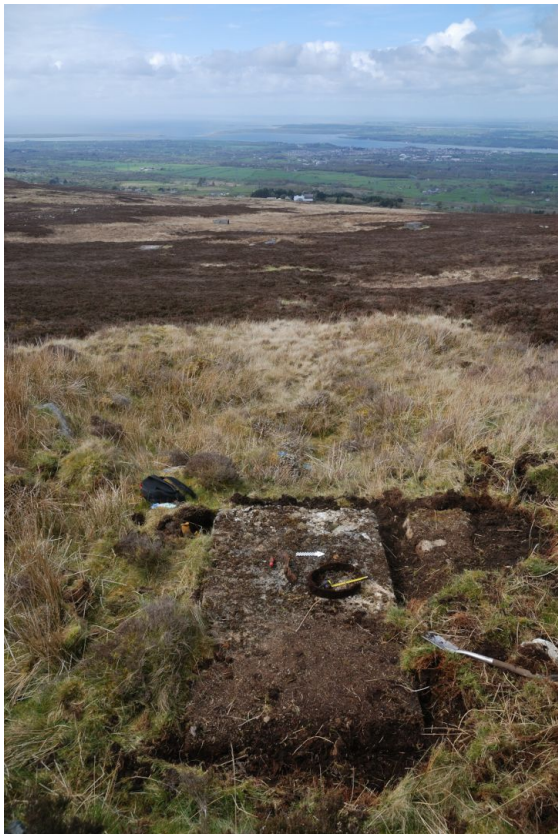
D28. *Concrete platform and lesser platform to its right, separated by a 1ft sloping gap. The second platform seems, from the sequence of concrete at the foundation level, to have been built after the first, main platform. The platforms are at the head and aligned with the centre of an inclined trackway running at least as low down as Mast 9, the centre mast of the rearmost three masts of the original, 1914 antenna. The recovered oval band is seen, placed for documentation, with the tape open to 1ft. The transmitter hall lies in front of the trees in the distance (upper centre).*

Removal of surface vegetation was conducted in late April 2023. The concrete platform was revealed to measure 2.5m by 1.42m, with the easternmost (short) edge being obviously curved for the last 15cm. This curved face was found to have severely decayed but still recognisably – by visual examination and, particularly, touch – corrugated steel sheet in intimate contact, possibly as a former; its use as siding is considered unlikely, given it seems to curve with the concrete, but it cannot be ruled out.

A second concrete platform was discovered, separated by a sloping gap of 1ft between it and the main platform. This is seen to be much less well-defined a platform than the other, with its northern side entirely ill-defined in concrete that simply seems to peter-out. Careful removal of peaty overgrowth on the second platform revealed a deposit of small coal and clinker fragments, together with several larger pieces, up to a couple of centimetres across. The coal provided the required insight into this feature of the Marconi site in that it was clearly fuel for a steam boiler. The oval iron band may or may not be distorted, but it was certainly part of the boiler; bands with rivets can

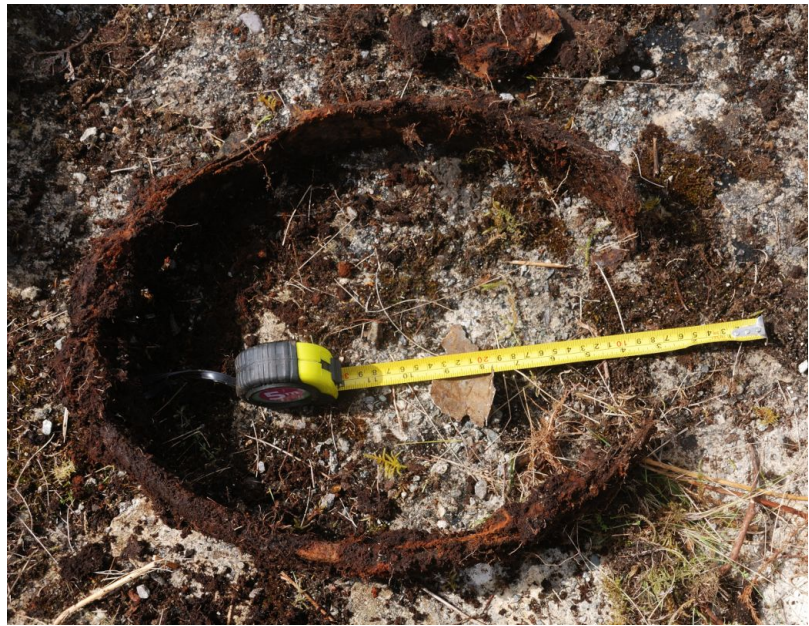
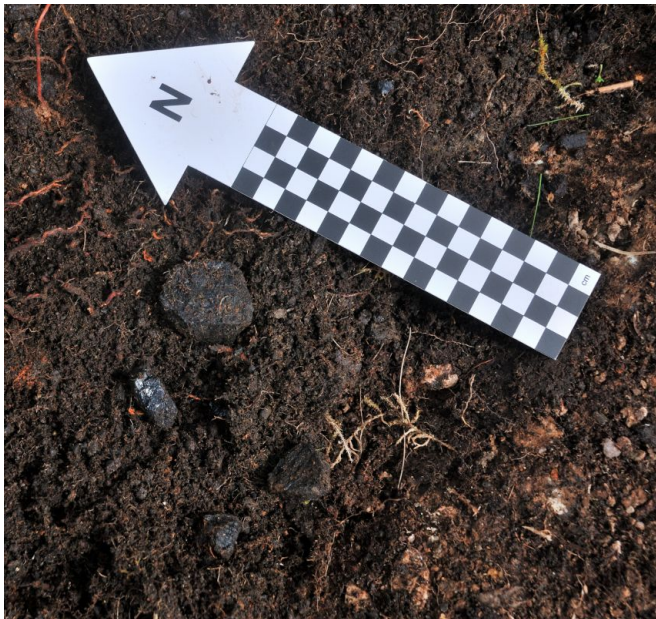
D29. Recovered oval iron band of 2¾" width, the oval's long axis internally being 1ft (tape open to 1ft), though it may have originally been more circular shape. The outer perimeter of the band is badly decomposed but contains identifiable rivet heads. This, in tandem with the coal found next to it, very strongly suggests it was part of a steam boiler for powering an incline head winder. If the oval shape was original, it was likely part of the fuelling door assembly.

D30, left: coal fragments, one showing a characteristic sun glint, found at the centre of the second, poorly-defined concrete platform. Most of the base area is covered in much finer coal fragments. The lack of anchoring bolts for any machinery is likely a result of the temporary nature of the portable boilers and winders. There is no question that this was the location of a steam-powered incline winder, the fuel remains indicating where the boiler once stood.

D31, right: part-molten clinker, a tell-tale sign of a steam engine at the incline winder location.

be seen in portable boilers of the time. Further careful excavation by stiff brush revealed part-molten clinker, a characteristic waste product of steam engines.

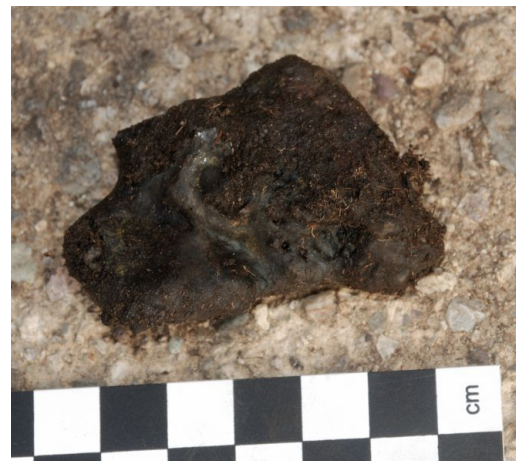
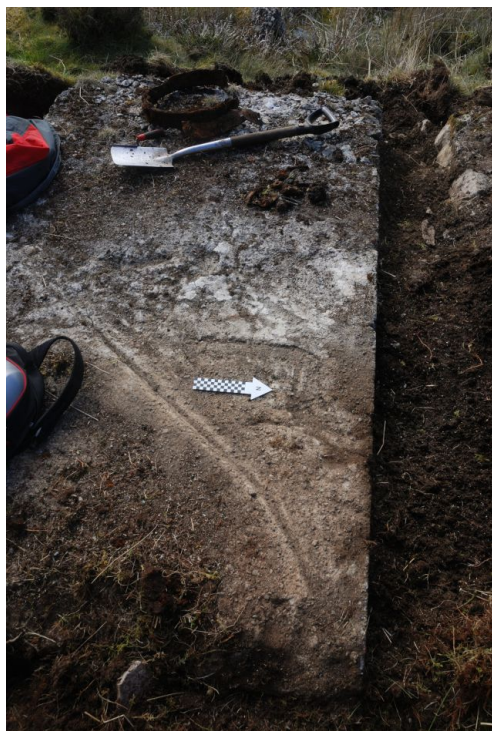
D32, left: *Main platform base after brush cleaning, showing narrow channel, draining to the rear and light impressions in the concrete surface, potentially those of double-bend pipework. The lime-rich concrete surface appears to be somewhat heat-modified at this point. Orientation as per arrow, 1ft gap between bases at far right, incline direction is to top centre (W-NW).* **D33**, below: *aerial view of winder site.*

These findings crucially provide the first known, direct physical evidence that confirms the early 1910s accounts of steam engine-powered trackway winders having been used at the site. That this material survived on a wet, acid hillside in sufficiently well-preserved condition to allow understanding, 110 years later, is little short of a miracle and a highlight of this whole work.

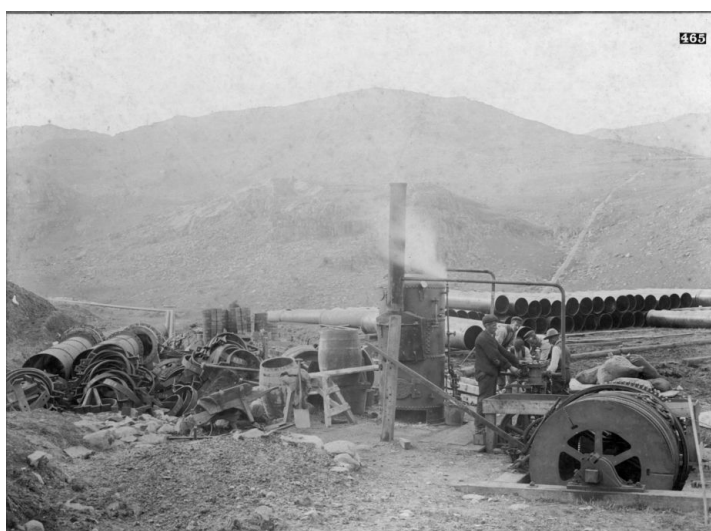
D34: *The steam haulage engines used for constructing the Marconi site were similar, if not identical to the ones used in 1905/6 for the construction of Cwm Dyli's supply pipes and power lines. Graham Isherwood considers that no permanent mounting was required for the haulage loads likely at Carnarvon, with temporary 'pegging' being sufficient to stabilise the system. Note the long brake lever. The engine is of a type widely advertised by Appleby Brothers of Southwark, London as being 'semi-portable', of which this may have been an example. Gwynedd Archives XS1245.6, under academic licence.*

The question then arises: what kind of steam haulage was it? What did it look like? Thanks to the decades-long experience of slate specialist industrial archaeologist and author, Graham Isherwood, we now have a very good and perhaps definitive picture. Graham passed on a scan, originally a photograph from the Gwynedd Council archives, of just such an engine in use for the construction of the electricity supply line from Cwm Dyli to the Glynrhonwy slate quarries – a line that was shared at one time with the wireless station.

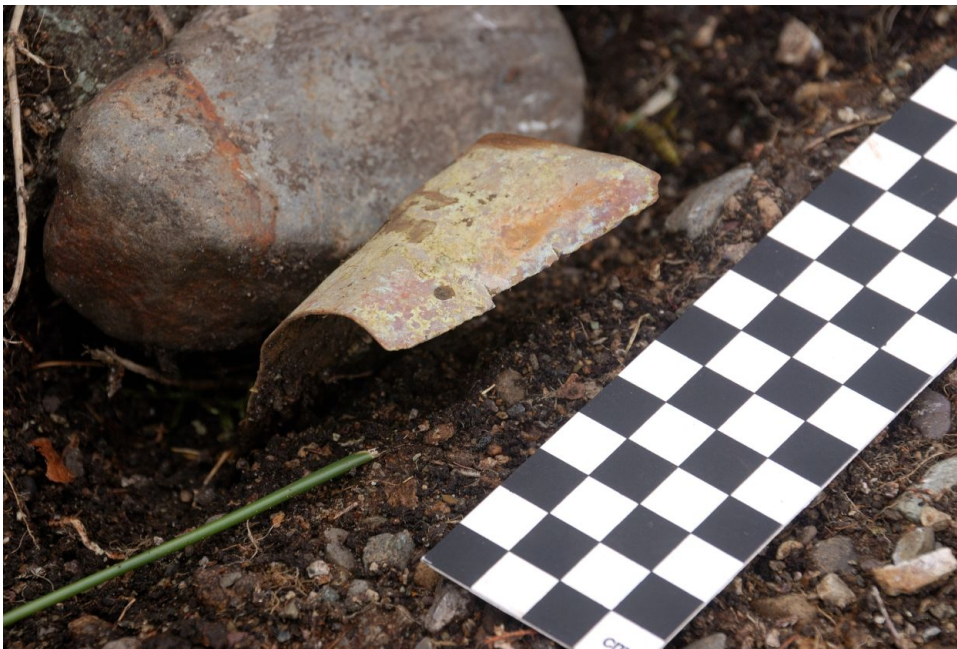
*Stay cable anchor block 13/17A grounding strap, cut by salvagers at the centre rear of the anchor but with 95cm of the strap remaining in the ground. Scale squares = 1cm, **not** indicating north.*

The band was found to be non-magnetic and therefore copper or copper alloy. It measured 22mm wide by 1mm thick, with a remaining length of 95cm overall. The band was buried at shallow depth – approximately 4" – within ballast-sized broken stone. This type of covering appears to have been used across the whole of the Carnarvon site, at least from the time of installing the elevated counterpoise, when counterpoise masts seem to have been connected to one another by copper wires buried along shallow cuts.

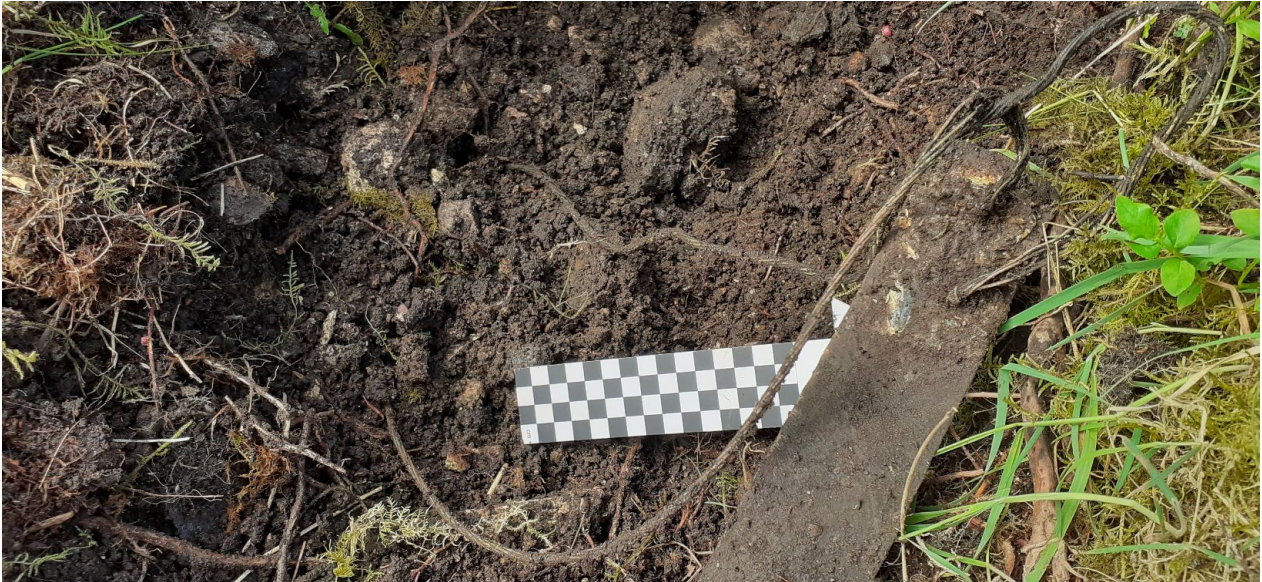
*Excavated grounding strap (right) for the stay cable of Mast 13/17 at anchor block 13/17A, with two bonded, 7-strand copper wires running into the earth. The wires and band were covered with ballast-type stone. Scale squares = 1cm (**not** arranged to show north).*

At the ground end of the copper band were bonded, by some remarkably durable soldering that remains largely sound, 100 years later, despite having been placed in very acidic, wet ground, two 7-stranded copper wires. These connected to a relatively thin, zinc-plated iron sheet placed vertically in the ground.

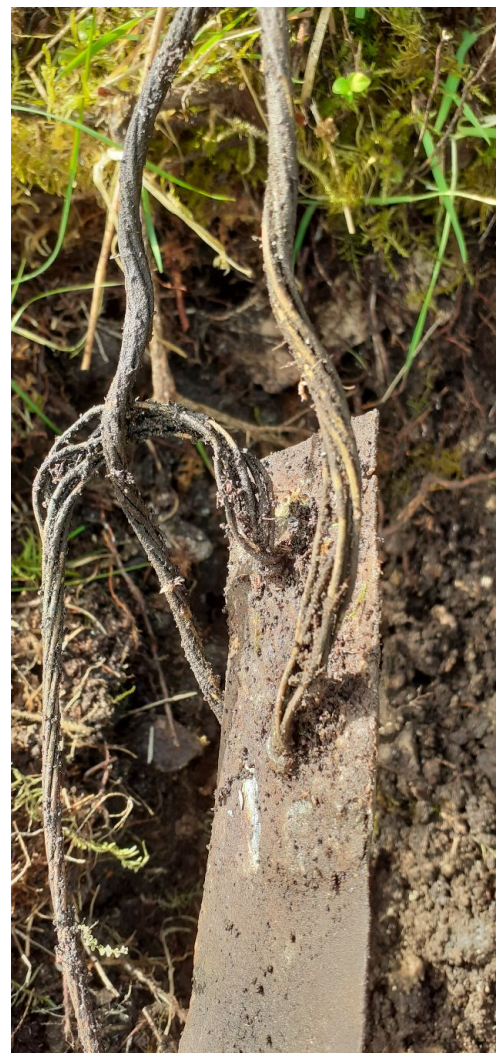
Right: detail of two, 7-strand copper wire metallurgically bonded to the copper grounding strap. The bonding remains strong and mostly uncorroded after 100 years in the ground.
