Marconi's Carnarvon Station 1912-1939

Archaeological Reconstruction
and History of a Trans-Oceanic
Wireless Site

John Rowlands

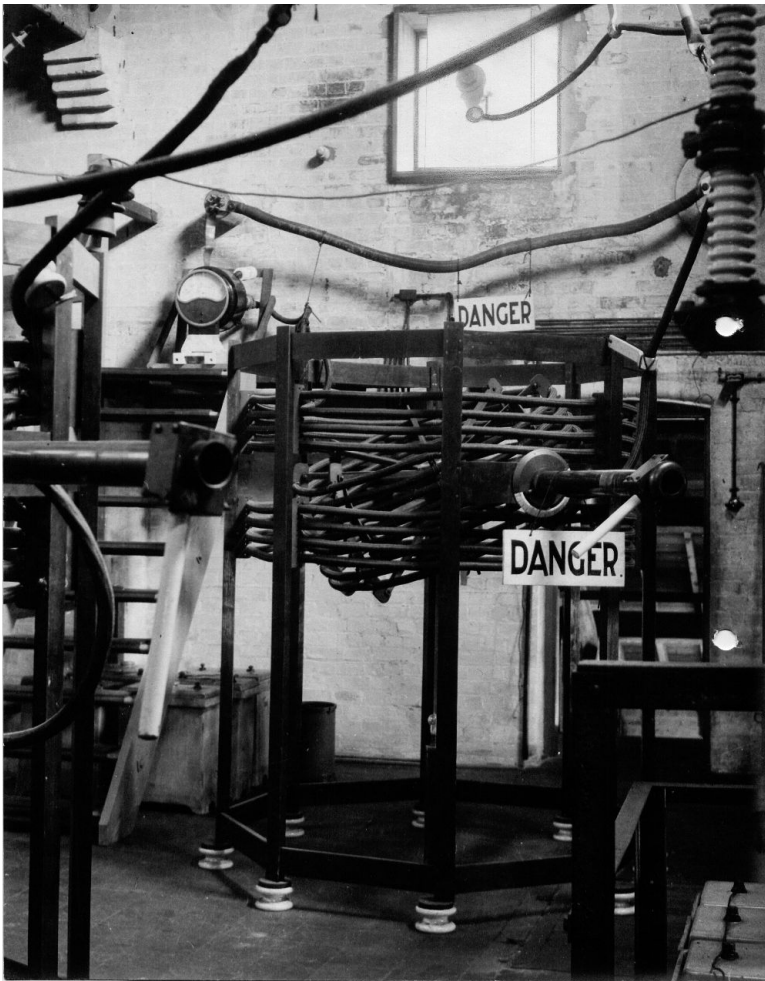
N3.

N3, above: a very clear 1924 image of the lead-out variometer at the transmitter hall. With enhancement, the ammeter appears to indicate about 150A. The radiator feed passes through a glass insulator window. The variometer has a graduated scale. A small part of the feeds appearing across the window were apparently contemporaneously hand-retouched.

N4, right: holed and hooked porcelain insulator supporting a ground feed wire that is strapped to it. The wire connects to the two insulators for the ground connections either side and below the window (one directly above the ammeter).

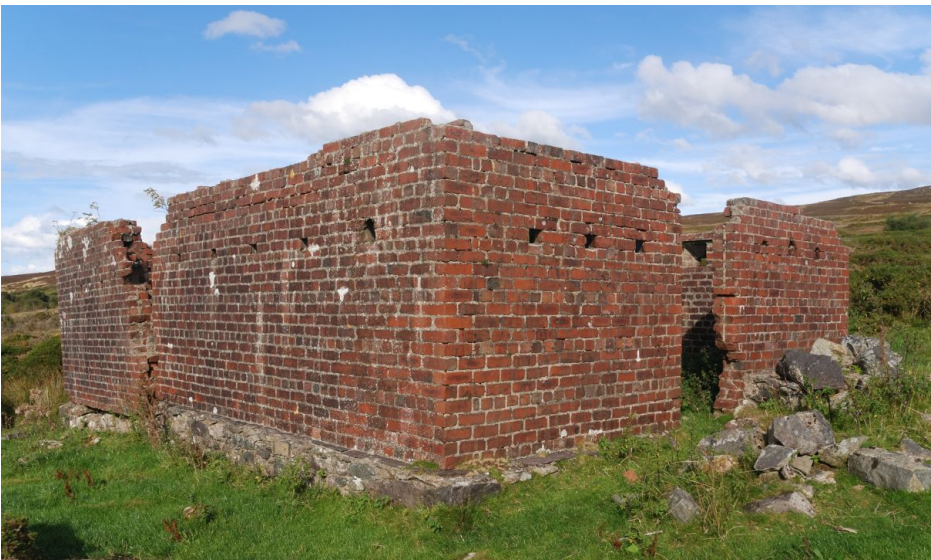
Blockhouse 2 is the first blockhouse out amongst the antenna field. It is at the lower end of a long inclined trackway bed that runs to the summit of Cefn Du. Together with blockhouse 5, it remains the only blockhouse where much of the structure remains intact, though the western and northern elevations have whole-height wall failures due to subsidence of the simple stone foundations, which incorporate a slate damp proof course, on boggy ground. The firing 'ring' of shooting holes number 6 on the southern elevation and 8 on all other elevations. Each firing position, as in the case of all other blockhouses, has a fluted shape with a slate upper face, narrowing to an aperture of 11.5cm wide by 20cm high as a 'standard' size at the external face of each elevation. On the eastern elevation, which faced uphill, the apertures have been made taller, typically measuring 32cm high, to allow the necessary above-horizontal firing uphill – though there is no record of the station being attacked.

Left: blockhouse 2, southern elevation, with remnant porch, in front of doorway, western elevation to the right.

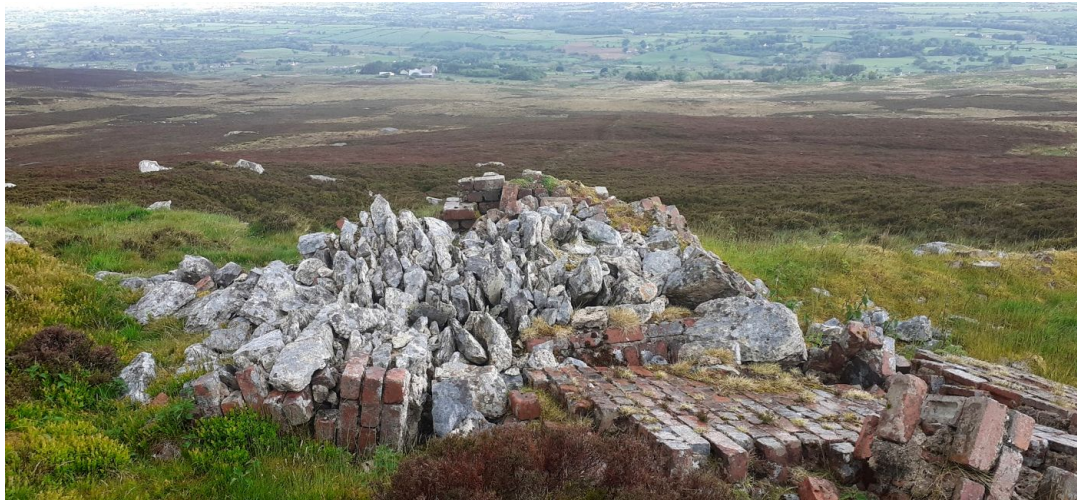
Blockhouse 4 lies near the summit of Cefn Du, next to the position of the incline head steam winder engine. It is all but entirely ruined, but with sections of cleanly inward-fallen southern elevation brickwork, and remains of a few firing ring holes. Like all other blockhouses, it was built on stone foundations, the external dimensions of which measure 6m by 5m.

Above: ruinous remains of blockhouse 4, looking west with the transmitter buildings much lower down the hill, top centre left. A trace of the long inclined trackway is visible beyond the highest point of the ruin.

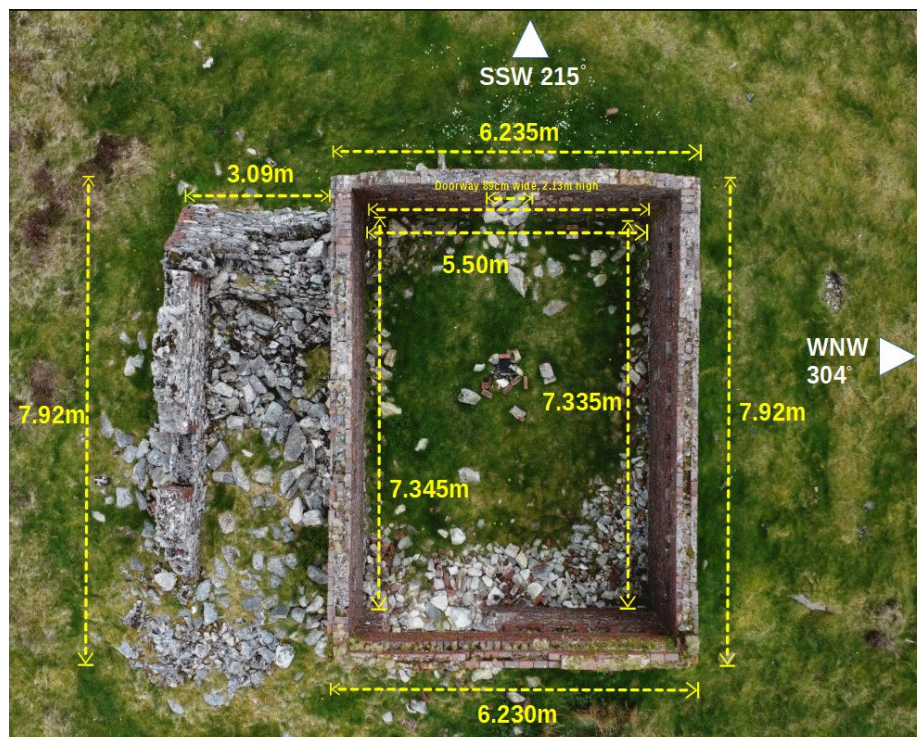
Above: aerial drone view of blockhouse 5.

The firing ring consists of eight holes, spaced by 36cm/14 inches on the WNW and ESE elevations. There are six holes on the SW elevation incorporating the doorway – three either side of it. There are eight holes, spaced at 15cm/6 inches or one brick width on the NNE elevation.

The recess, being of a size to accommodate a 3 inch thick timber, for the joists of the loft floor, has its lower edge at 6 feet above the ground floor, and lies immediately above the top of the doorway aperture and top of the firing ring apertures.

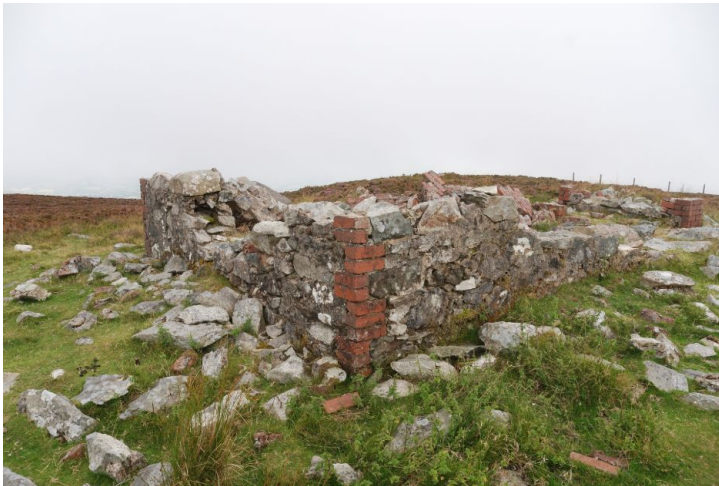
Blockhouse 6 lies at the very summit of Cefn Du, adjacent to the modern triangulation station pillar. It is seen in archive images of 1923 (see **H5**) to have already become substantially derelict, with no roof and collapsed walls. Today, it is a mostly collapsed structure, though its outline and some of its features, such as the porch, remain clear. Its external dimensions are 6.3m long by 4.63m wide. Its northern and eastern elevations are of stone, some 45cm thick, but its southern and western elevation appear to have been mostly or wholly of brick. A simple porch wall, with open sides, lies 74cm in front of the western elevation's doorway, as it did at all the blockhouses, in this case being largely of stone, with brick corners and being some 46cm thick and 2.31m wide.

Left: blockhouse 6, eastern elevation to left, northern to right.

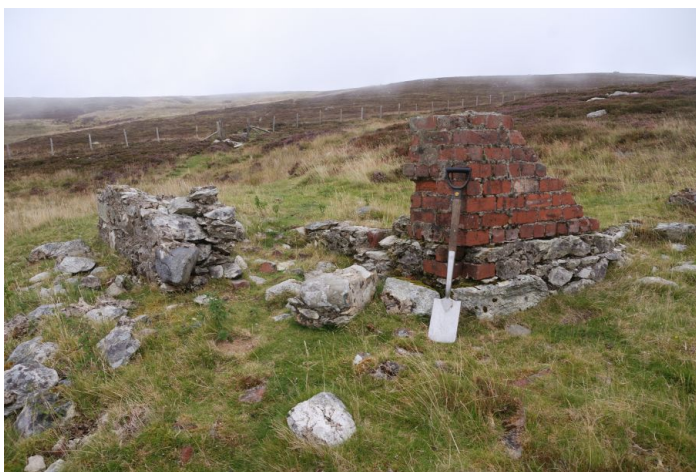
antenna, fairly close to the row of 32 wire tensioning pillars. It is now a fairly prominent, but almost entirely ruined feature in the landscape, amounting to a reasonably well-defined stone foundation outline, a small section of surviving southern elevation and the open porch wall. The external dimensions are 7.70m long (with slight uncertainty due to overgrowth) and 5m wide. The walls are three brick widths wide, at 34cm. The stone-built porch wall is 48cm thick, its internal separation from the western elevation of the

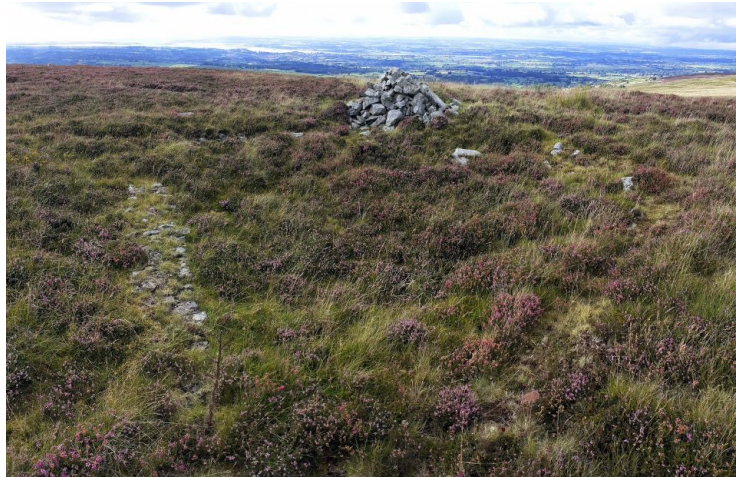
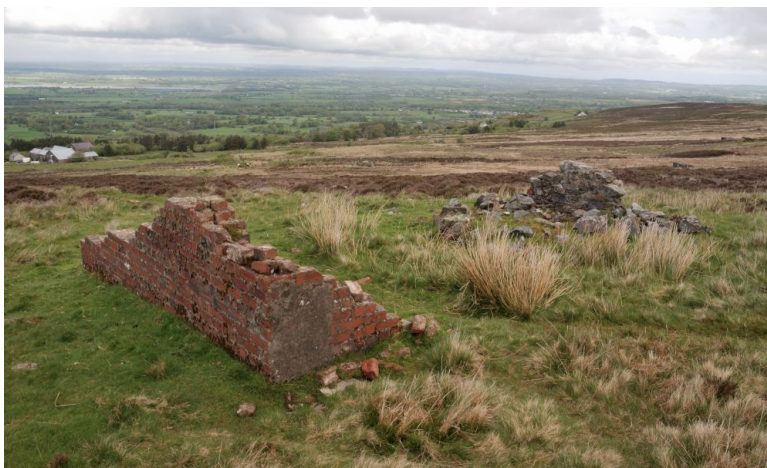
Blockhouse 8 is located along the transmitter hall-Cefn Du summit stone-built raised trackway, now simply a pile of stone and some brick, with a stone foundation, with possible remnant evidence of a slate damp-proof course as clearly seen at, for example, blockhouse 1. The external dimensions, though overgrown, are approximately 7.2m long (as measured at the eastern elevation), and 6.1m wide (as measured at the southern elevation). This blockhouse is unusual in that it is divided internally by ca. 47cm-thick stone walls into three cells or rooms of 2.2m internal width (southernmost cell), 2m (centre) and 1.6m (northern cell). Brick fragments incorporated into the foundations of these dividing walls and the lack of keying-in, suggest they were modifications carried out after WW1 was over, or later, possibly as some form of agricultural shelter or store. There are no convincing remains of firing holes, but there are very poor suggestions of them from angled cement elements.

Right: sparse remains of blockhouse 8, looking north-north west. Southern elevation to left of photo.
