Inspection Report

Repair/Replace or Maintenance Summary

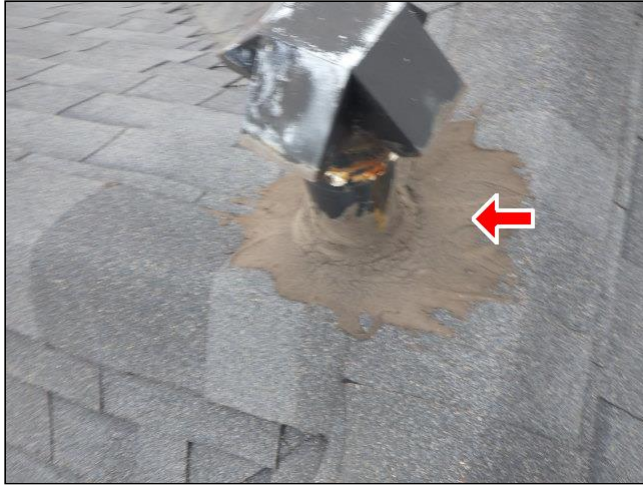
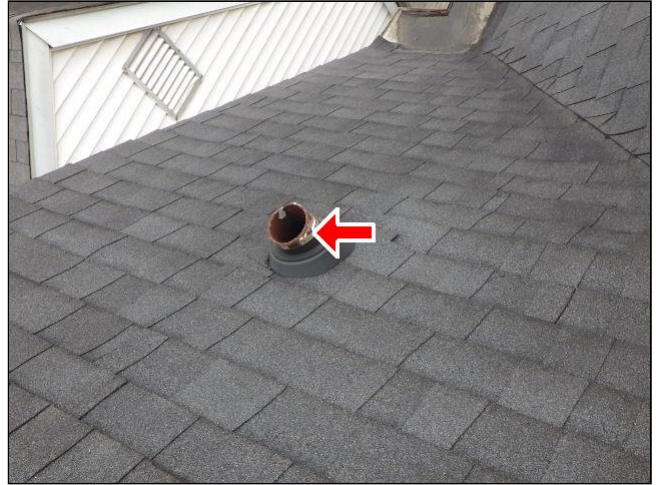
The vent pipes and flues have been sealed. Client is advised that whenever a sealant is used, it must be monitored and maintained on a regular basis to prevent water penetration. Vent pipe on the rear needs to be extended. Vent pipes should extend at least 6" above the roof.

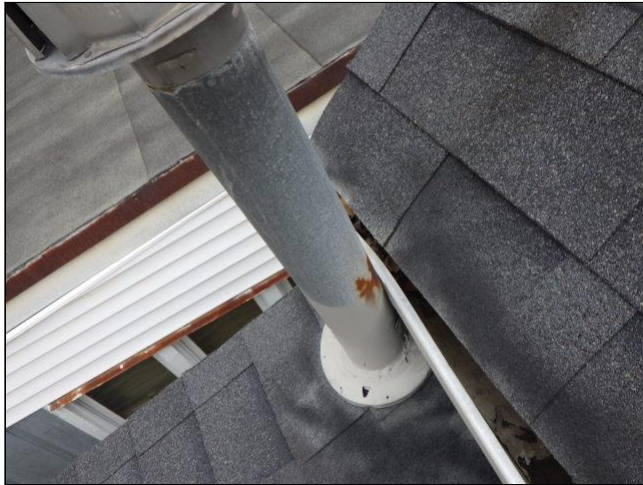
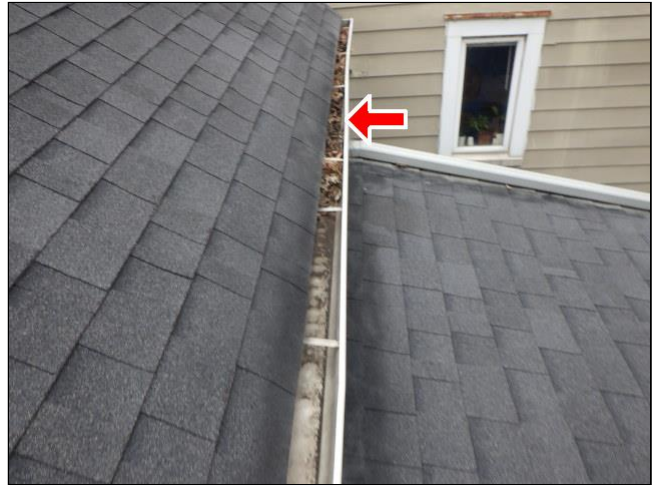
The rear gutter is bent at the exhaust pipe. Gutters are clogged with leaves and debris. Keep gutters clean to prevent water from overflowing gutters. Qualified contractor to repair.

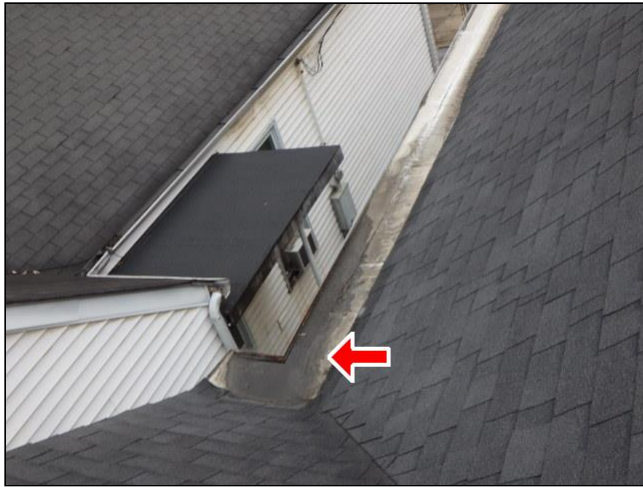
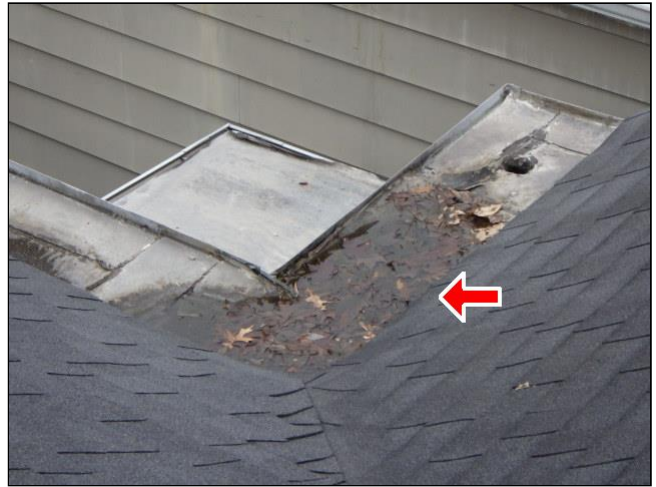
Box gutters are not within the scope of the inspection. Box gutters appear clogged and holding water. Box gutters need to be checked yearly for cracks or separation at the seams. Recommend having complete box gutters system inspected by a contractor prior to closing.

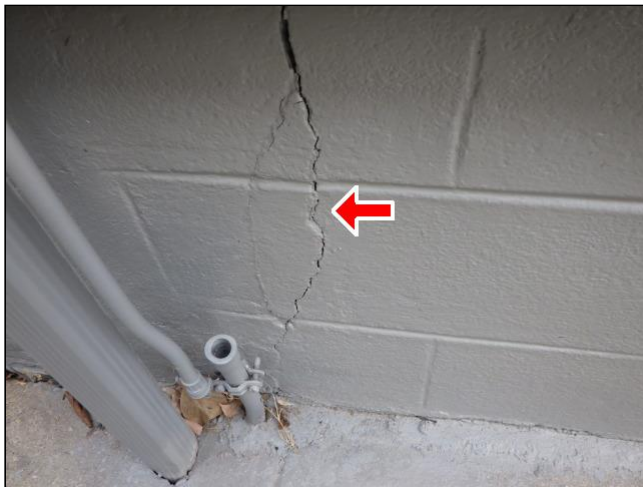
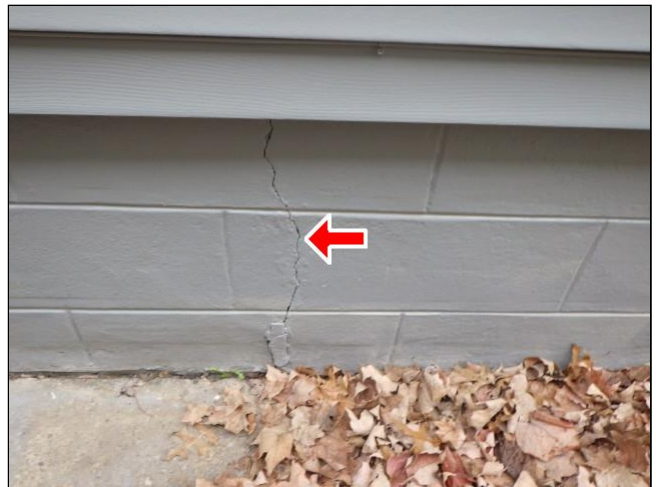
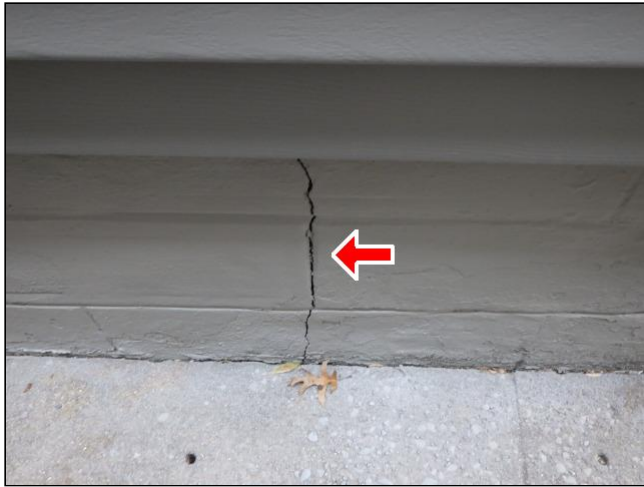
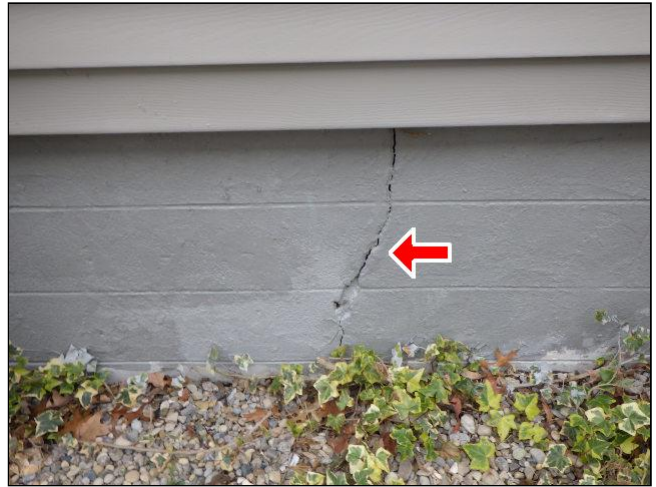
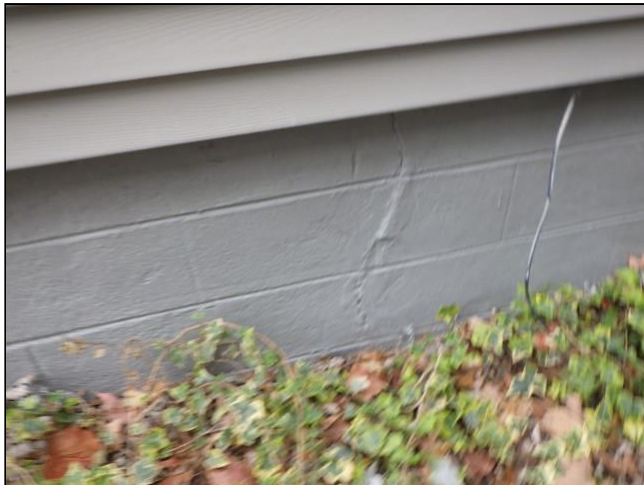
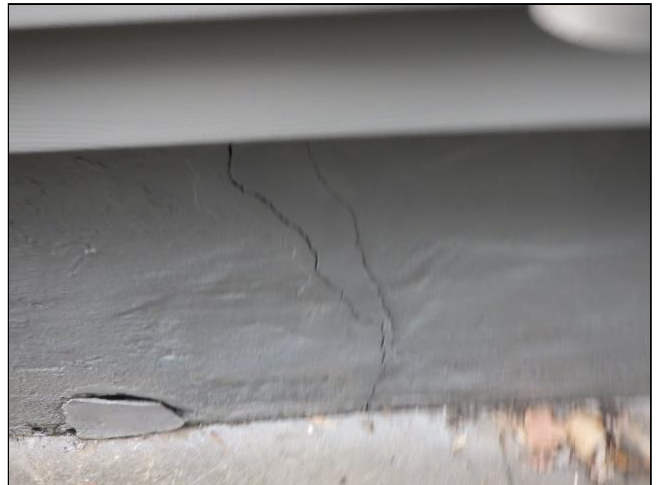
- ✘ Cracks observed in the foundation walls at the left and right sides . Although there were no other signs of failure at the time of inspection, I recommend a qualified foundation contractor or structural engineer to further evaluate the complete foundation to determine if any repairs are needed within the time period of your contract, prior to closing. NOTE: The inspector is not a state certified engineer, and can not determine if the apparent settlement has stabilized.

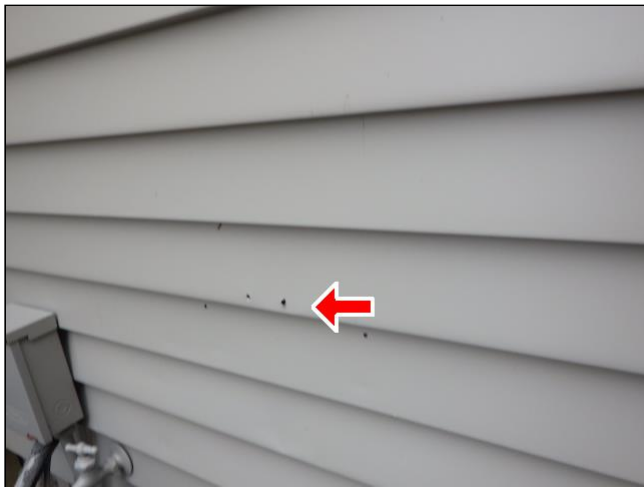
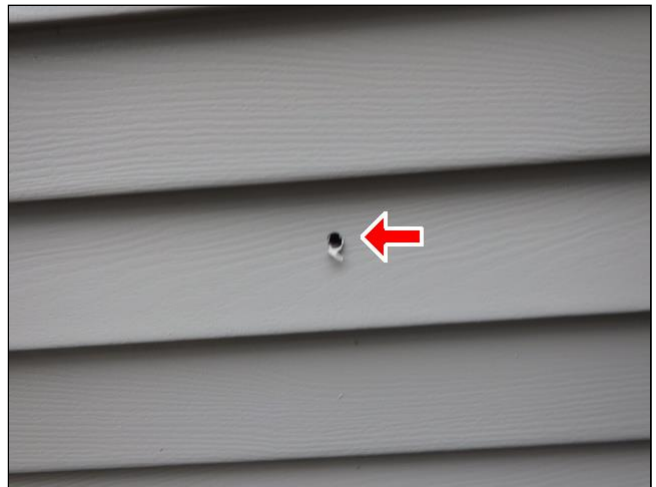
There are holes in the siding at the right and rear sides of the home. Recommend further evaluation of the complete exterior siding and replacement or sealing of any holes that may allow water intrusion or insects by a qualified professional contractor within the time period of your contract prior to closing.

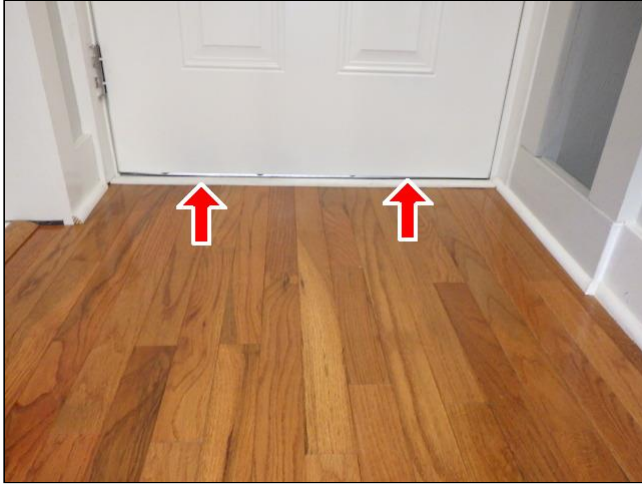
2.2 Item 1(Picture)

(1) Gaps at the bottoms of the exterior doors need to be corrected to keep the cold air from entering the home. Contractor to make appropriate repairs.

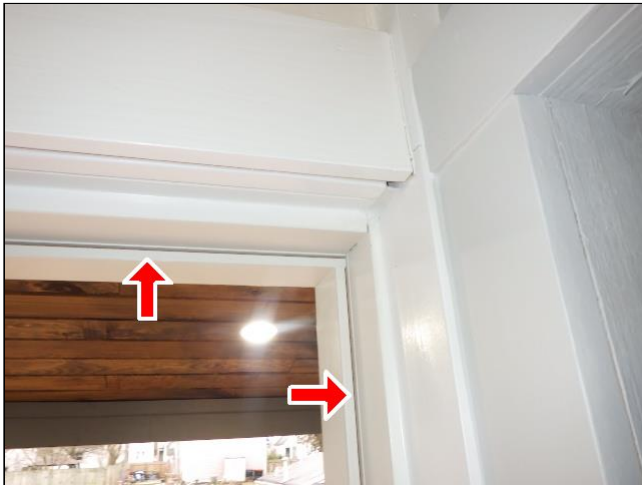
2.2 Item 2(Picture)

(2) The weatherstripping is missing on the rear door. Weatherstripping should be replaced to provide a proper seal.

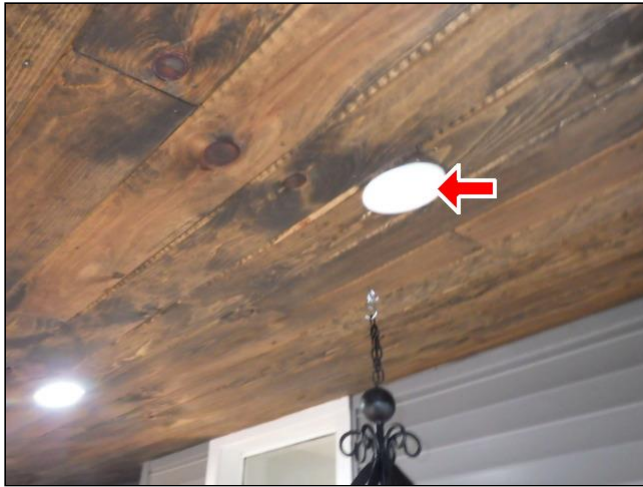
2.5 Item 1(Picture)

One recess light fixture on the rear covered deck did not work. Unable to determine if fixture needs repair or bulb needs to be replaced. Recommend further evaluation and repair.

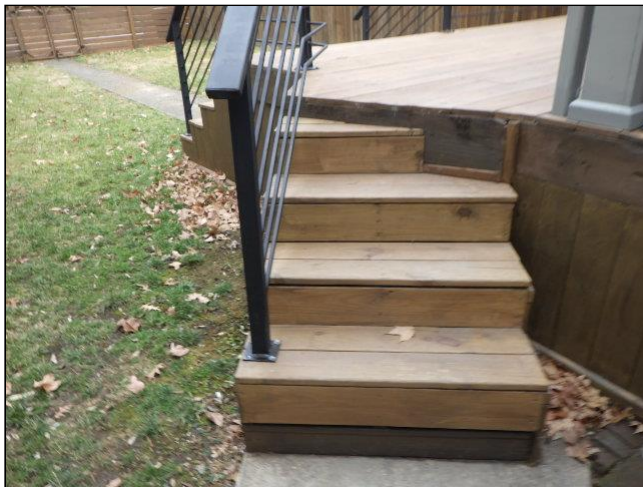
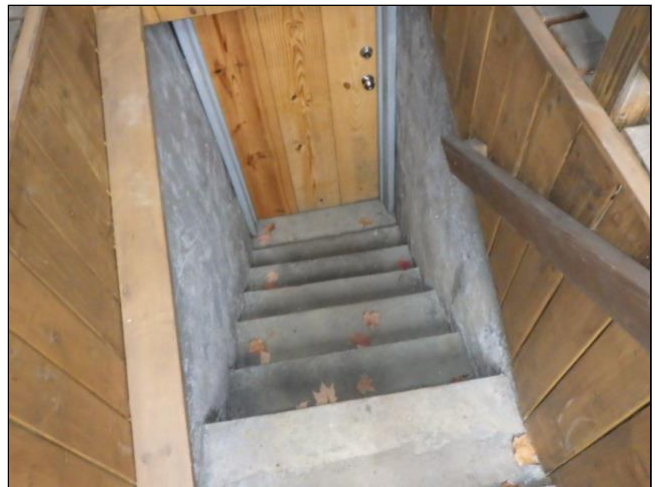
- ✘ The rear steps are uneven. This may be a trip hazard. Recommend adding handrails for safety to all stairs where three or more steps are present.

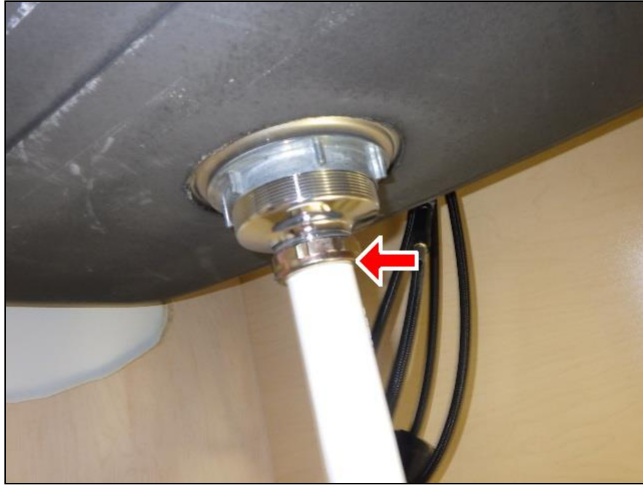
6.2 Item 1(Picture)

- ✘ The drain pipe/connection under the sink is leaking. Qualified plumber to repair drain pipe/connections and further test sink for proper operation after repairs are made.

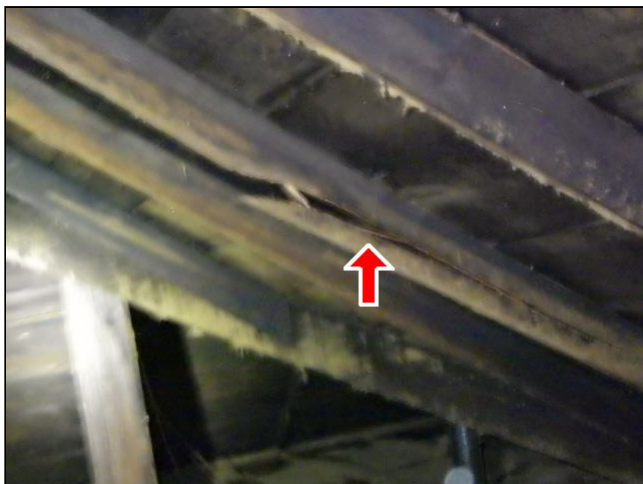
9.2 Item 1(Picture)

(1) One of the rafters is split in the right side of the attic. A second rafter needs to be sistered to the damaged one. Qualified contractor to repair rafter and further evaluate roof framing for proper support within the time period of your contract.

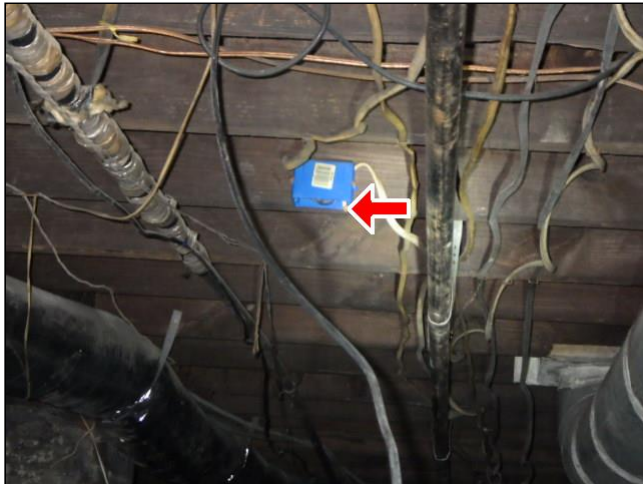
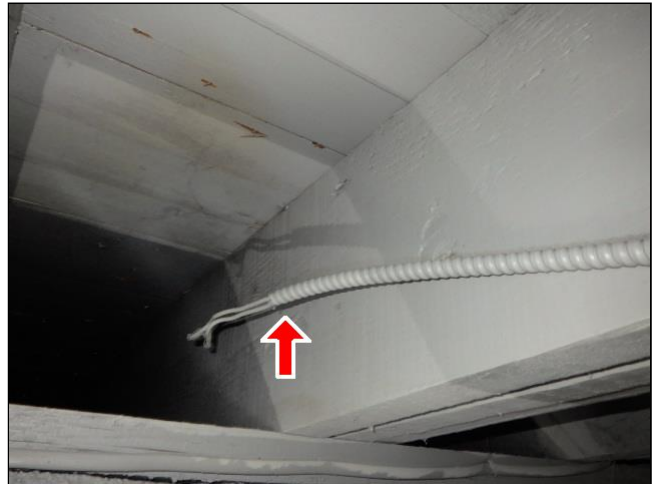
- ✘ Open junction box in the crawl space needs a cover plate installed. Open wire in the cellar needs to be terminated in a junction box. Licensed electrician to repair as needed for safety.

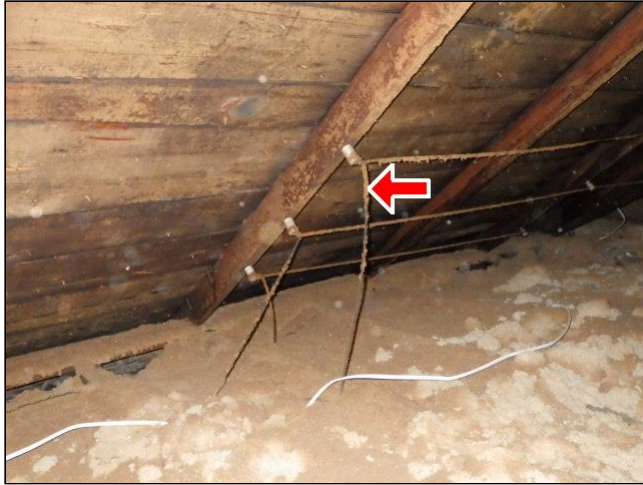
11.6 Item 1(Picture)

- ✘ Original knob and tube wiring observed in the attic space. Unable to determine if some/any knob and tube wiring is still active and in use. This type of electrical wiring is outdated. Recommend consulting with sellers and a licensed electrician to determine if any knob and tube wiring is still active. If active, I recommend a licensed electrician check the condition of the wiring and for the need of repair or possible replacement within the time period of your contract.

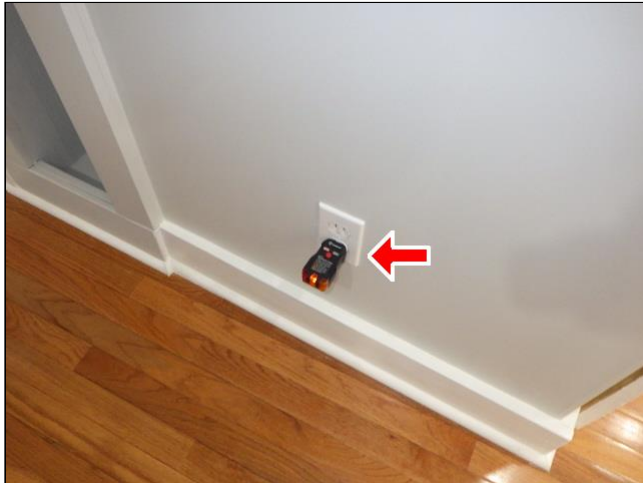
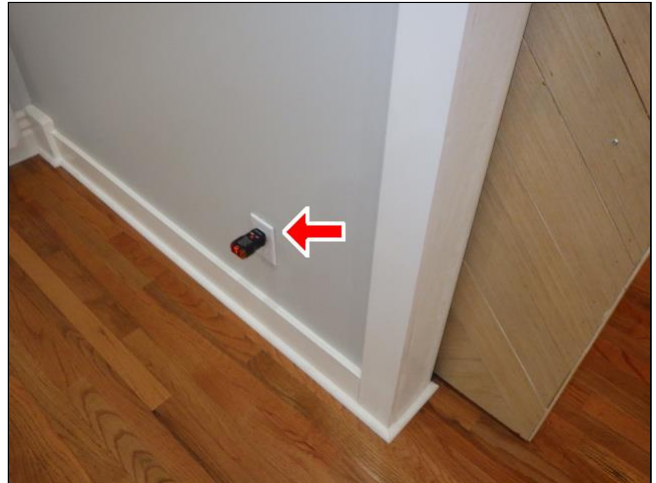
Several outlets in the rear hall and front room have open grounds. Recommend a licensed qualified electrician repair outlets and further evaluate all outlets for proper operation and installation.

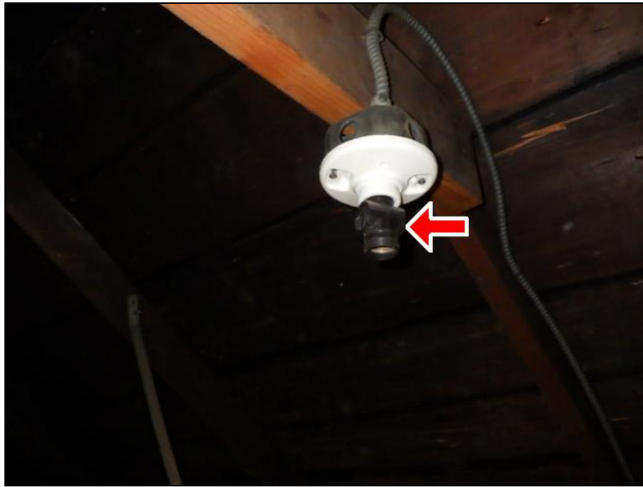
11.9 Item 1(Picture)

The light fixture in the attic did not work. Unable to determine if fixture needs repair or bulb needs to be replaced. Recommend further evaluation and repair.

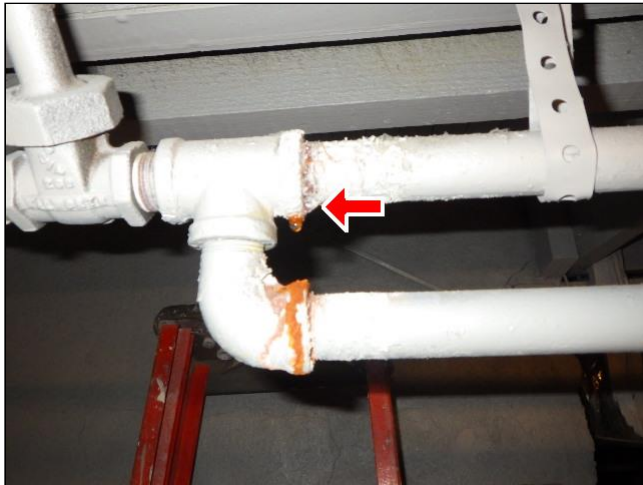
13.0 Item 1(Picture)

- ✘ (1) The house has galvanized pipes that are dipped in a galvanizing solution to coat it inside and out for better protection against corrosion. This type of pipe will corrode over a period of years and can develop pinhole leaks along its length. Galvanized pipe has a tendency to wear (or corrode) from the inside out and gives few clues to its impending failure. A visual inspection cannot reveal the condition of the water pipes unless they are readily visible and showing signs of heavy corrosion. Galvanized water supply lines have a tendency to clog up and restrict the water flow throughout the property. There is no cure for this problem other than replacement of the pipes. Recommend contacting a qualified plumbing contractor to evaluate and determine what repairs are needed.

- ✘ (2) The galvanized pipe in cellar is corroded and leaking. Plumber to repair and inspect all supply lines. (Galvanized pipes may have to be replaced in the future. They can corrode on the inside causing a reduction in water pressure.)

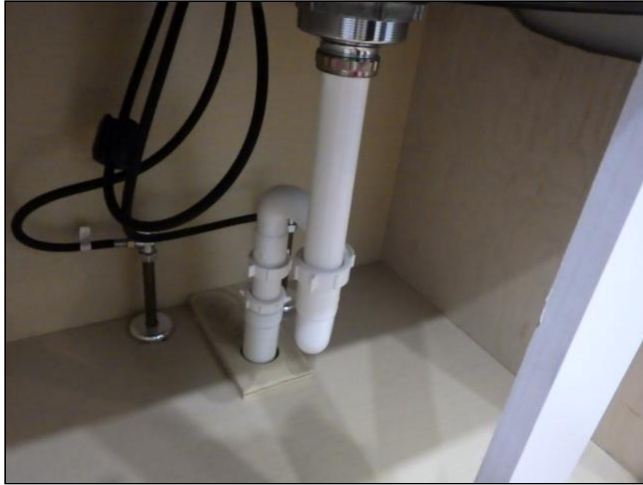
13.4 Item 1(Picture)

- ✘ The sink drains do not appear to be vented to today's construction standards (Kitchen sink). This may have been allowable when the house was constructed. There are no signs of failures at the time of inspection. If this is a concern, I advise a qualified licensed plumber to further evaluate complete plumbing vent system for possible repairs or upgrades needed.

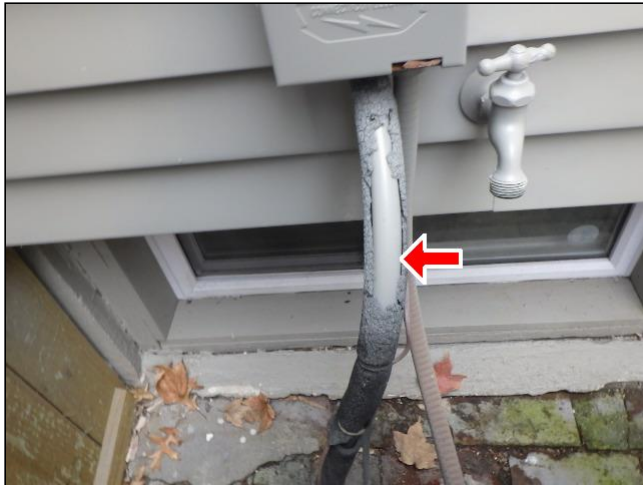
15.1 Item 1(Picture)

✘ The copper cooling line is exposed on the outside by the A/C. Insulation needs to be added to the line.

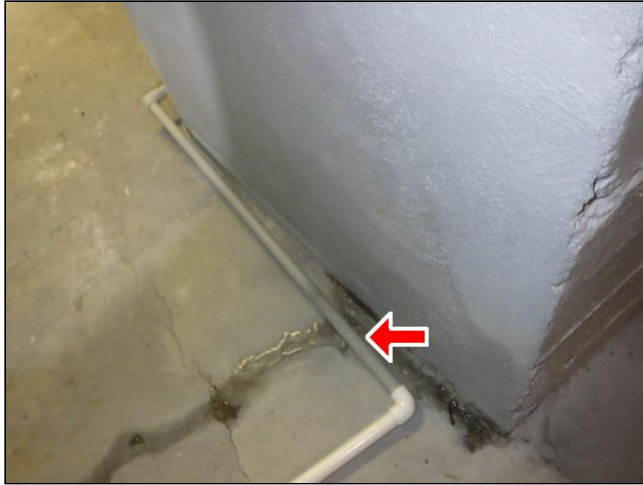
15.2 Item 1(Picture)

✘ The condensation line is leaking in the cellar. Qualified contractor to repair/replace as needed.

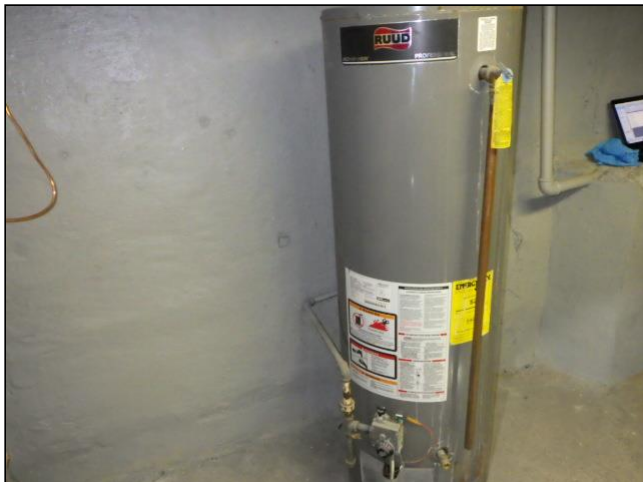
17.3 Item 1(Picture)

- ✘ (1) The water heater is missing the inspection sticker from the county building / permit department. Although the water heater was functioning properly at the time of inspection, I recommend a qualified licensed plumber to further evaluate complete water heater for proper operation, installation, and county inspections.

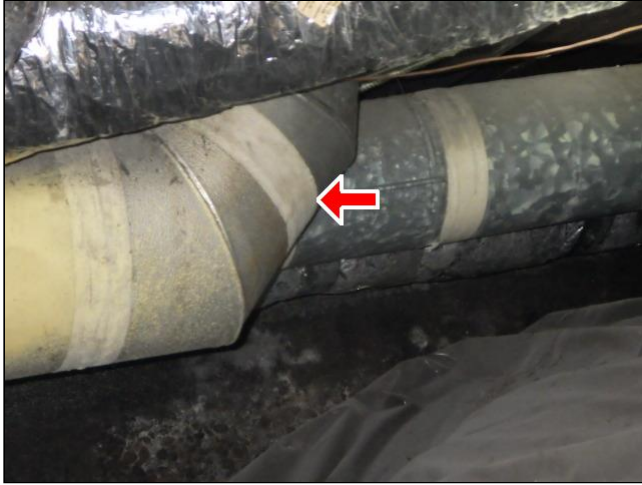
17.6 Item 1(Picture)

✘ There is possible asbestos tape at the duct work connections. Asbestos is harmful if made airborne and breathed into the lungs. This material is typical for buildings of this age. NOTE: Based on the age of the home other material could contain asbestos or other toxins. If this condition is a concern for you, I advise further evaluation by a qualified professional contractor within the time period of your contract.

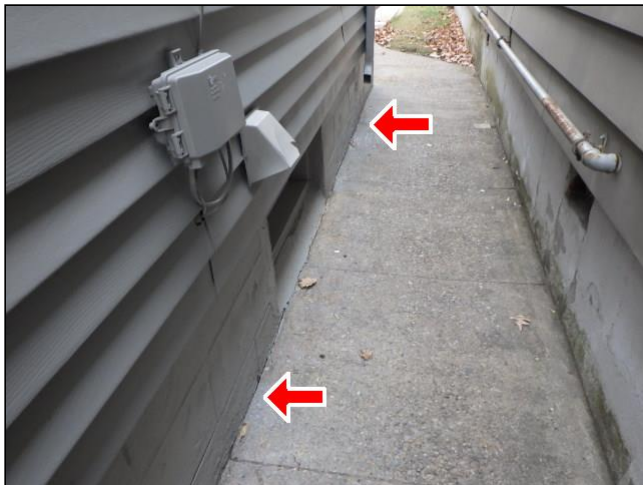
3.2 Item 1(Picture)

Recommend sealing the gap between the concrete sidewalk and foundation to keep out water.

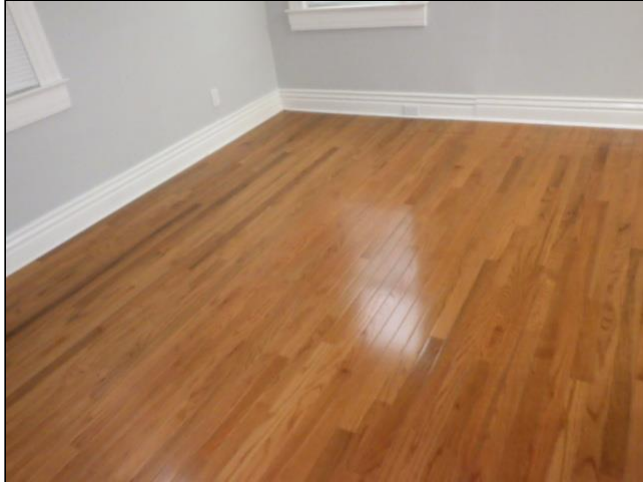
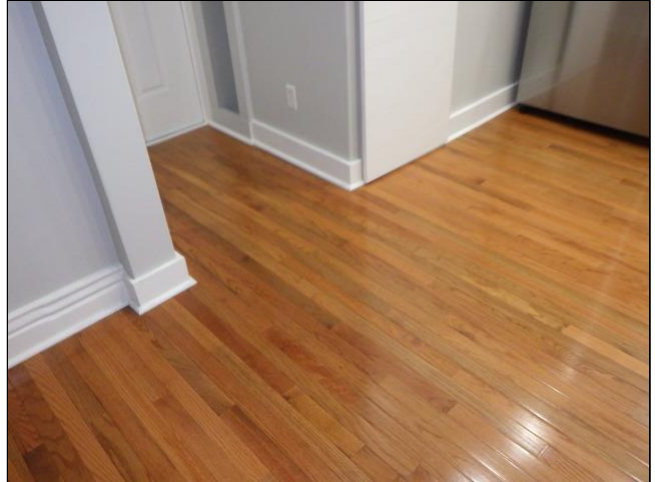
i Floors are slightly sloped in areas but typical for a house of this age.

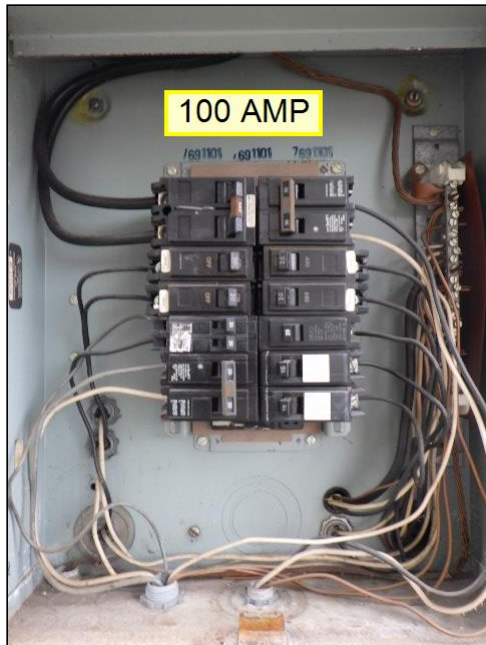
11.1 Item 1(Picture)

View of main panel box with cover removed.

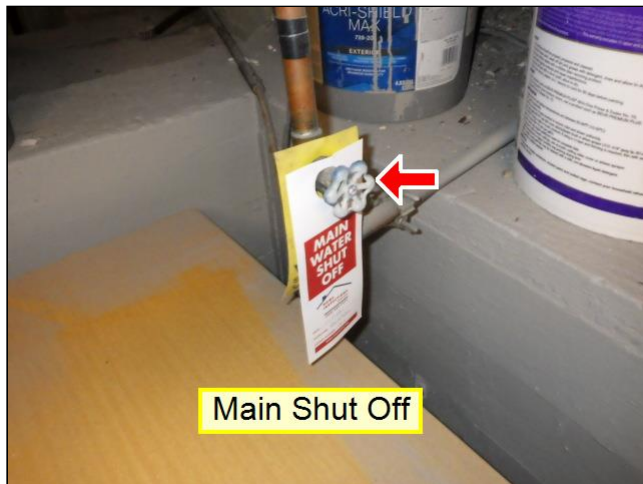
13.1 Item 1(Picture)

The main shut off is located in the cellar.

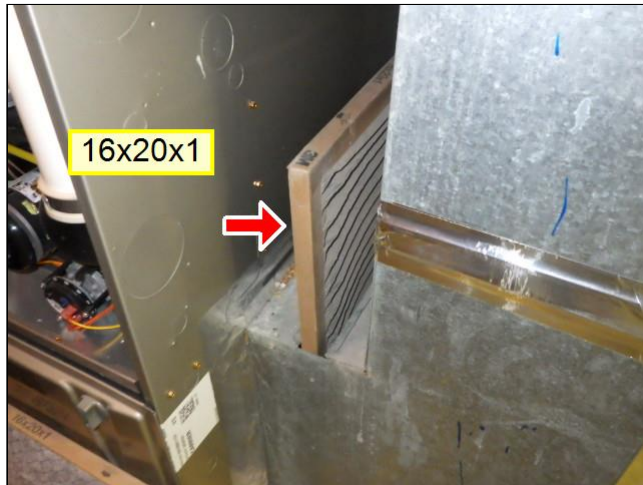
14.5 Item 1(Picture)

Check the filter monthly and replace as needed. Dirty filters will result in poor furnace and A/C performance and will cause increased utility costs. It is also hard on the blower motor and can cause the A/C to ice up and stop working. Indoor air quality will also be decreased.

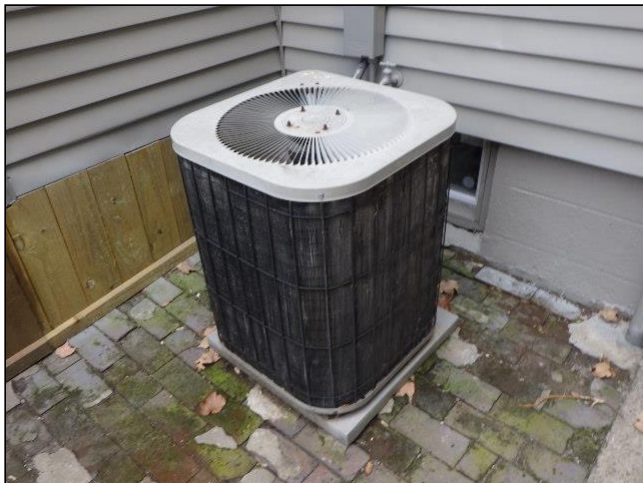
15.3 Item 1(Picture)

The average life of a normal A/C unit is 15 to 20 years. Unable to determine remaining life of unit. **NOTE: This AC unit is past it's life expectancy. The inspector does not, and will not warrant or guaranty the AC unit, AC can fail at anytime (There are no exceptions).**

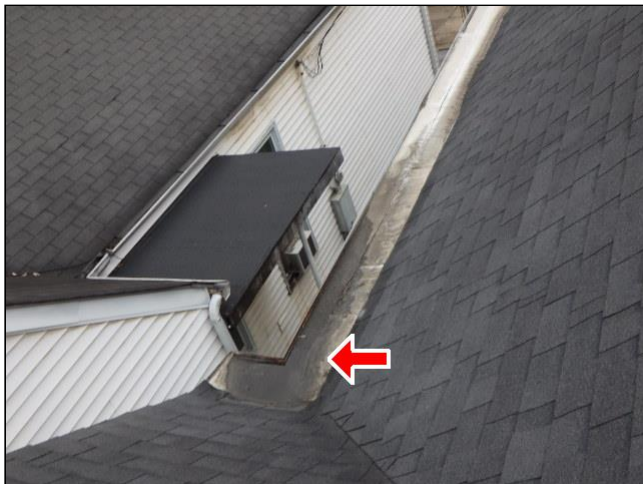
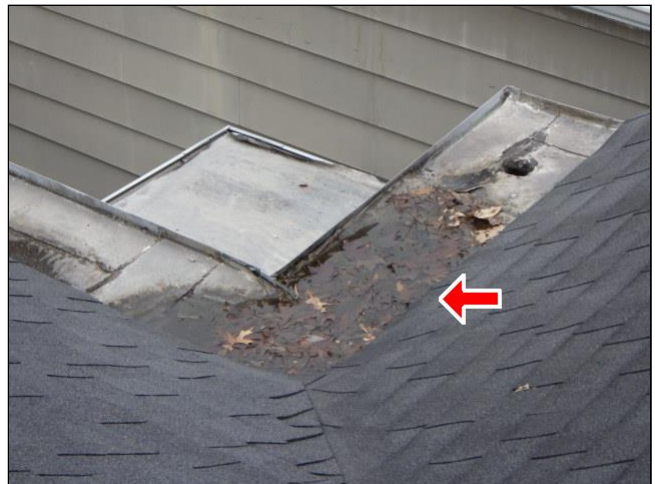
Box gutters are not within the scope of the inspection. Box gutters appear clogged and holding water. Box gutters need to be checked yearly for cracks or separation at the seams. Recommend having complete box gutters system inspected by a contractor prior to closing.

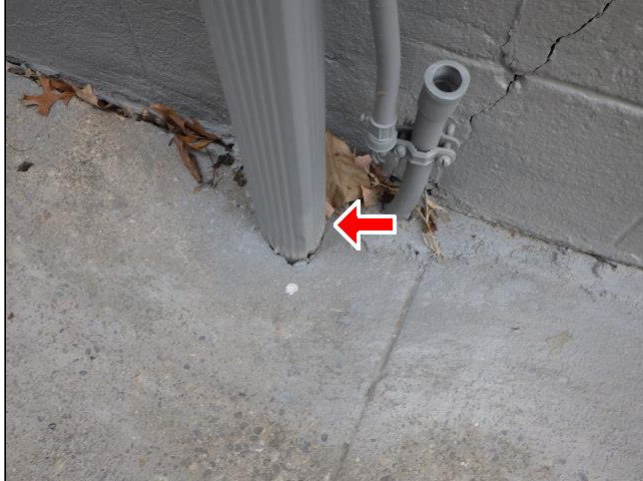
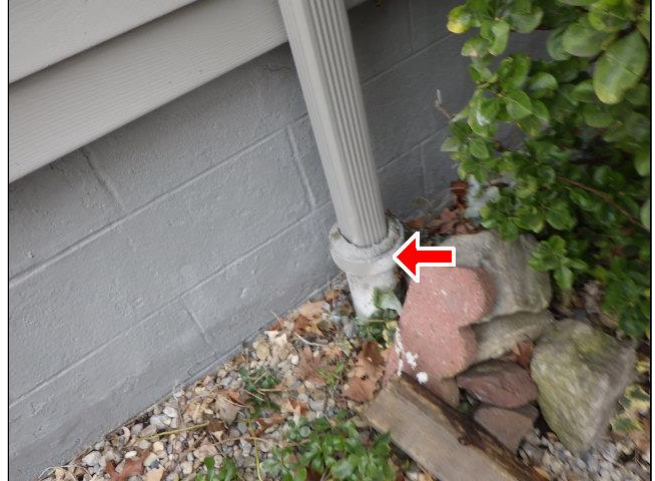
- ⊘ The downspouts are run underground to the storm sewers. It is beyond the scope of a home inspection to determine if the lines are functioning properly.

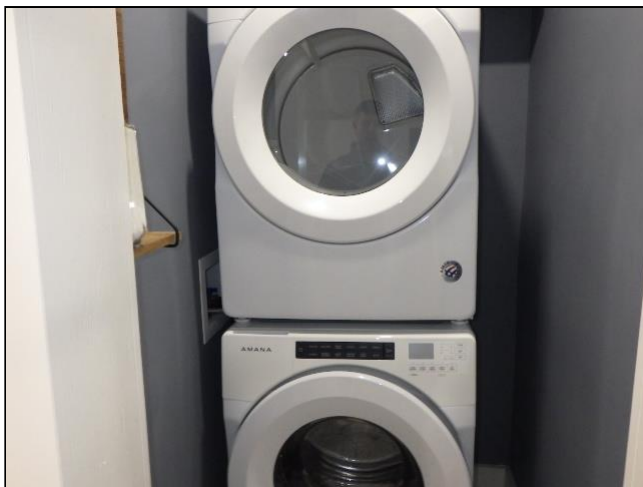
16.0 Item 1(Picture)

- ⊘ A home inspection does not include the connections of a washing machine per Standard of Practice (including drain system). If this is a concern, I highly recommend having connections inspected and tested by a professional qualified contractor before closing and moving in.
